# **STRUCTURAL INTEGRITY REPORT**

## **CONDOMINIUM CONVERSION**

**1500 Ouellette Ave.  
WINDSOR, ONTARIO**

**Date: November 2022  
Our Project No.: 22-A170**

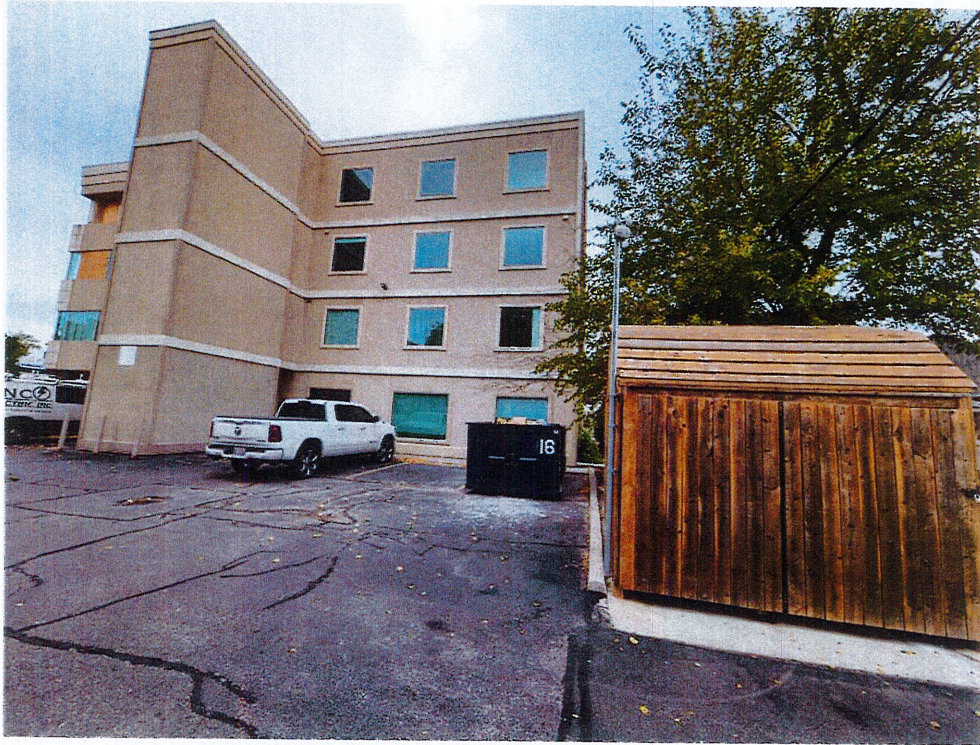
- From our observation, it would appear that the condition of the building's overall structure is sound. It appears that, overall, the building is maintained on regular basis.
- Asphalt pavement of the above grade parking area south of the building is extremely deteriorated and the part of the basement underneath the paved area shows signs of concrete delamination and cracks

Exterior EIFS façade (deteriorated asphalt pavement)

- *It is our recommendation to remove existing deteriorated asphalt pavement, implement top and soffit concrete delamination repairs and install new water proofing membrane before the reinstatement of the asphalt pavement. This work should be done under the supervision of a qualified professional engineer licensed to practice in the province of Ontario.*

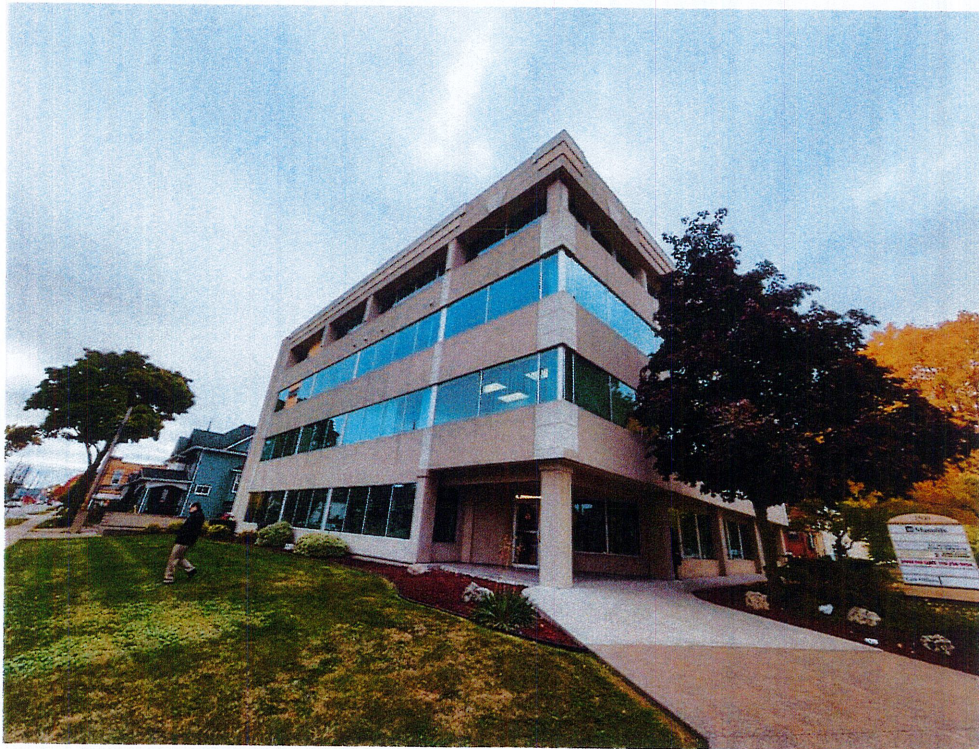
Exterior EIFS façade

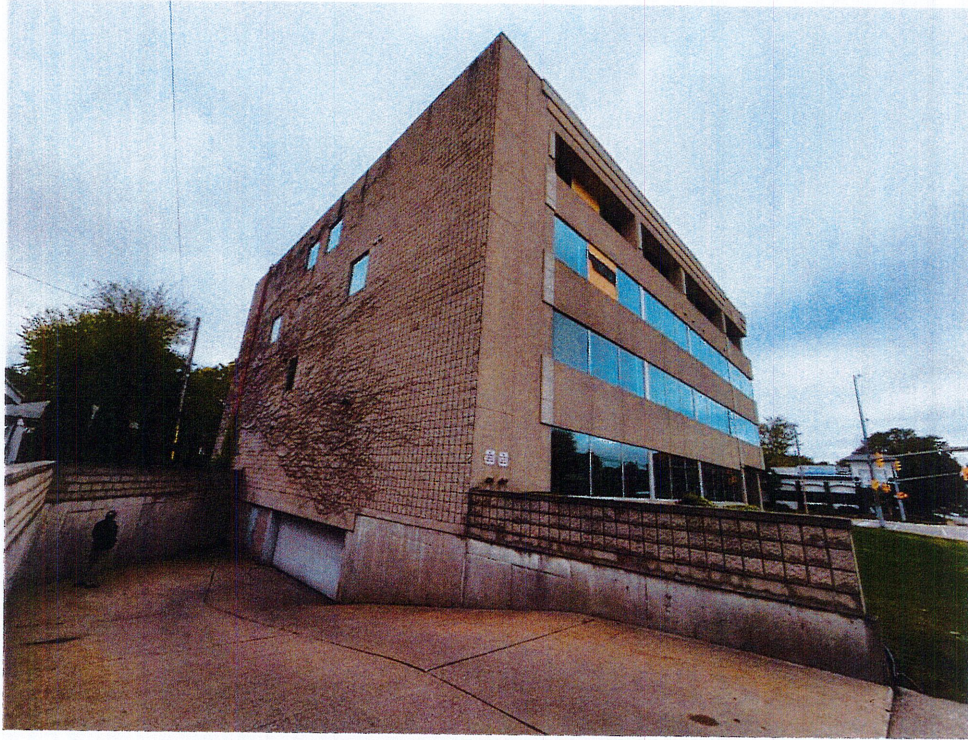
Exterior block façade

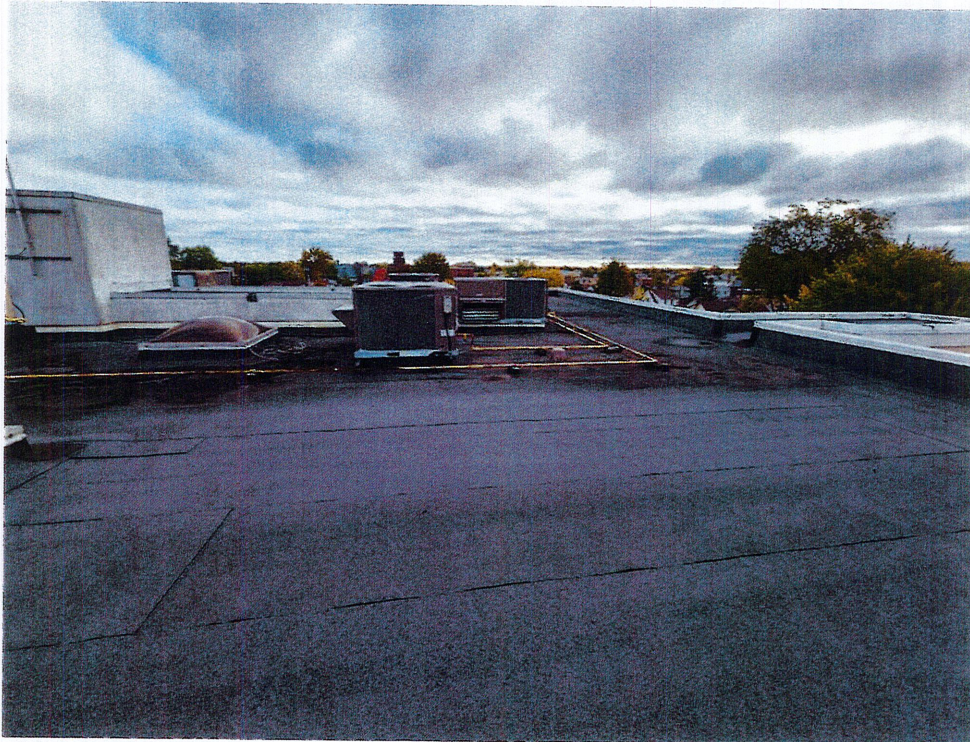
From our observation, it would appear that the condition of the roof is sound. There were no visible cracks or decay on the exposed areas. It appears that the building is maintained on regular basis.

Roof

*No action is recommended at this time.*

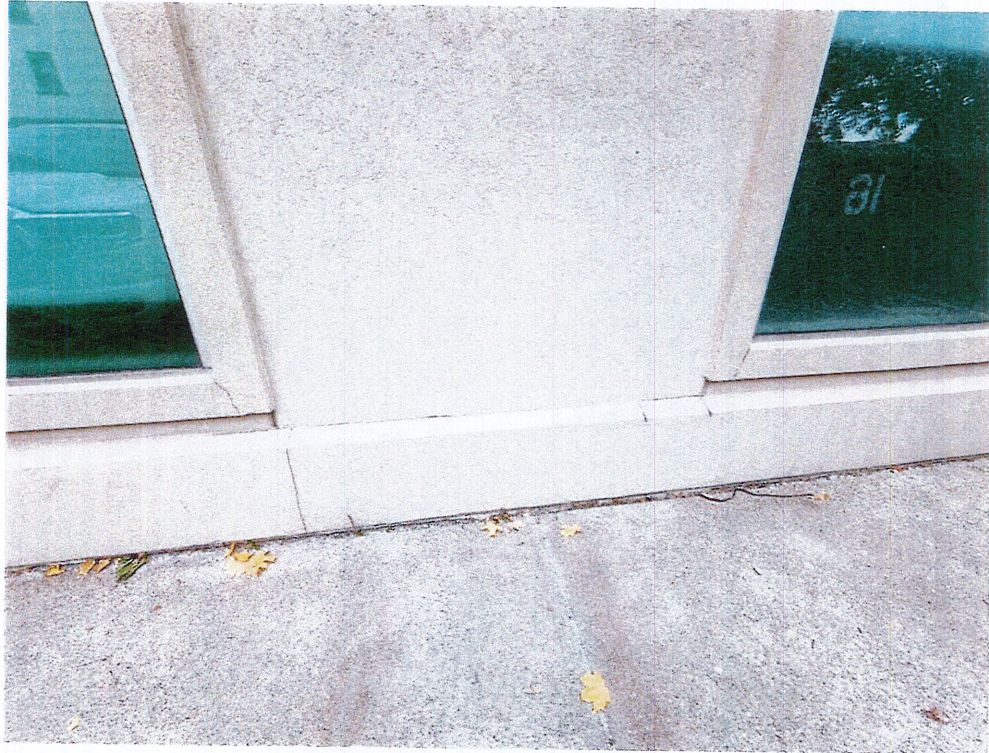
There were some locations where cracking in the exterior insulation and finishing system (EIFS) cladding was noted. These locations are at the corners of windows and between the floors at south and north elevations.

Exterior EIFS cracks at windows

*It is recommended that cracks in the exterior insulation finish system cladding to be repaired along with the crack noticed in the west wall concrete block wall*

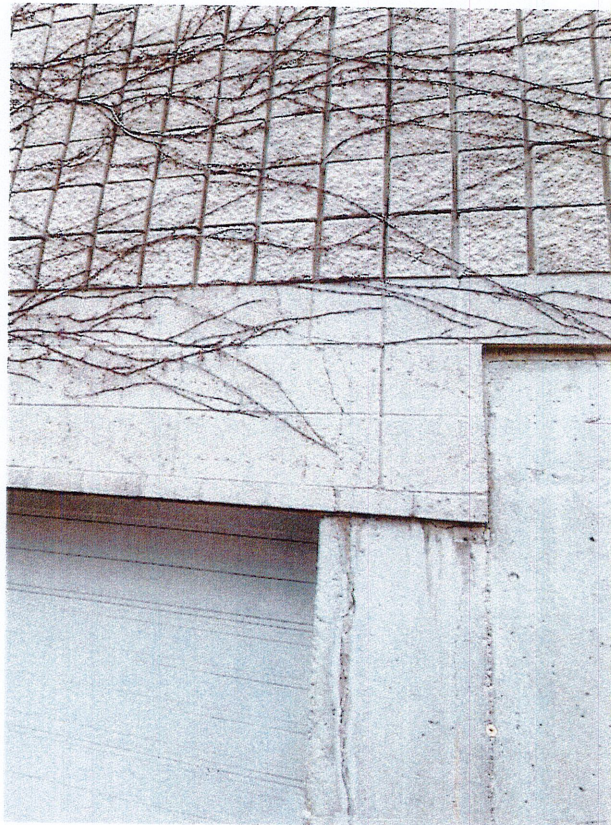
There was one location where cracking in the exterior concrete block was noted. This location is at the concrete block above the lintel of overhead door in basement level.

Exterior block cracks at overhead door

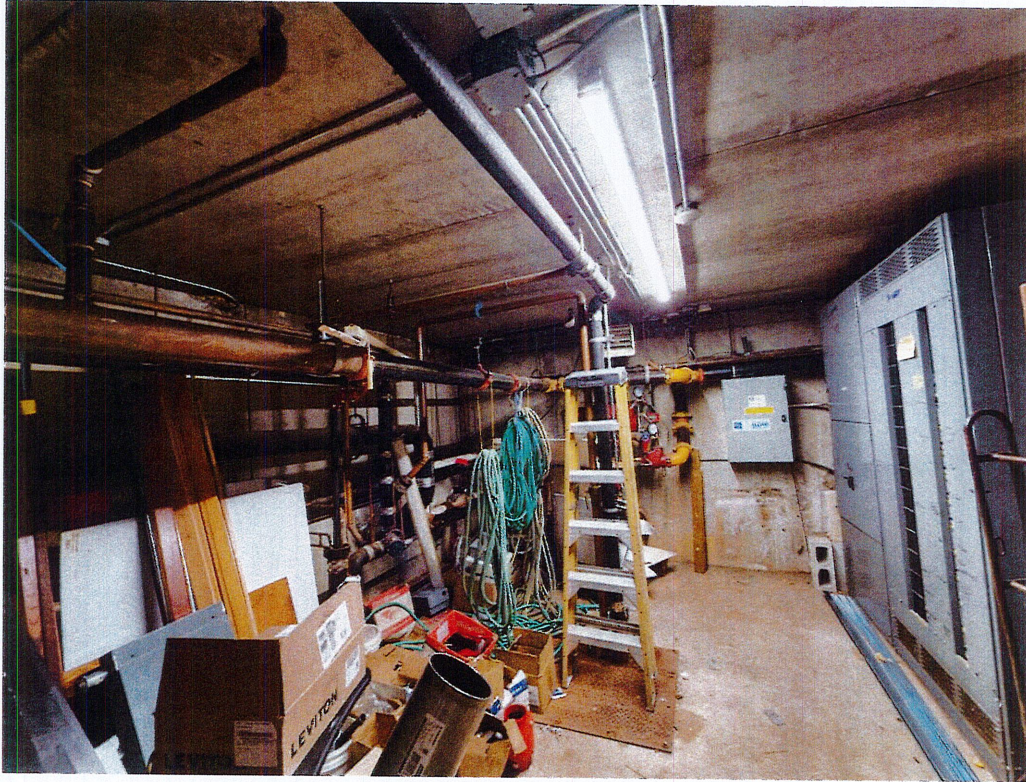
Main electrical room

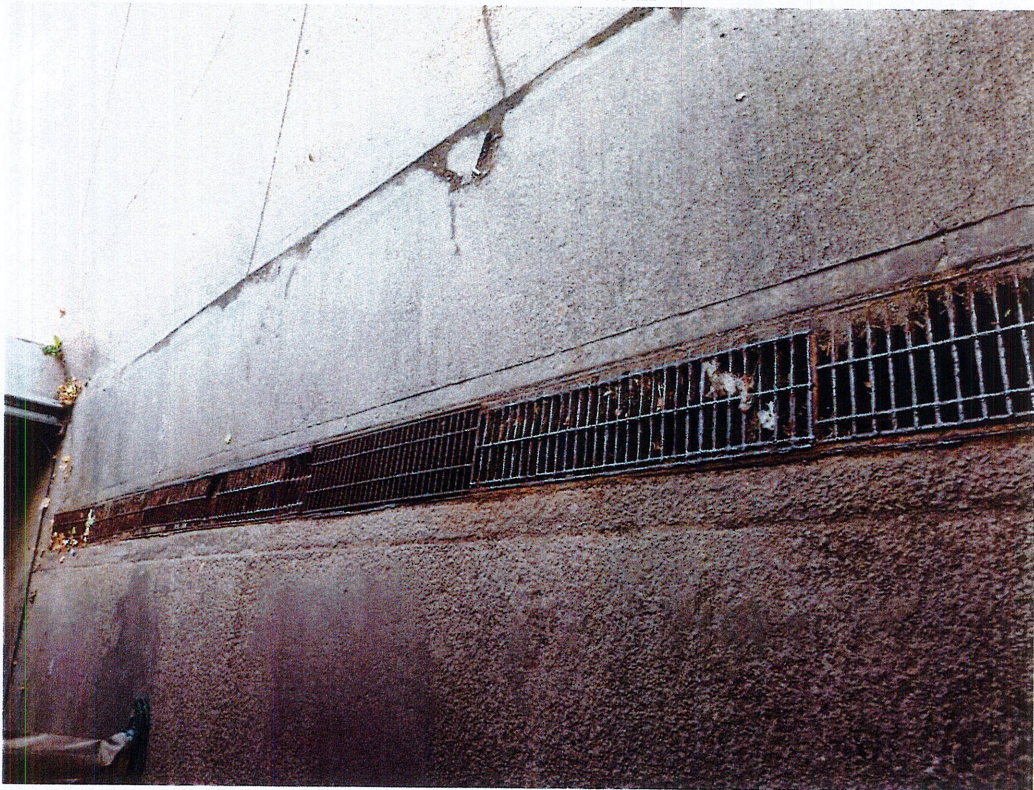
- From our observation, it would appear that the building internal walls, floors and ceiling finishes are in good condition. There were no visible structural cracks or decay in the exposed areas. It appears that the building is maintained on regular basis.
- Basement level overhead door trench cover is deteriorated.

Deteriorated drain trench cover

- *Replace basement overhead door trench cover.*

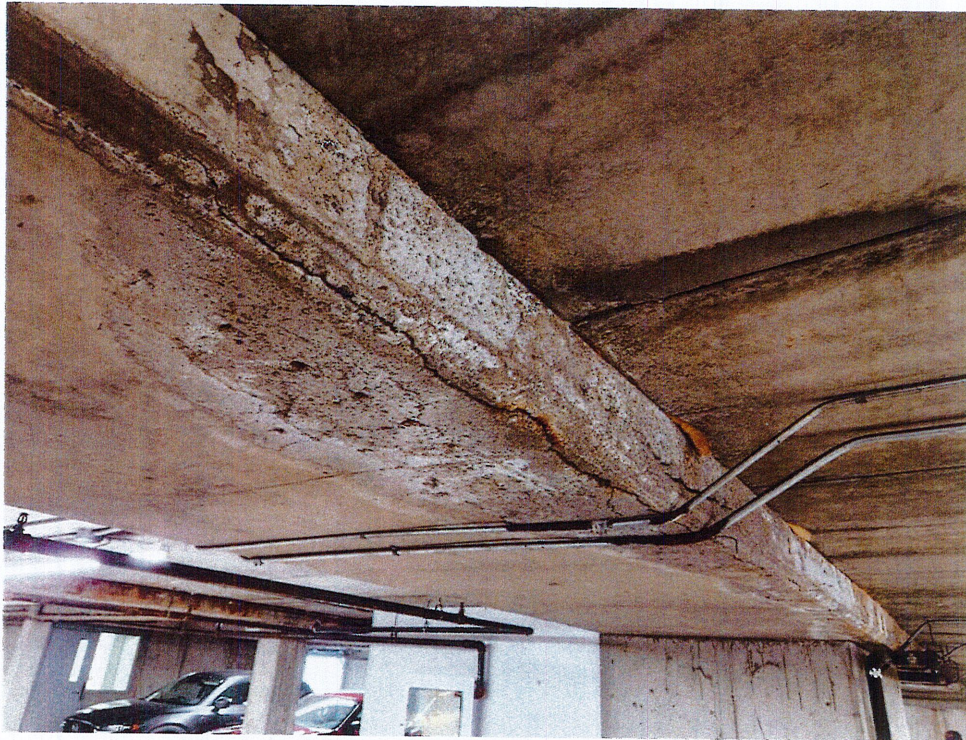
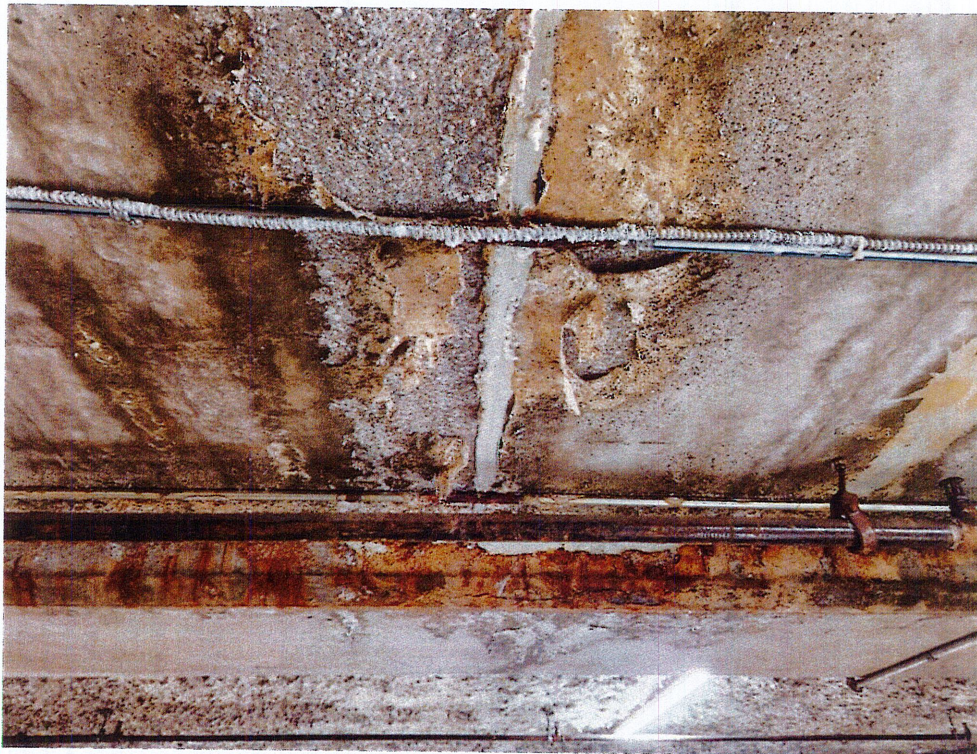
Concrete beam delamination at parking deck
