# Transit Windsor Garage Feasibility Study

Future Facility Strategy

Prepared for the City of Windsor  
by IBI Group

October 28, 2021

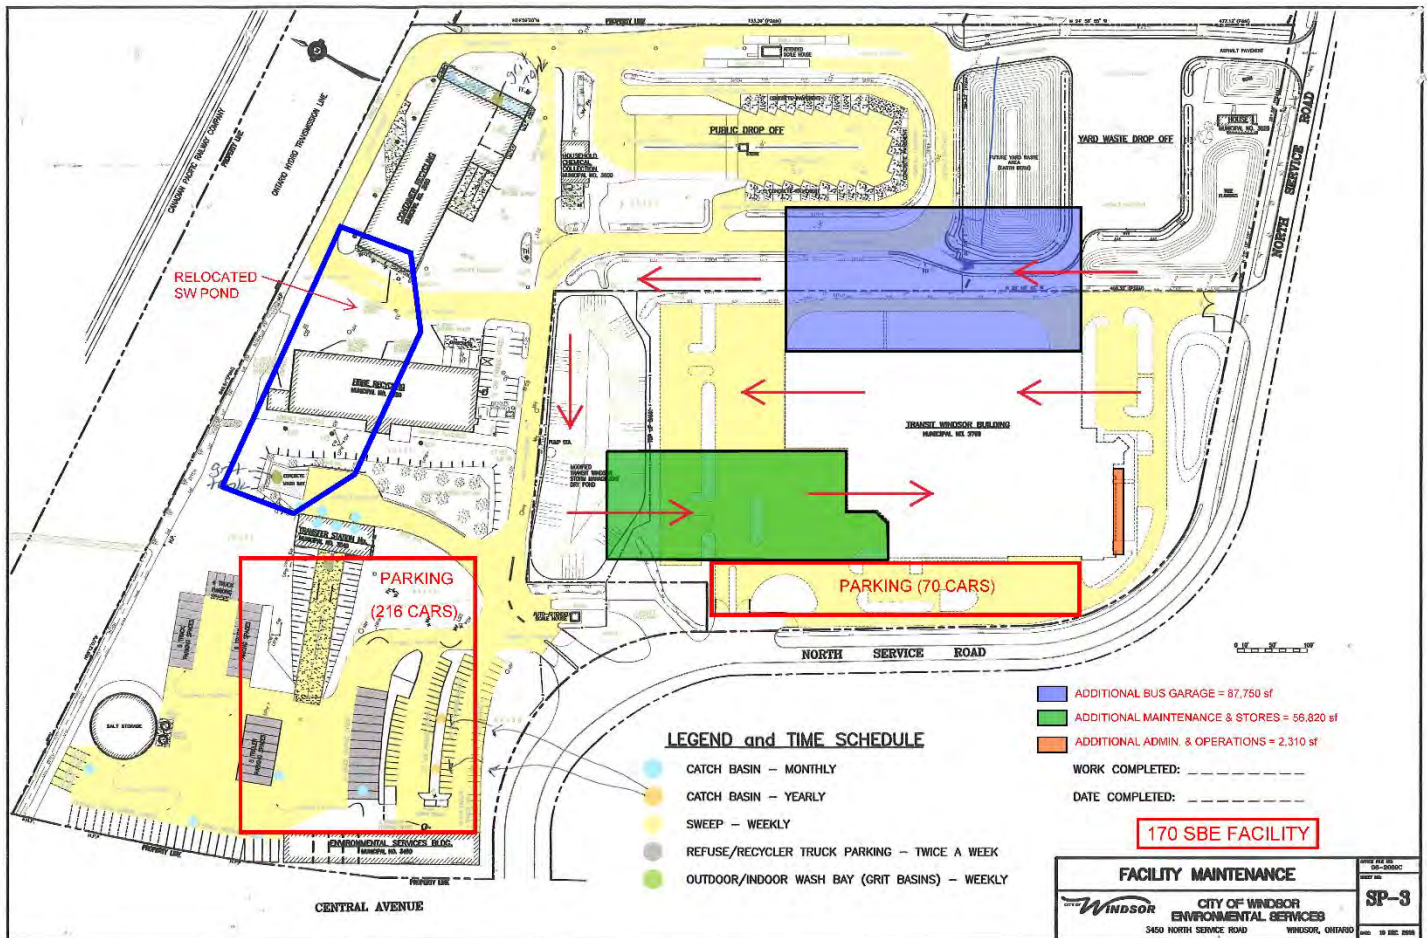
**Exhibit 4.2: 171-Bus Facility Overlaid on Existing Site**

As noted earlier, the existing facility was designed for 96 buses and some 230 employees, is approximately 12,200 m<sup>2</sup> in size, and is situated on approximately 10 acres (4.1 hectares). The facility illustrated in Exhibits 2.1 and 4.1, would be approximately 35,850 m<sup>2</sup> in size and require a site of 21 acres (8.5 hectares). Based on these parameters, the city's future transit facility needs cannot be accommodated on the existing site. An additional 11 acres is required. To illustrate and confirm this conclusion, the concept plans for a 171-bus and 242-bus facility were over-laid on the existing building and site. Exhibits 4.2 and 4.3 demonstrate that the future facility requirements cannot be accommodated on the existing site.

Over-laying the future facility requirements on the existing facility also illustrates the challenges associated with attempting to expand the existing building specifically with regard to the vehicle maintenance area, the service lanes (the need to add an additional lane) and the vehicle storage area. Further, as may be visualized from the diagram, it would be difficult to restructure and expand the building while maintaining operations, especially vehicle maintenance activities since many parts of the building structure would need to be altered. Additionally, as noted earlier, the building structure would be difficult to modify to expand the building given its concrete block rather than steel frame design.

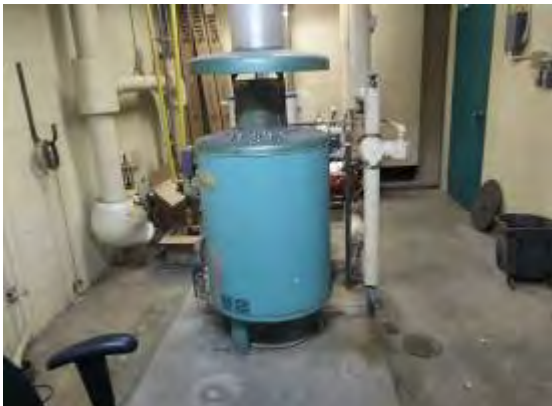
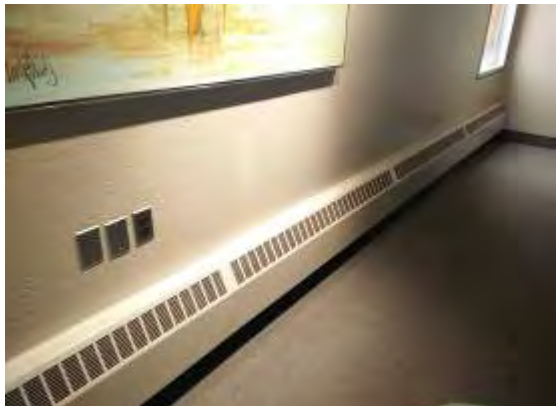
<p><b>Typical Life Span:</b> 25</p>	<p><b>Remaining Life:</b> 2</p>	<p><b>Current Effective Age:</b> 23</p>
<p><b>Recommendations</b></p> <p>Its typical lifespan is 25 years however it has already passed its typical life expectancy as is still observed to be in fair and working condition. Replacement of the boiler can be deferred to year 2. Other primary heating components can be replaced on an as-needed basis.</p>		
<p><b>Project Breakdown</b></p>	<p><b>QTY:</b> 1</p>	<p><b>Capital Cost:</b> \$20,000</p>

<p>Hot water boiler</p>	<p>Fin tube radiators in boardroom</p>

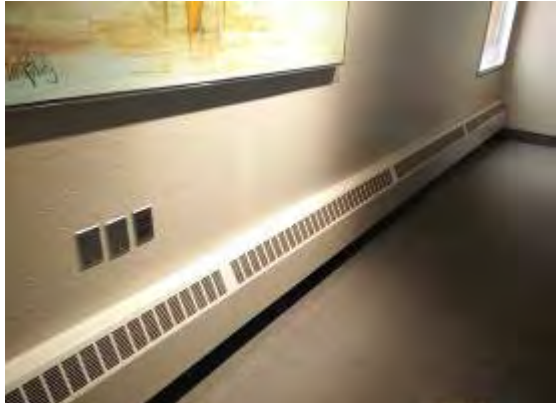
<b>Component Rating:</b> Fair (3)		<b>Installation Date:</b> 1979
<b>Typical Life Span:</b> 35	<b>Remaining Life:</b> 3	<b>Current Effective Age:</b> 32
<p><b>Recommendations</b></p> <p>Replacement of ductwork does not truly occur unless damages have been observed or the sizing is insufficient for the air handling unit provided. This item is anticipated for repairs and/or replacement during the study period. An allowance is carried for general repairs and/or replacements to the hydronic distribution system over the study period.</p>		
<b>Project Breakdown</b>	<b>QTY:</b> Allowance	<b>Capital Cost:</b> \$30,000

Excessive residue above heat emitting radiator	Fin tube radiators

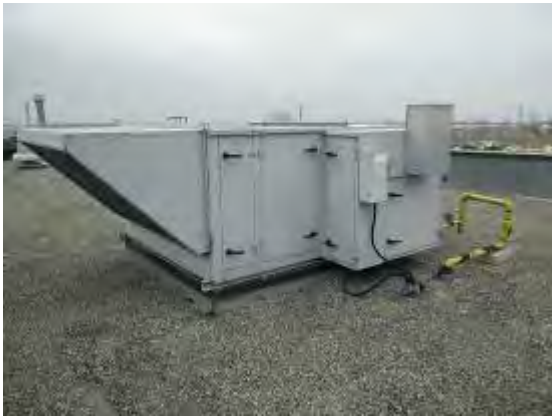
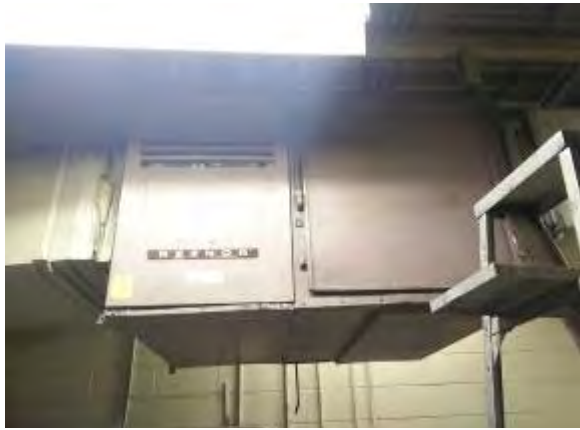
<p><b><u>Recommendations</u></b>          The interior make up air units have been deferred, where possible, to extend its normal life span. A budget of \$55,000 has been allocated for the replacement of these units and is recommended to be replaced in year 3. Based on a normal life span for this component, repairs and/or replacements are anticipated during the study period. Appropriate costs are carried. Regular maintenance such as air filter replacement can be done on an as-needed basis.</p>		
<p><b><u>Project Breakdown</u></b></p>	<p><b><u>QTY:</u></b> Allowance</p>	<p><b><u>Capital Cost:</u></b> \$100,000</p>

<p>Make up air unit</p>	<p>Interior make up air unit</p>

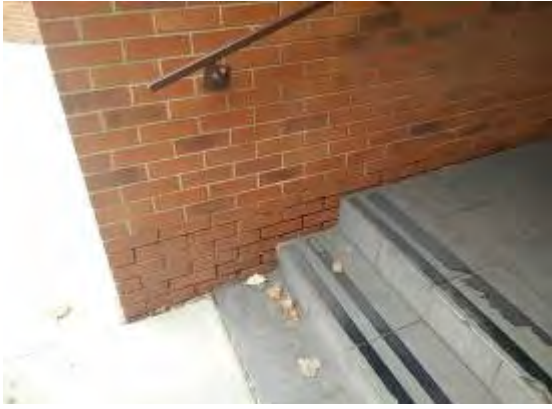
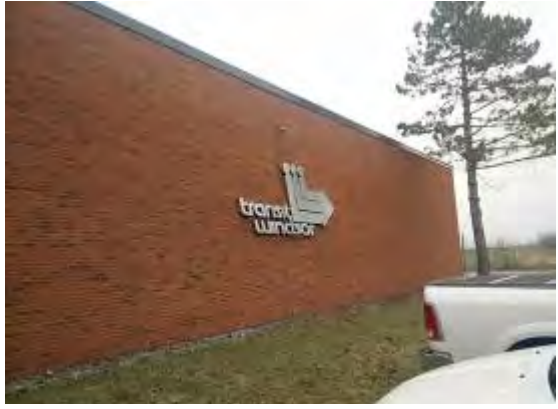
<p>Deteriorating mortar joints</p>	<p>Brick veneer at front of building</p>

<p><b>Project Breakdown</b></p>	<p><b>QTY:</b> Allowance</p>	<p><b>Capital Cost:</b> \$30,000</p>

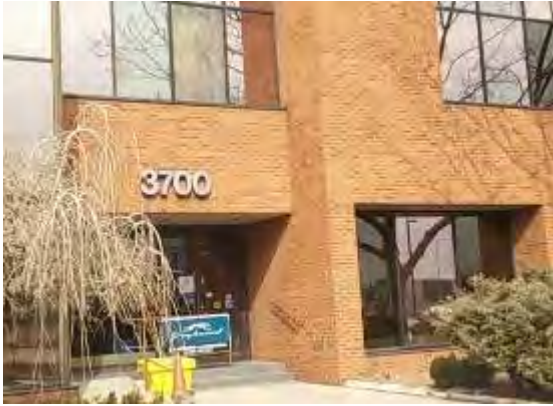
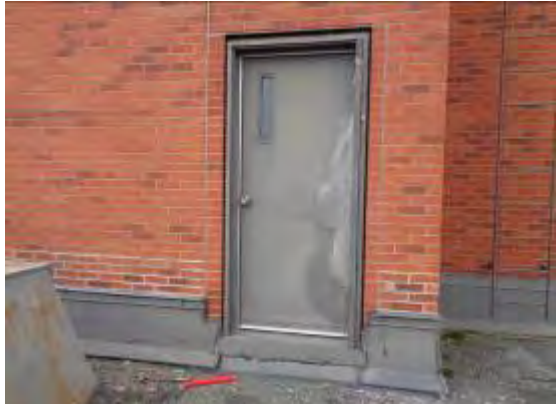
<p><b>Component Rating:</b> Fair (3)</p>		<p><b>Installation Date:</b> 1979</p>
<p><b>Typical Life Span:</b> 35</p>	<p><b>Remaining Life:</b> 3</p>	<p><b>Current Effective Age:</b> 32</p>
<p><b>Recommendations</b></p> <p>This item has been deferred, where possible, to extend its normal life span. Based on a normal life span for this component, repairs and/or replacements are anticipated during the study period. Appropriate costs are carried.</p>		
<p><b>Project Breakdown</b></p>	<p><b>QTY:</b> 25</p>	<p><b>Capital Cost:</b> \$90,000</p>

<p>Main entrance</p>	<p>Exterior door on rooftop</p>

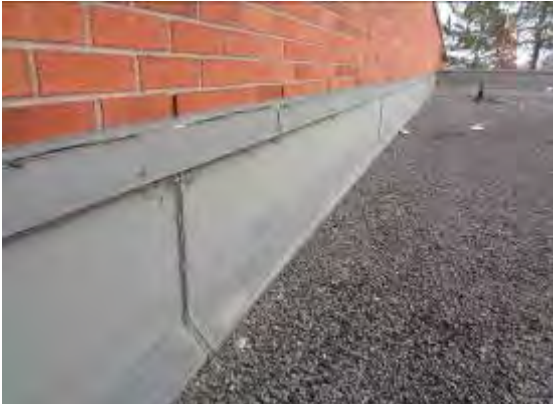
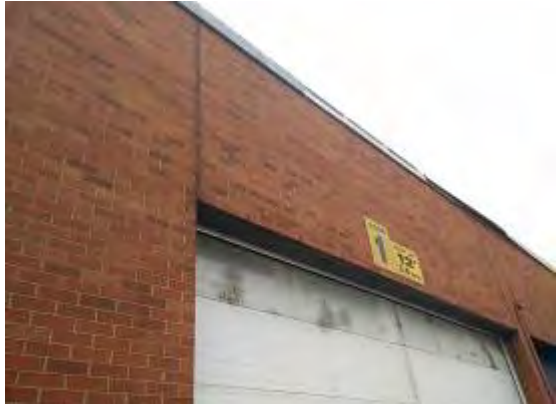
<p>Sealant at brick veneer and flashing</p>		<p>Sealant at exterior cladding control joint</p>

<p><b>Project Breakdown</b></p>	<p><b>QTY:</b> Allowance</p>	<p><b>Capital Cost:</b> \$15,000</p>

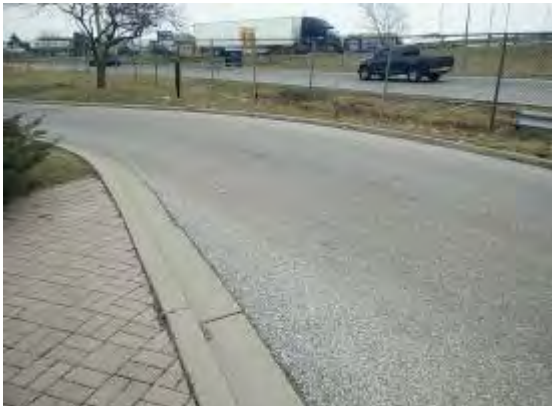
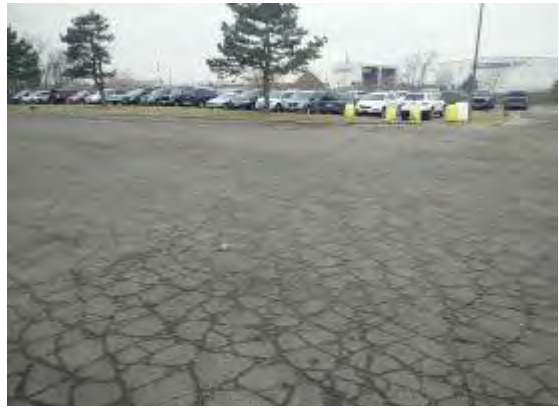
<p><b>Component Rating:</b> Poor (4)</p>		<p><b>Installation Date:</b> 1979</p>
<p><b>Typical Life Span:</b> 20</p>	<p><b>Remaining Life:</b> 1</p>	<p><b>Current Effective Age:</b> 19</p>
<p><b>Recommendations</b></p> <p>Paving of the asphalt driveways and parking areas is recommended to be done within 1 year due to its condition. An allowance is carried. Replacement of the concrete curbing should coincide with the asphalt repaving. General maintenance such as cleaning engine fluids off the asphalt paved areas is considered under operations and maintenance.</p>		
<p><b>Project Breakdown</b></p>	<p><b>QTY:</b> 150,000sf</p>	<p><b>Capital Cost:</b> \$613,000</p>

<p>Asphalt paved driveway</p>	<p>Rear parking lot area</p>
