### **UNDERWATER INSPECTION REPORT BY WATECH SERVICES INC.**

**UNDERWATER INSPECTION OF LAKE ST. CLAIR SEAWALL  
SEAWALL INSPECTION  
Windsor, Ontario**

**Prepared for:  
LANDMARK ENGINEERS Inc.**

**November 2019**

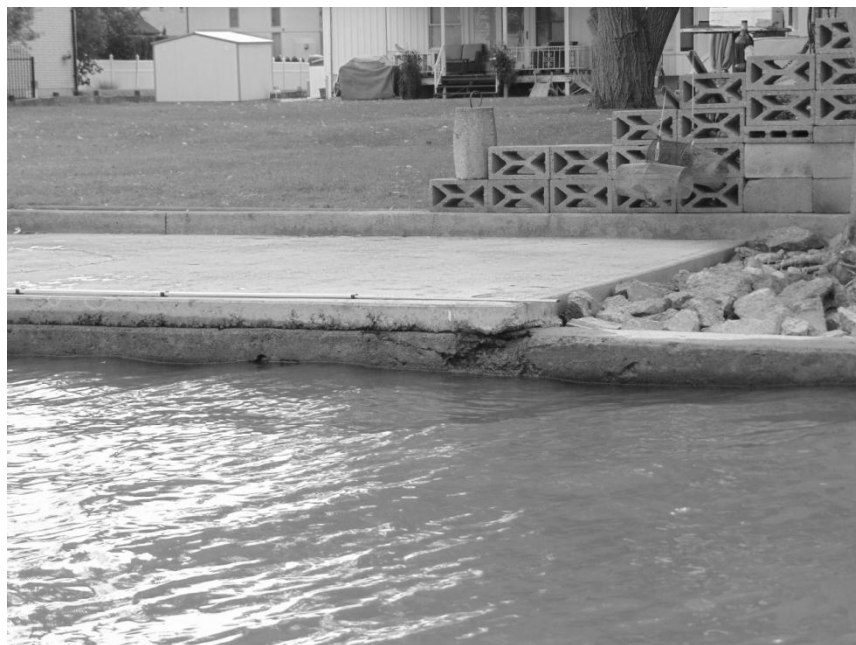
PHOTO # 16

Concrete panel area at  
chainage 0+100

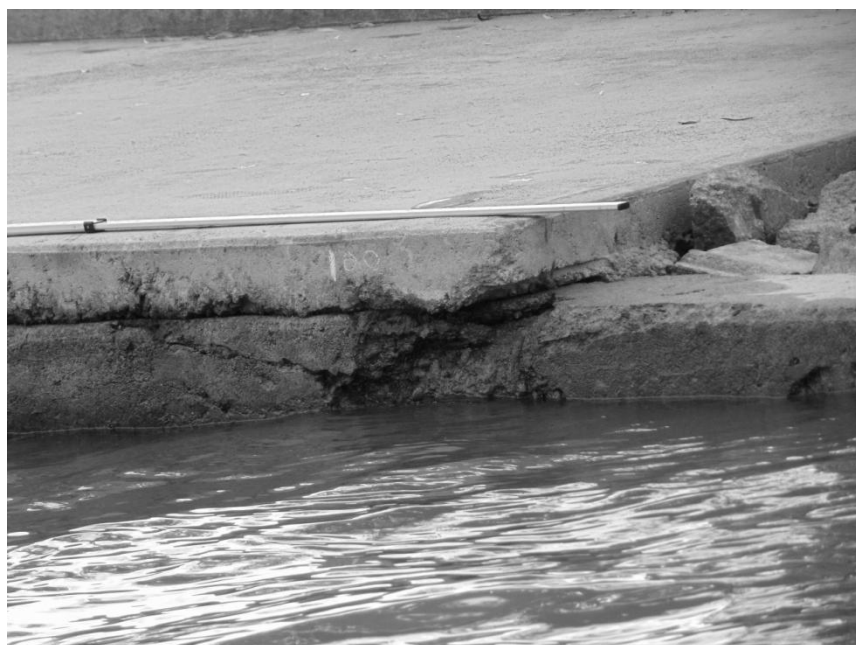
PHOTO # 17

Concrete panel area at  
chainage 0+120. Concrete  
surface spalling,  
dimensioned 0.254m wide  
by 0.076m high by 0.076m  
deep

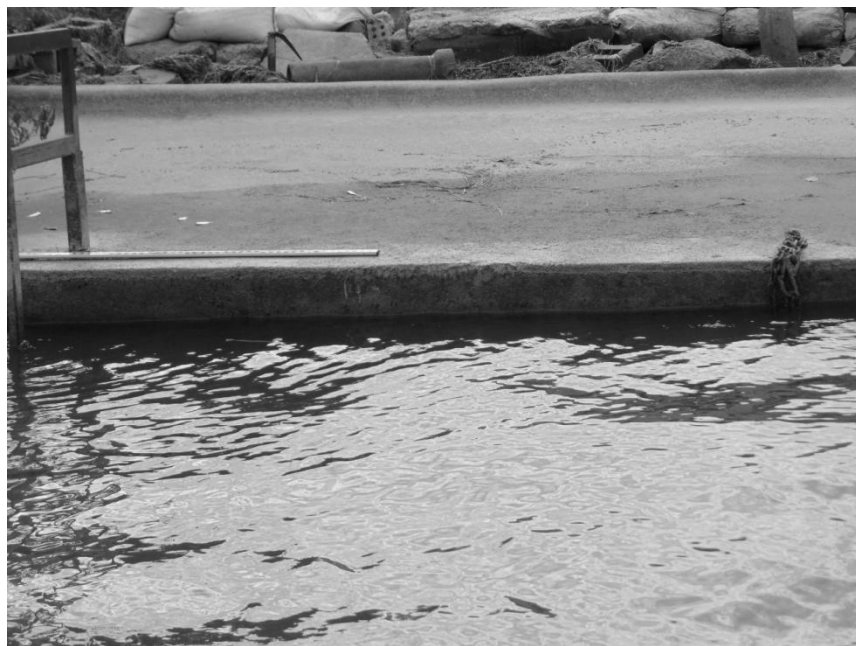
PHOTO # 18

Concrete panel area at  
chainage 0+120. Concrete  
surface spalling,  
dimensioned 0.254m wide  
by 0.076m high by 0.076m  
deep

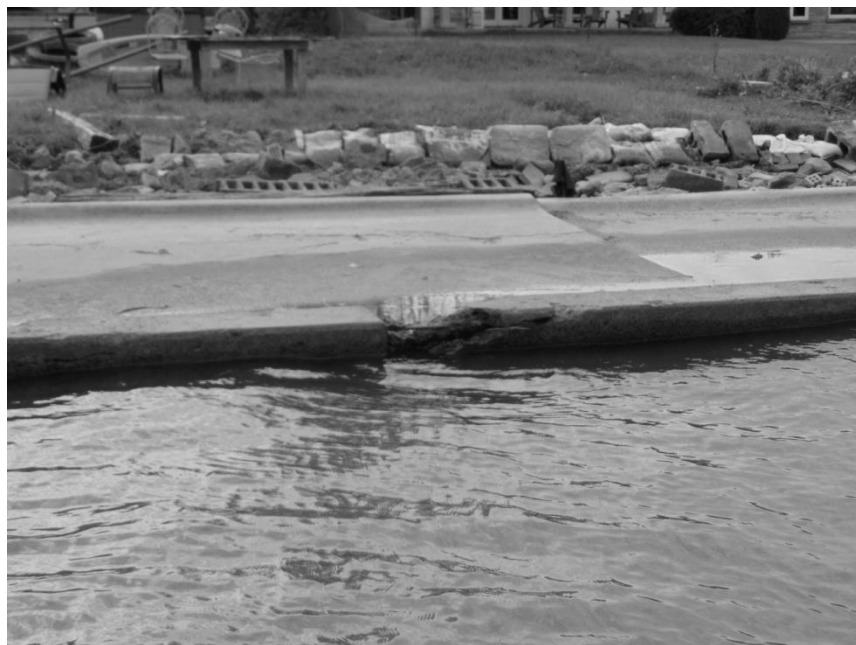
PHOTO # 20

Concrete panel area at  
chainage 0+140

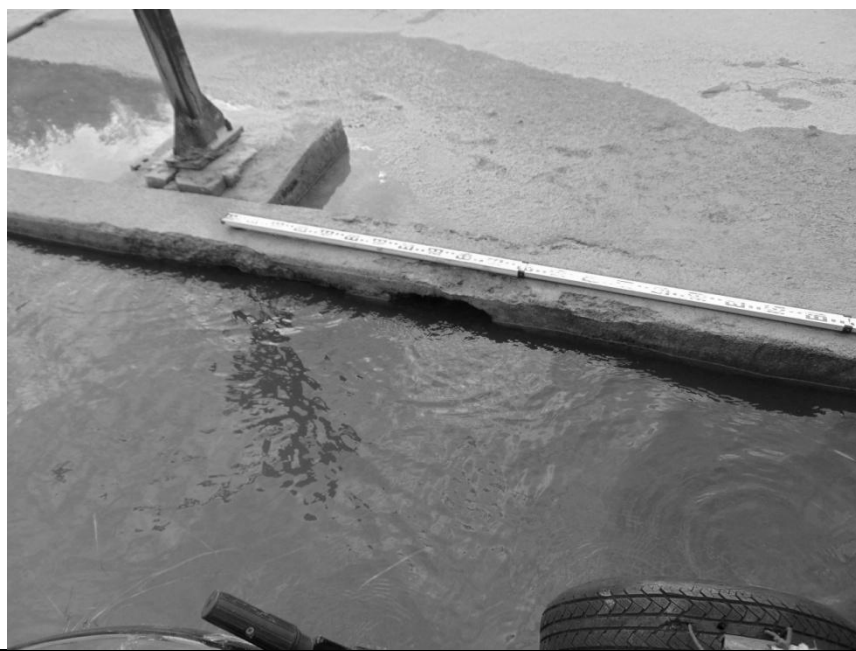
PHOTO # 21

Concrete panel area at  
chainage 0+144. Spalling  
and concrete loss located  
in the joint of the concrete  
panel, dimensioned  
0.254m long by 0.186m  
wide by 0.152m deep

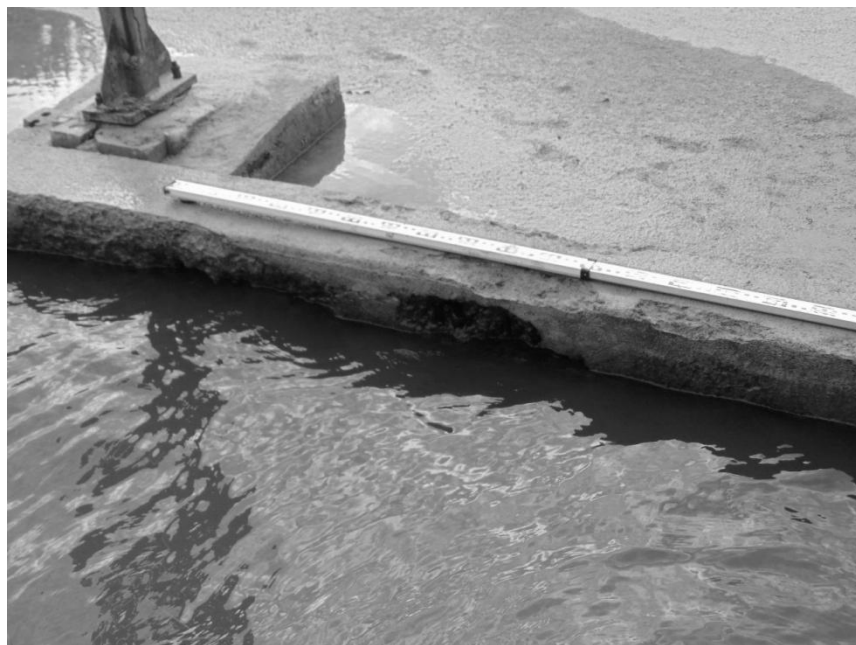
PHOTO # 22

Concrete panel area at chainage 0+150. Spalling of concrete and concrete loss dimensioned 1.5m long by 0.381m wide by 0.152m deep

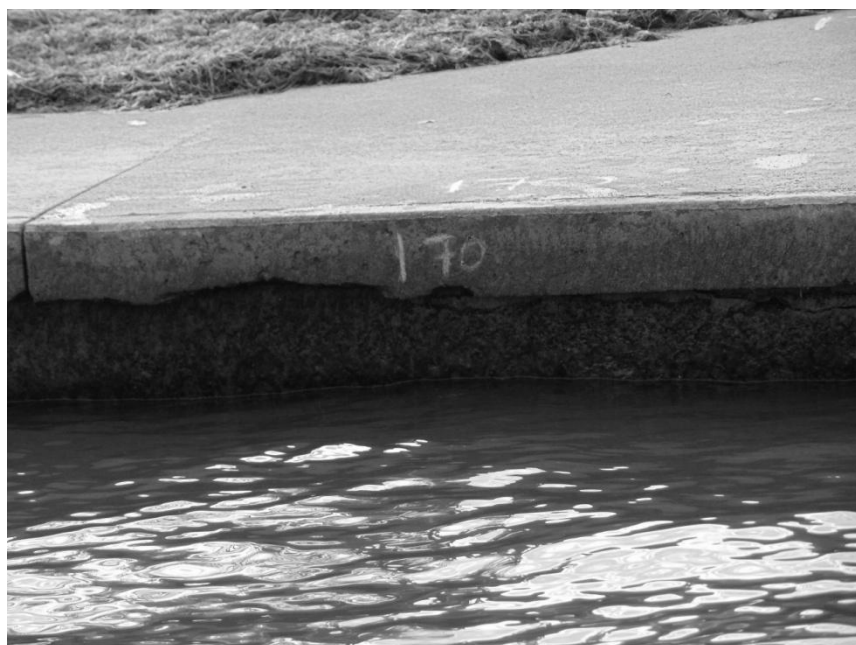
PHOTO # 23

Concrete panel area at chainage 0+150. Spalling of concrete and concrete loss dimensioned 1.5m long by 0.381m wide by 0.152m deep

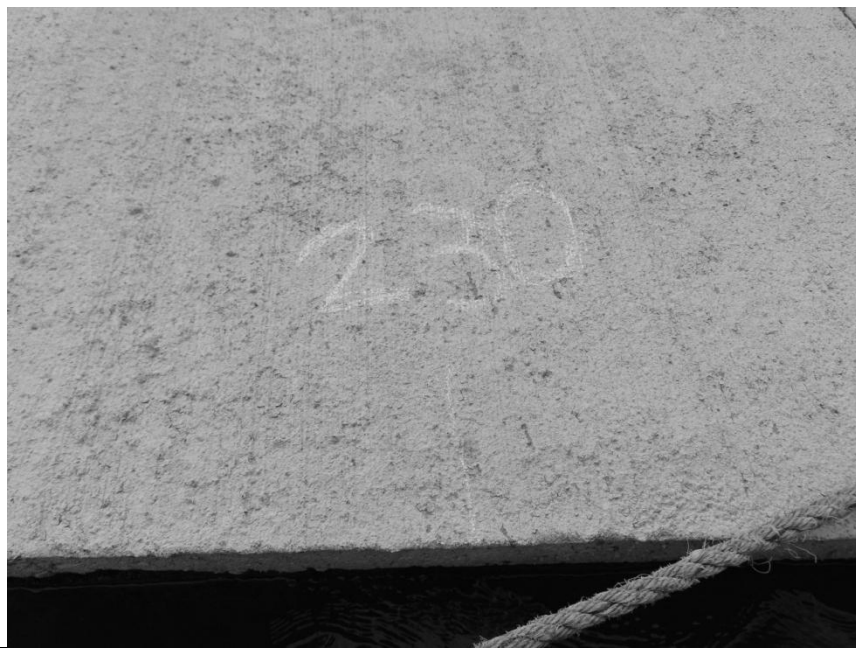
PHOTO # 29

Concrete panel area at  
chainage 0+210

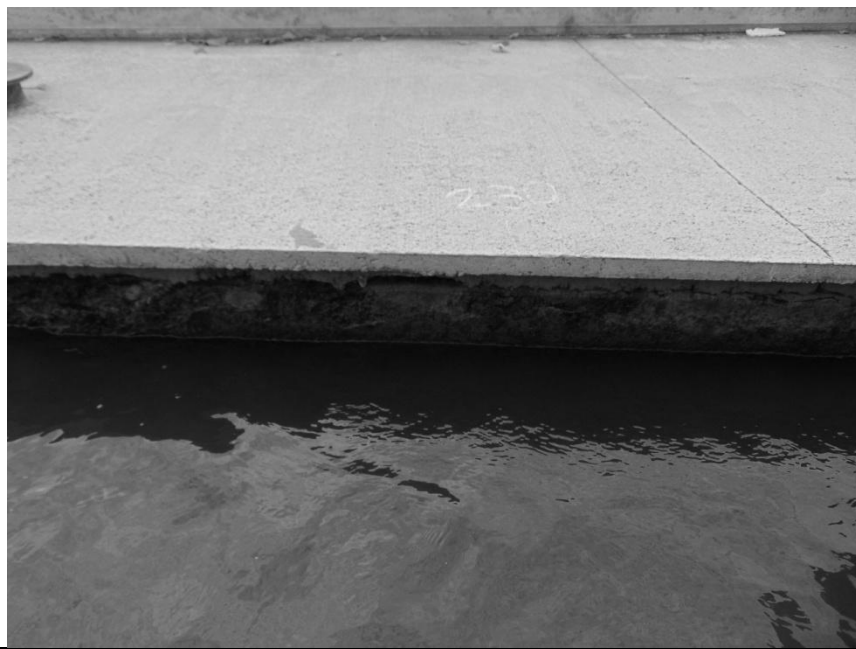
PHOTO # 30

Concrete panel area at  
chainage 0+230. Concrete  
in typical condition

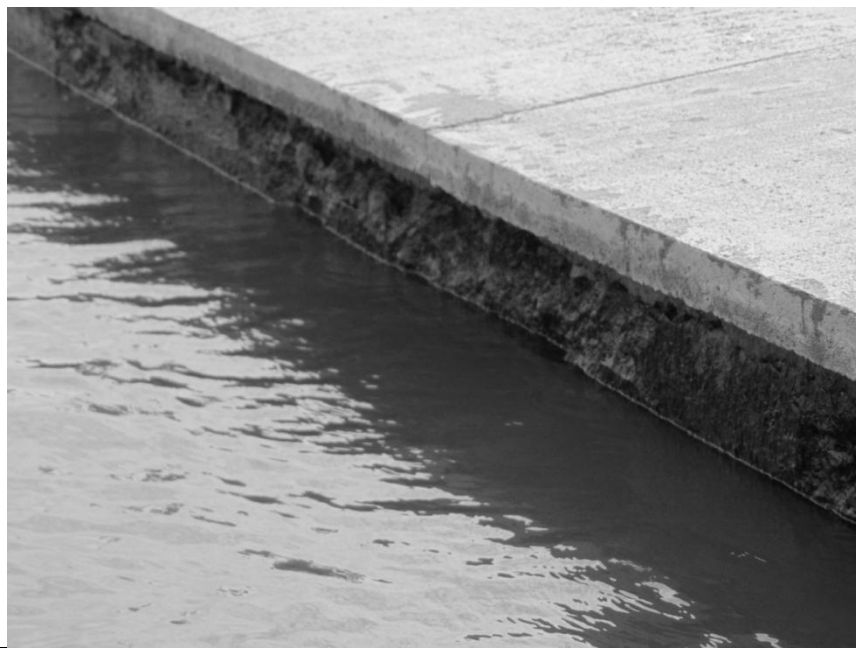
PHOTO # 31

Concrete panel area at chainage 0+230. Concrete in typical condition

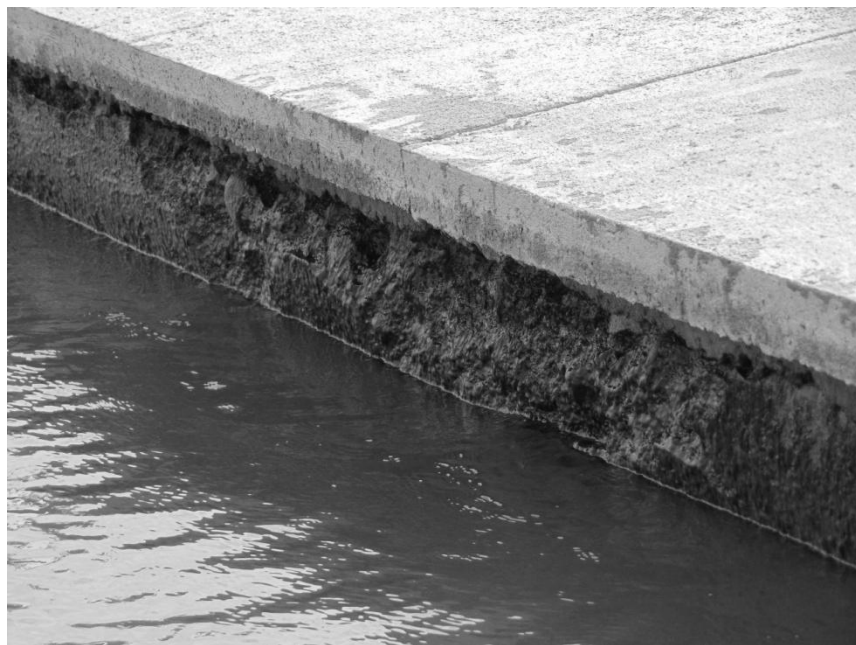
PHOTO # 32

Concrete panel area at chainage 0+220. Spalling and on the vertical face dimensioned 1.83m long by 0.20m high by 0.05m deep

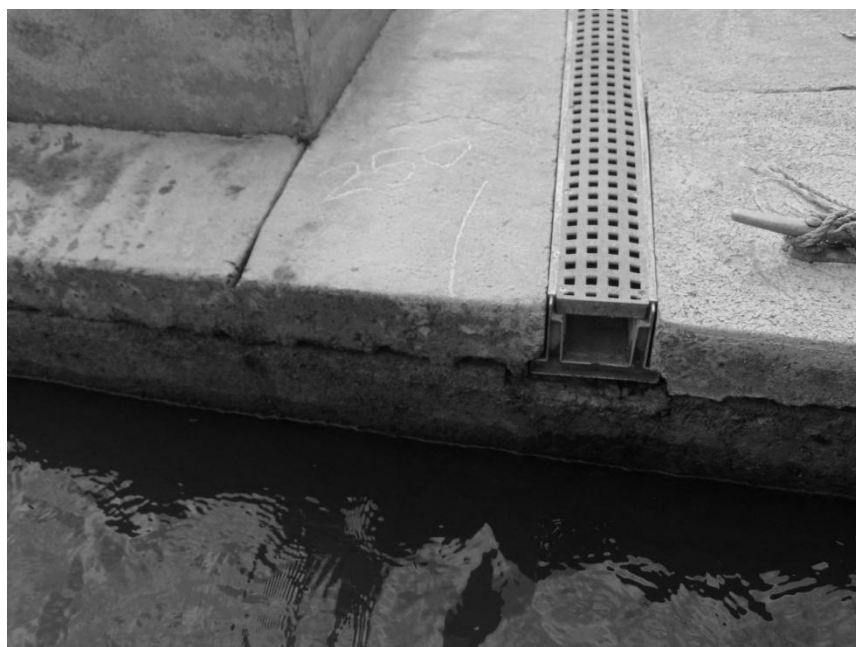
PHOTO # 35

Concrete panel area at chainage 0+229. Spalling on the vertical face, dimensioned at 0.5m long by 0.20m high by 0.05m deep

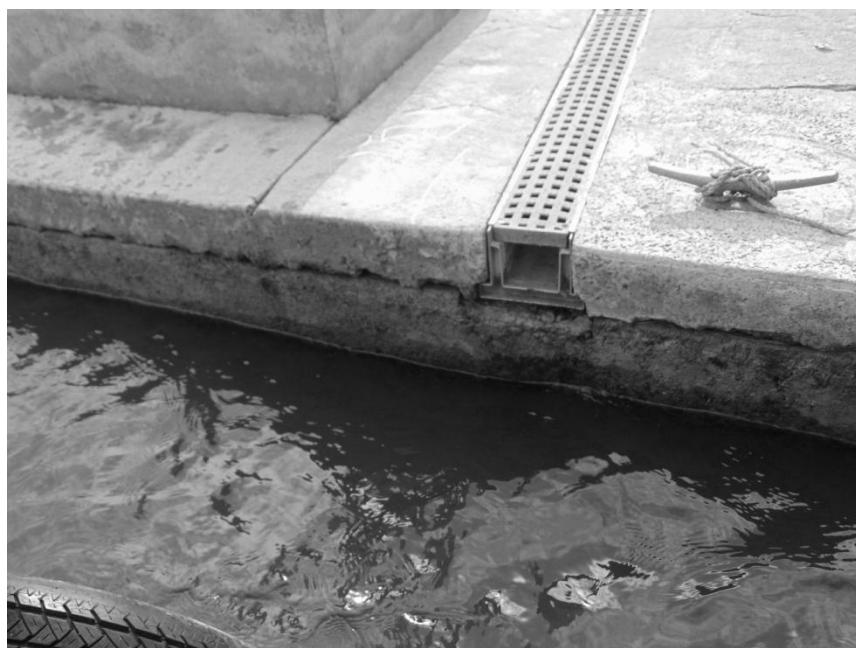
PHOTO # 36

Concrete panel area at chainage 0+250. Surface concrete is in typical condition

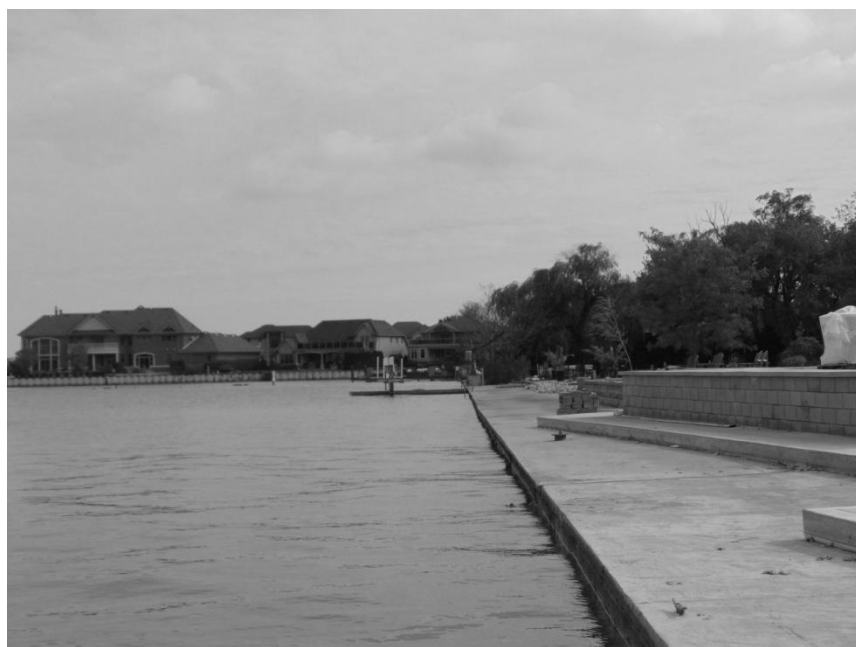
PHOTO # 37

Concrete panel area at chainage 0+250. Surface concrete is in typical condition

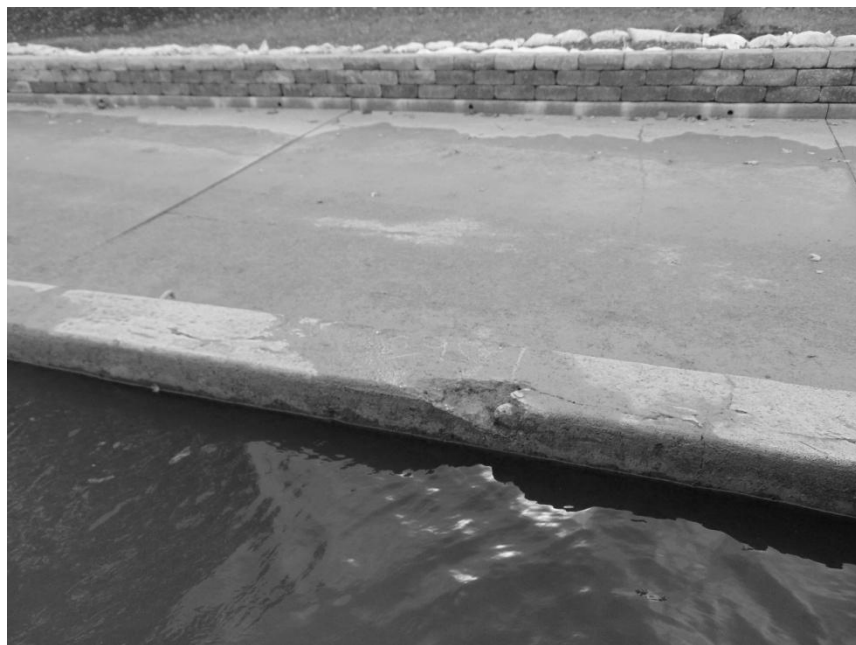
PHOTO # 40

Concrete panel area at  
chainage 0+219

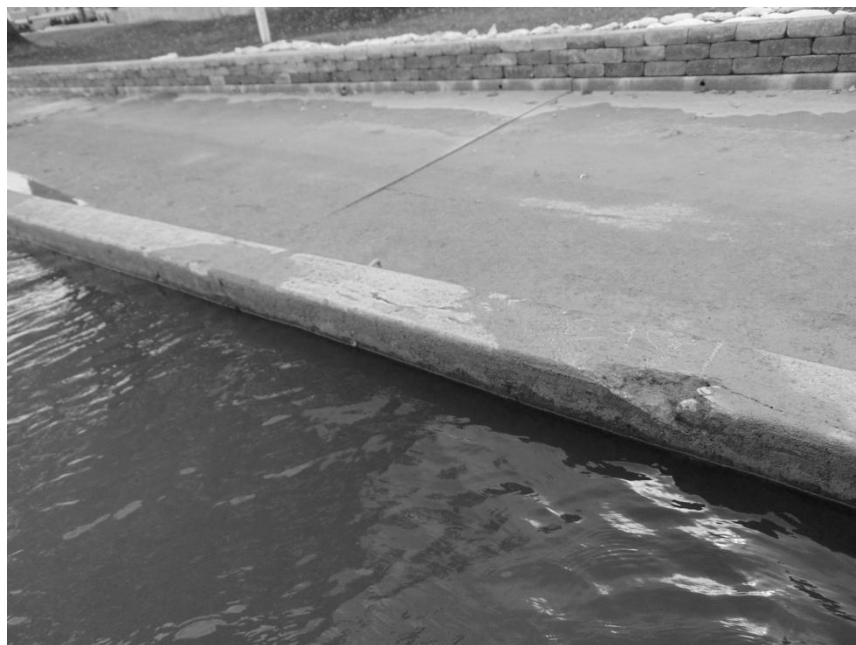
PHOTO # 41

Concrete panel area at  
chainage 0+270. Surface  
concrete is in typical  
condition

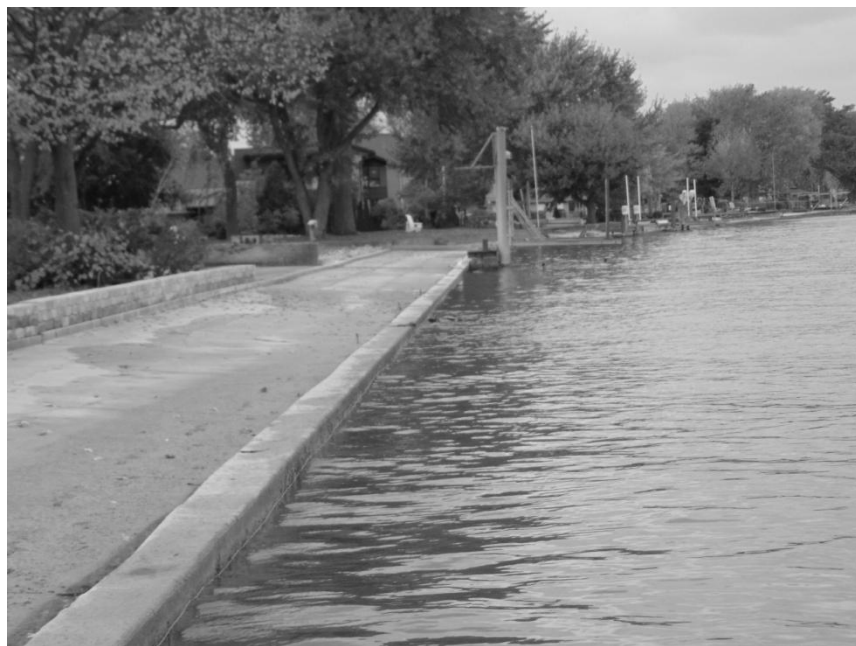
PHOTO # 42

Concrete panel area at  
chainage 0+270. Surface  
concrete is in typical  
condition

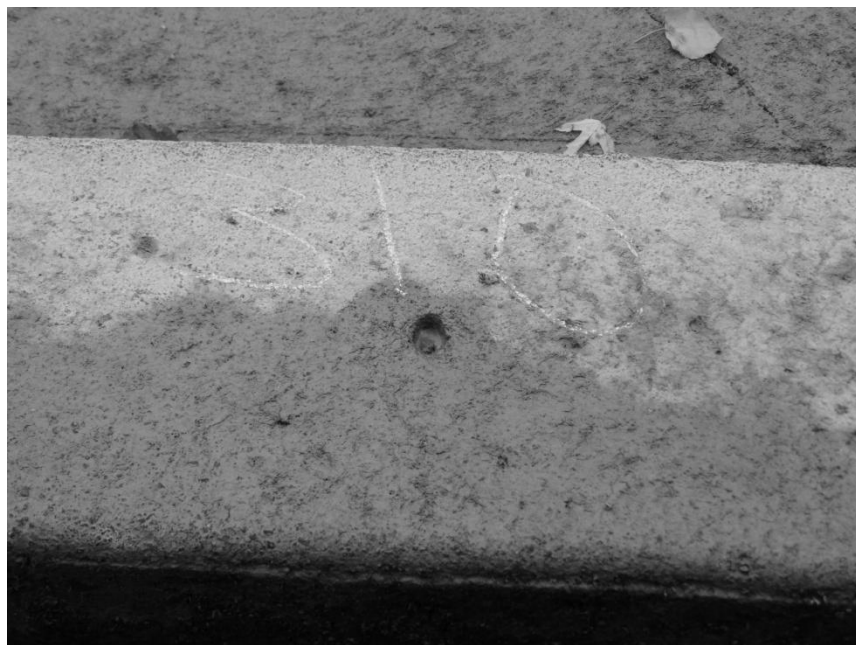
PHOTO # 44

Concrete panel area at chainage 0+285. Concrete panel deck has sunk 0.813m

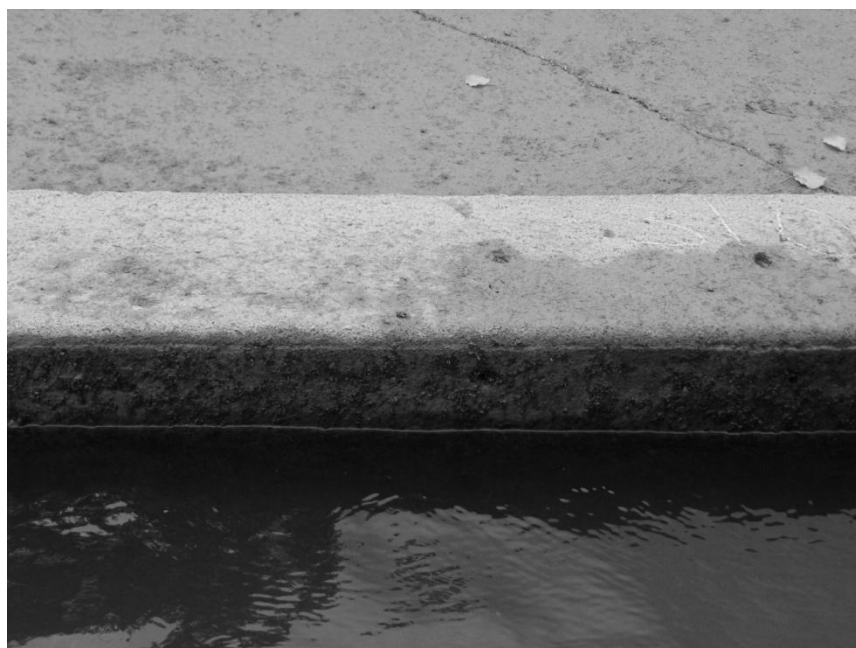
PHOTO # 45

Concrete panel area at chainage 0+310. Concrete is in typical condition

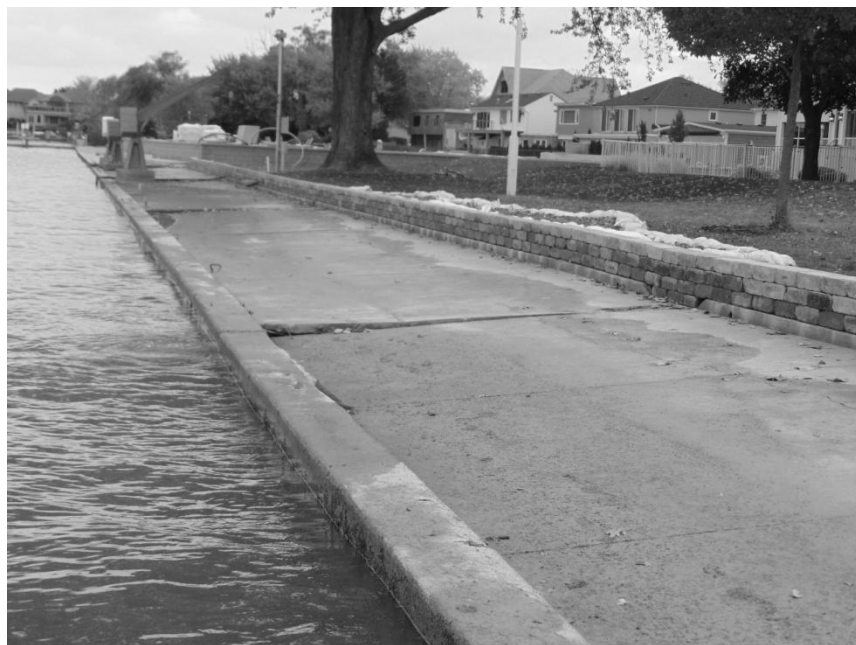
PHOTO # 46

Concrete panel area at chainage 0+310. Concrete is in typical condition

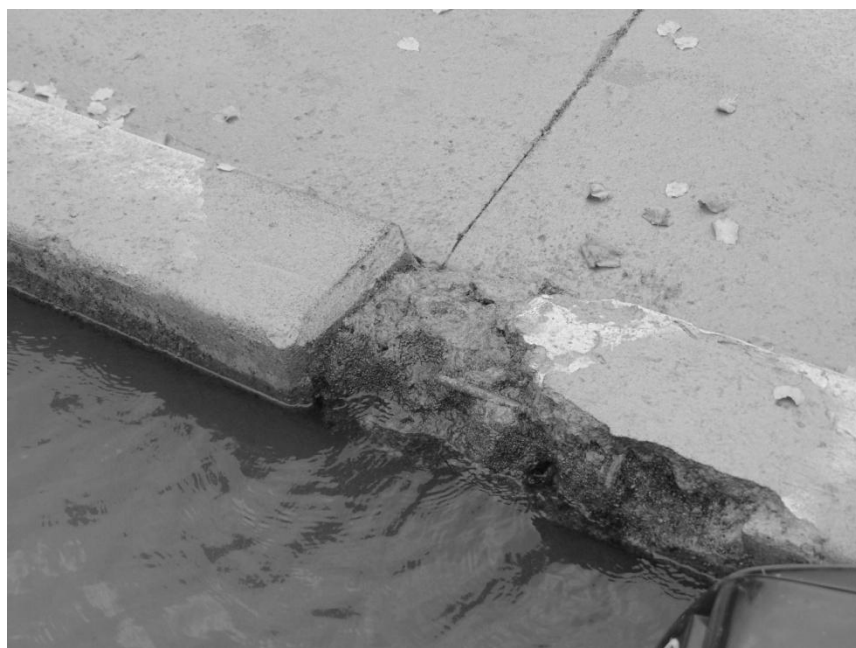
PHOTO # 48

Concrete panel area at chainage 0+315, showing missing surface concrete

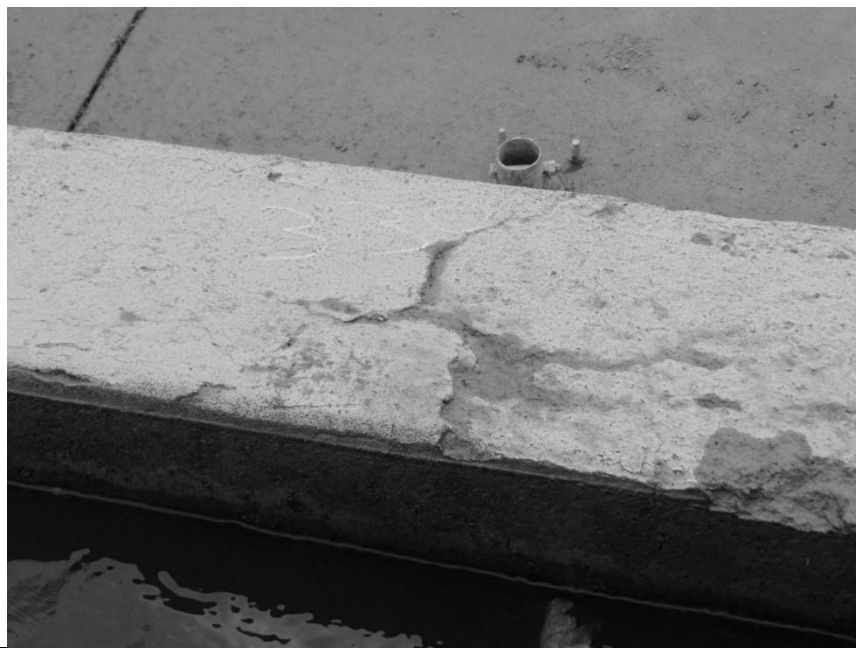
PHOTO # 49

Concrete panel area at chainage 0+315, showing missing surface concrete

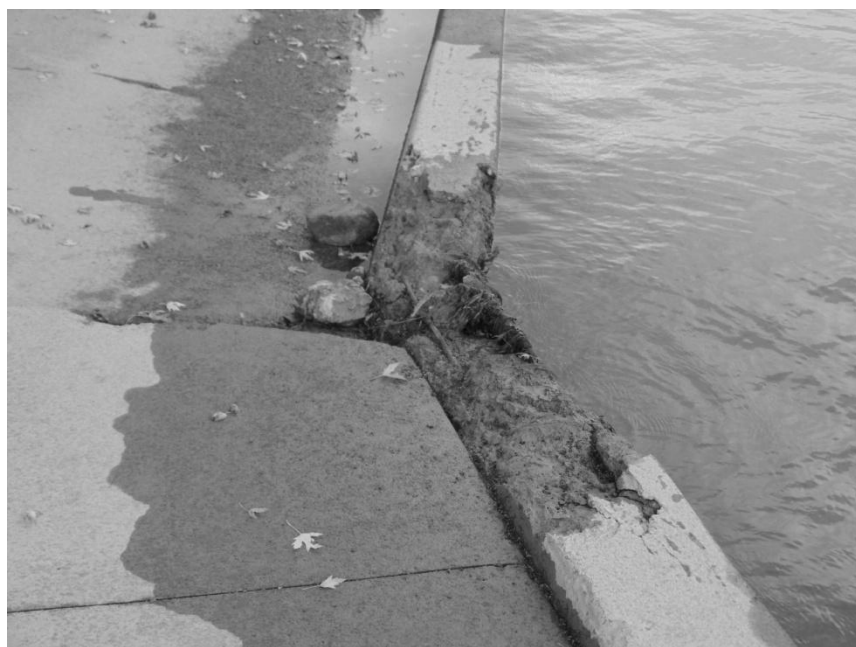
PHOTO # 56

tile visible void behind wall noted
0+360	Broken concrete located at the joint of the curb.
0+362	Drainage hole measuring 100mm in diameter. No drain tile visible void behind wall noted
0+369.4	Broken surface concrete at the point of deflection, to a depth of 50mm below the surface of the water. The concrete panel is at a lower elevation on the offshore side of the walkway, for a distance of 8.6 metres.
0+370	Drainage hole measuring 100mm in diameter. No drain tile visible void behind wall noted
0+378	End of the 8.6 metre long slope of the concrete deck. End of void at bottom of concrete panel.
0+420	The concrete panel area is at a higher elevation on the west side, and a lower elevation on the east side
0+428	Spalled concrete along the panel area, dimensioned 1 metre long by 0.5 metres wide by 100mm deep.
0+435	Concrete deck is in poor condition, with cracking and missing concrete. Beginning of offshore steel sheeting.

Concrete panel area at chainage 0+360. Broken concrete shown at the joint

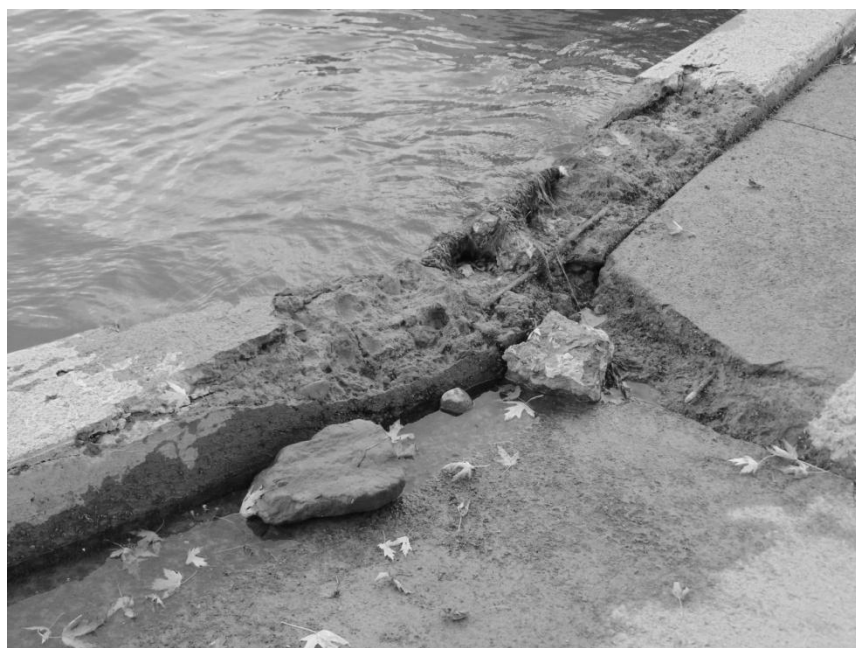
PHOTO # 57

Concrete panel area at chainage 0+369.4. Broken surface concrete at the point of deflection

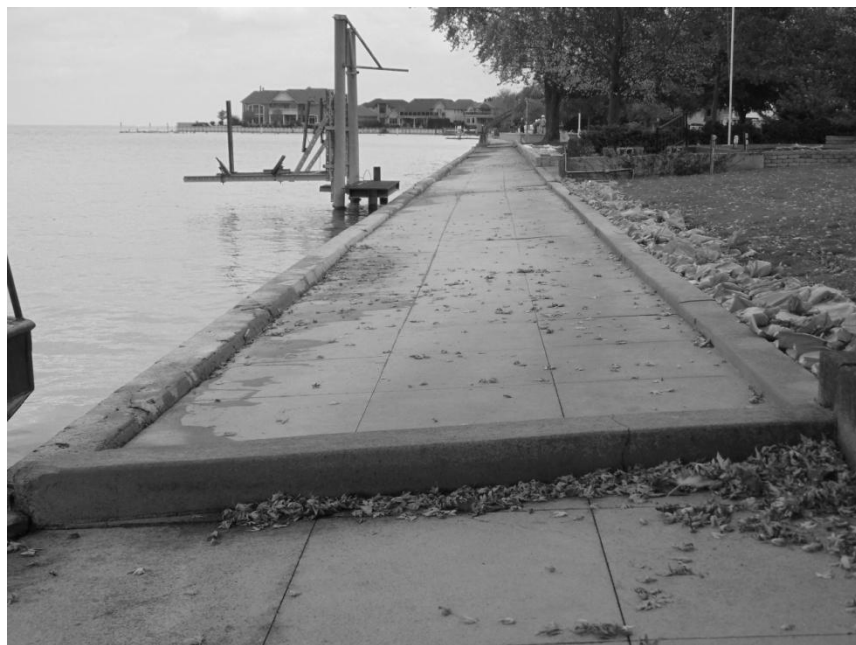
PHOTO # 58

Concrete panel area at chainage 0+369.4. Broken concrete extends to 0.05m below the surface of the water

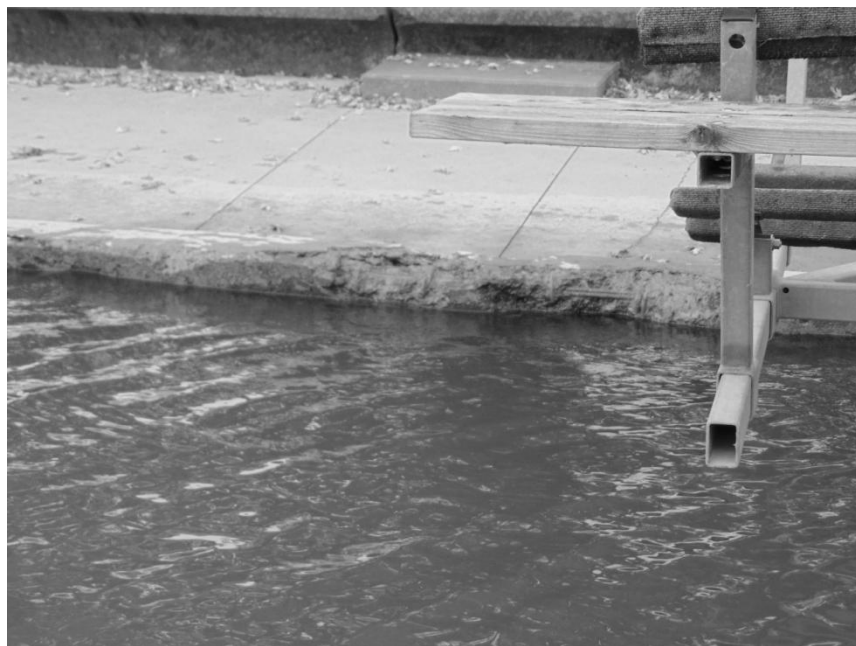
PHOTO # 69

Concrete panel area at  
chainage 0+428, showing  
spalled concrete  
dimensioned 1m long by  
0.46m wide by 0.10m deep

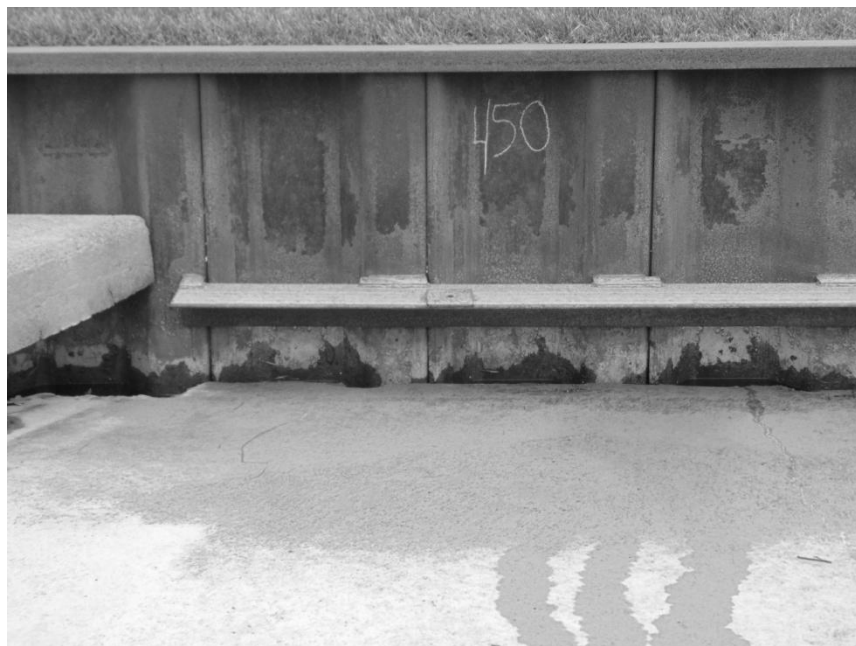
PHOTO # 72

Concrete deck at chainage 0+435 in poor condition

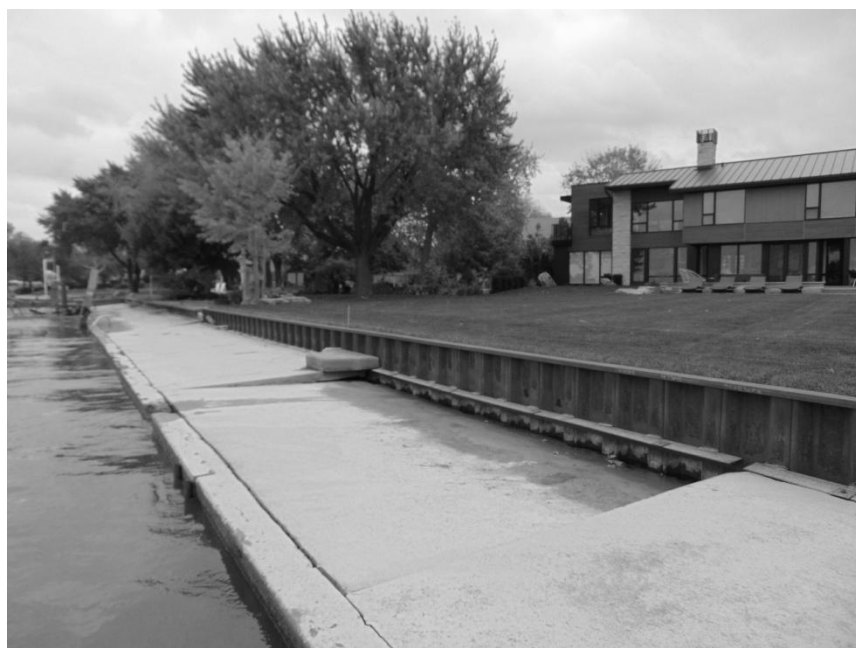
PHOTO # 75

0+450	Failed inshore concrete panel for a length of 5 metres, and damage along the concrete wall joint, dimensioned 0.5 metres wide by 2.5 metres long by 200mm deep.
0+455	End of the failed offshore concrete panel.
0+469	Spalled concrete along the offshore edge.
0+520	Concrete deck is in poor condition; the panel is at a lower elevation towards the water for a length of 10 metres. Spalled and missing concrete is present along the offshore edge. Wall generally has a 30mm to 102mm gap between the lake bottom and the concrete wall.

Damaged concrete wall  
joint at chainage 4+450,  
dimensioned 0.5m by 2.5m  
by 0.2m

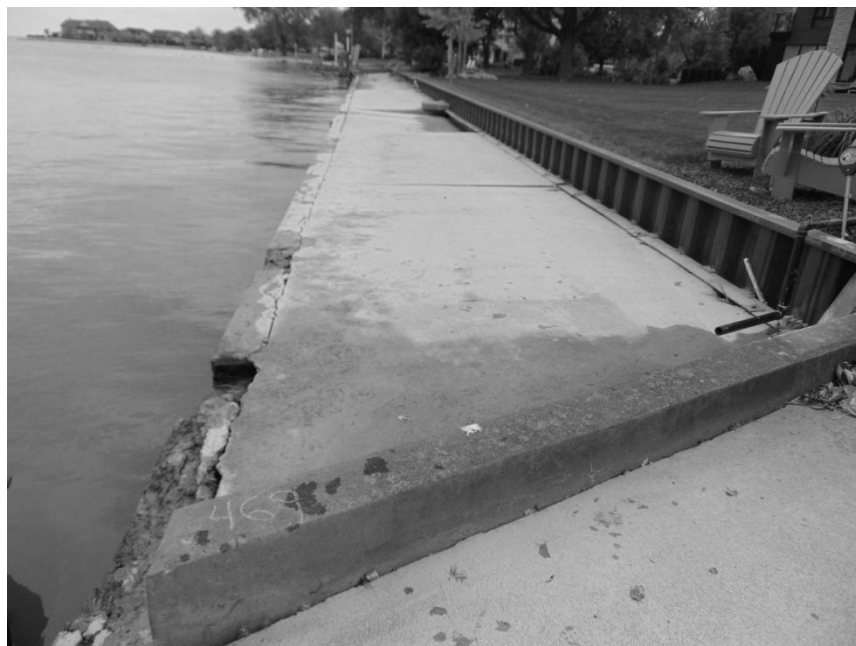
PHOTO # 78

Spalled concrete on the  
offshore edge, at chainage  
0+469 facing east

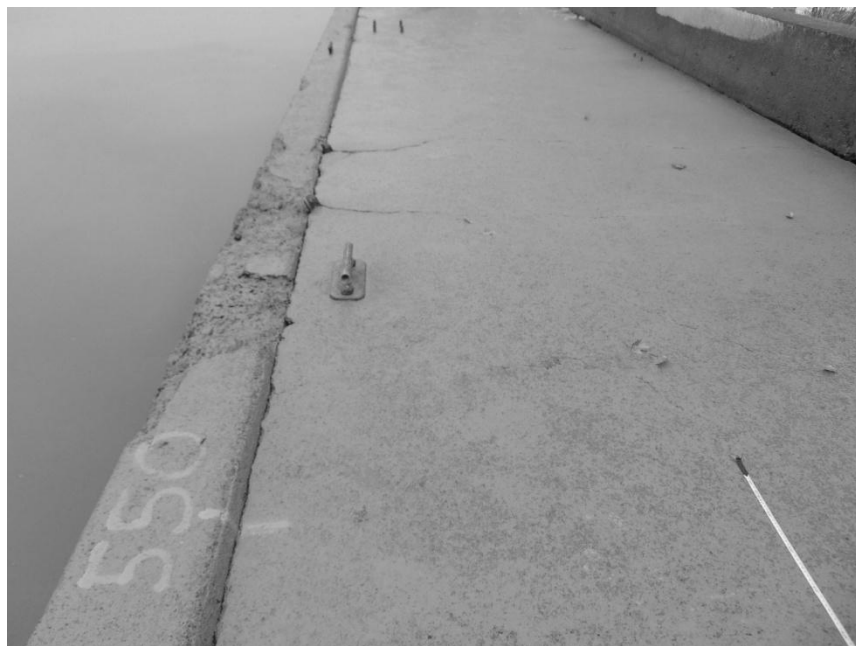
PHOTO # 84

0+540 looking east toward  
0+530 poor condition  
sloping toward water

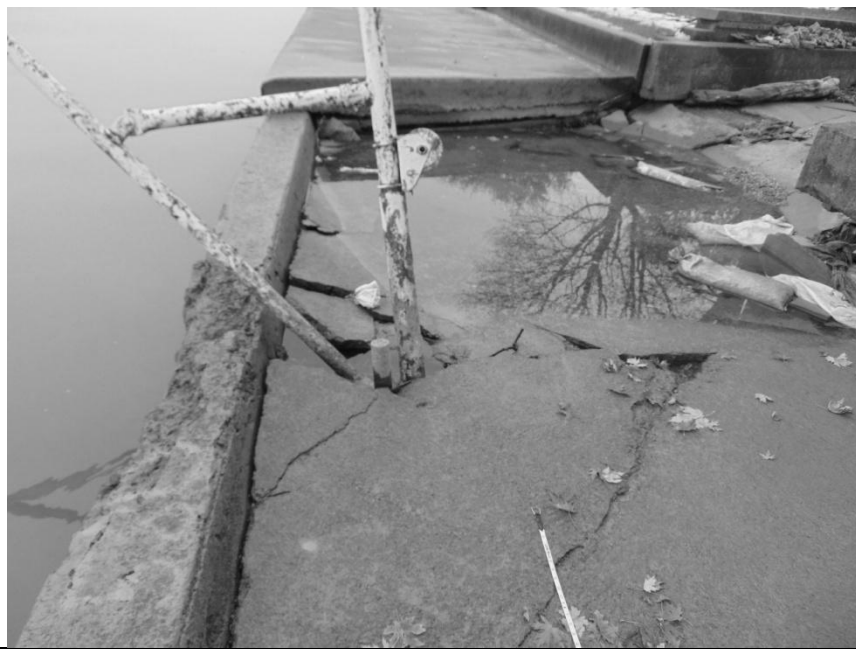
PHOTO # 87

0+570 looking east toward  
0+560 good condition

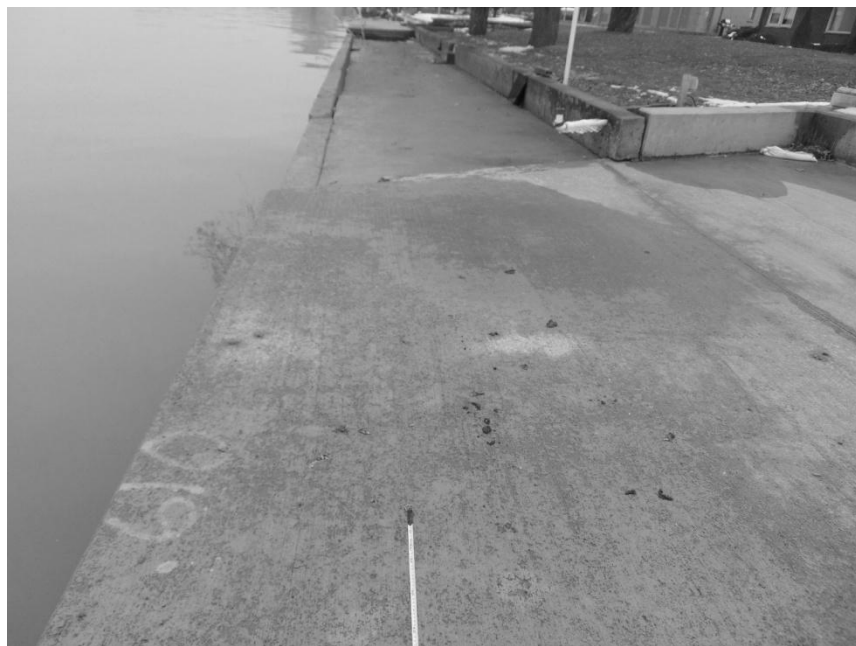
PHOTO # 90

0+600 looking east toward  
0+590 poor condition

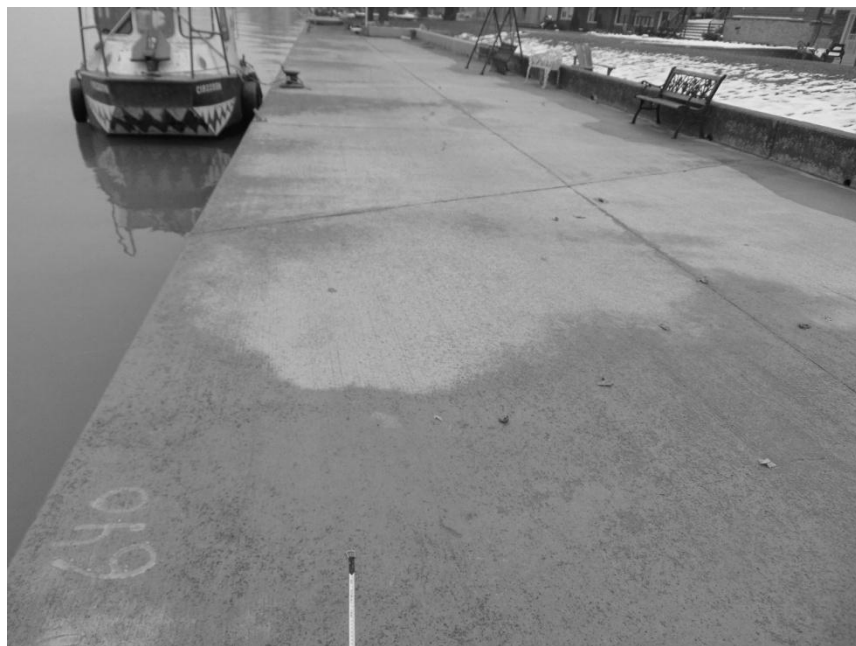
PHOTO # 93

0+630 looking east toward  
0+620 fair condition with  
surface cracking

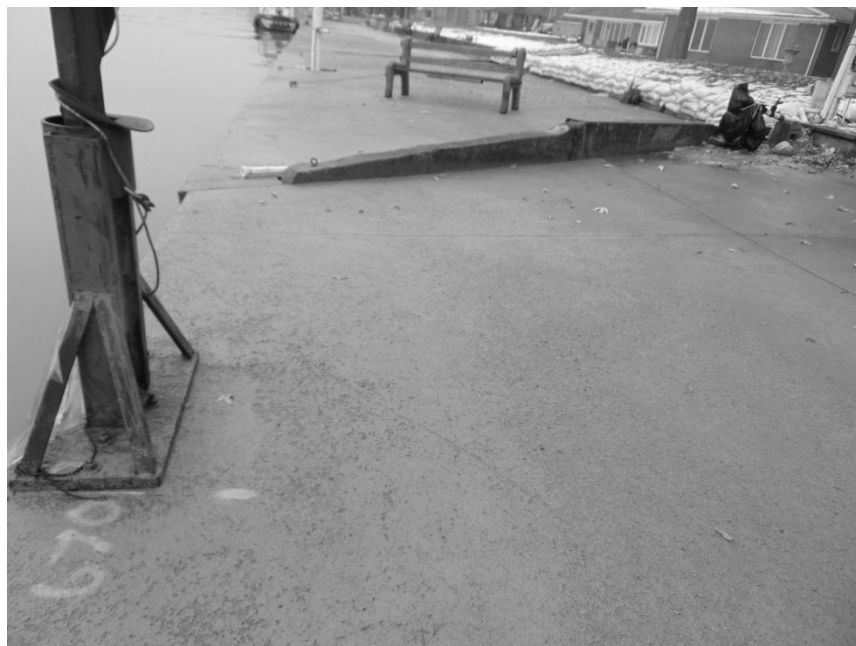
PHOTO # 96

0+660 looking east toward  
0+650 fair condition with  
surface cracking

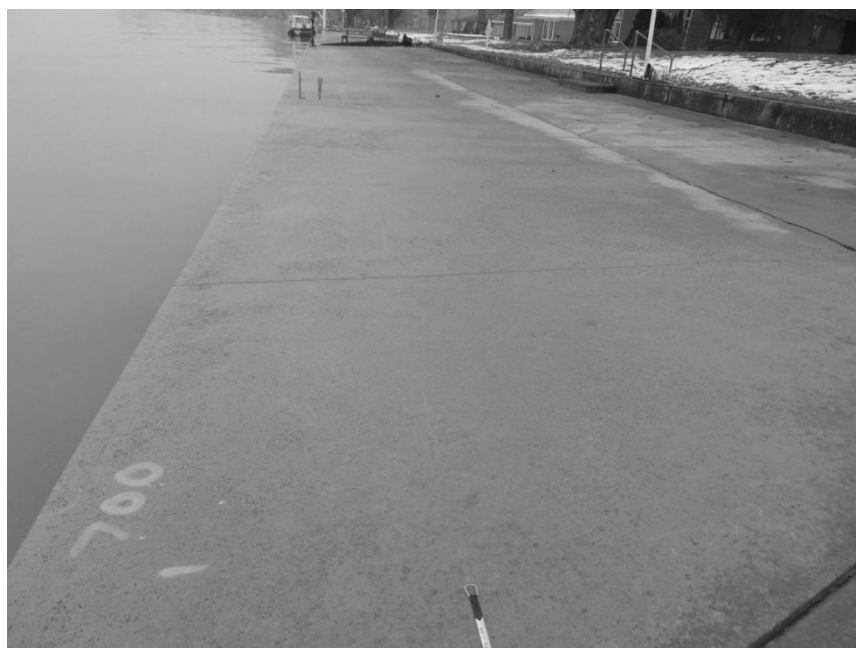
PHOTO # 99

0+690 looking east toward  
0+680 fair condition with  
surface cracking

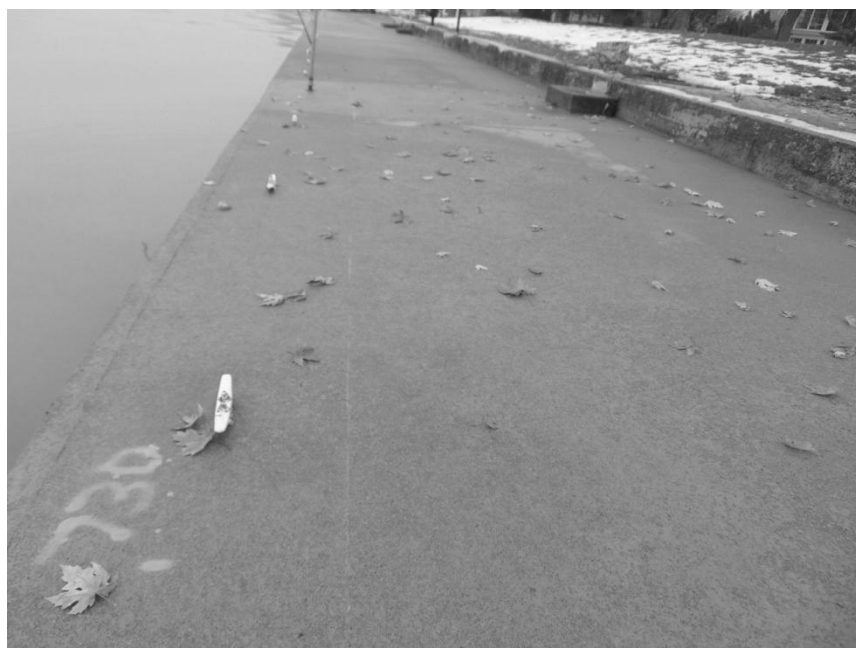
PHOTO # 102

0+720 looking east toward  
0+710 good condition

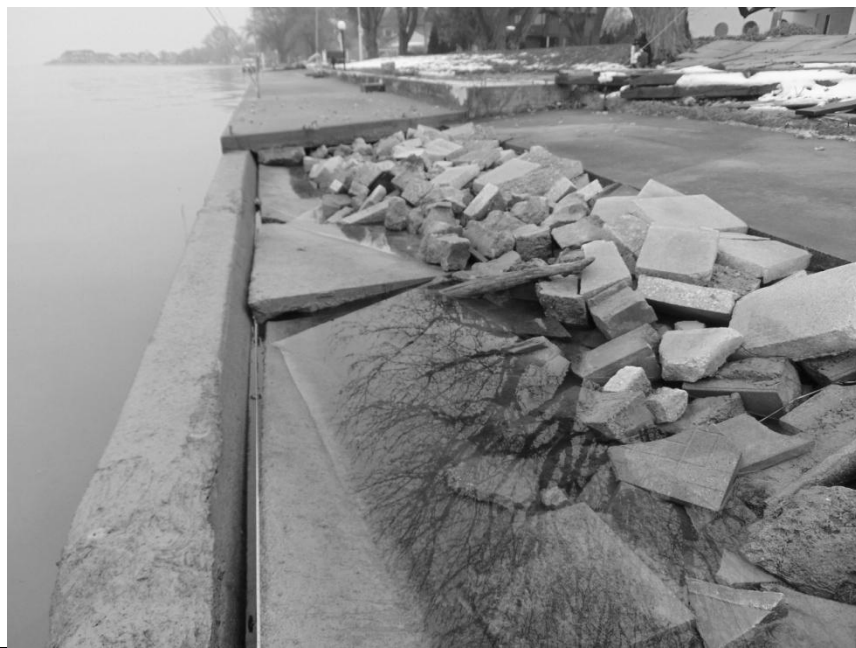
PHOTO # 103

0+730 looking east toward  
0+720 good condition

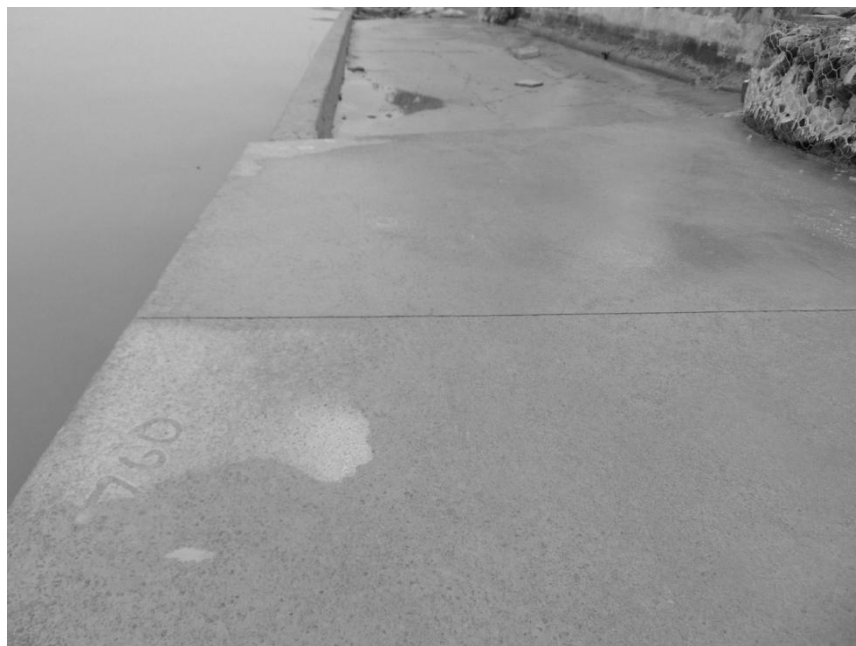
PHOTO # 105

0+750 looking east toward  
0+740 poor condition

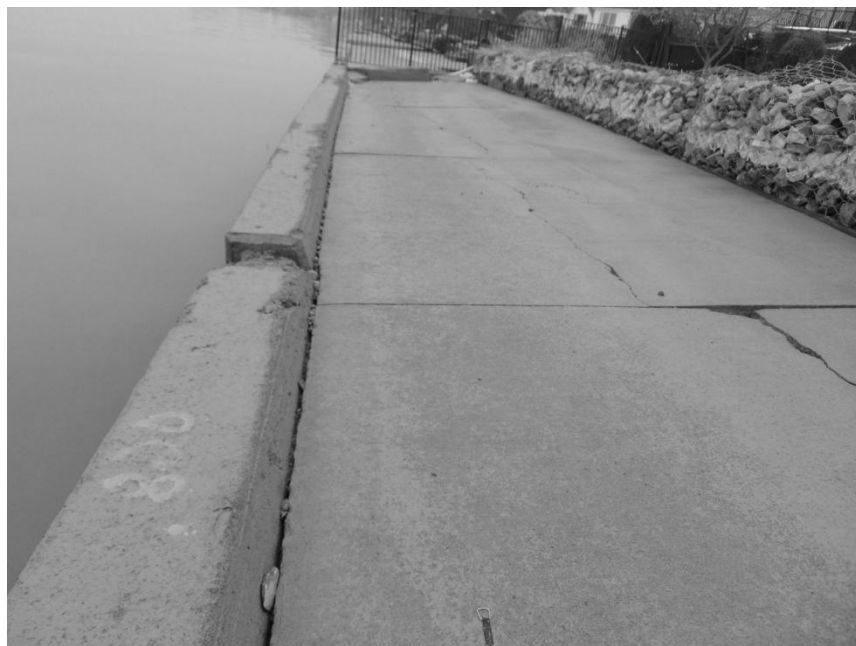
PHOTO # 111

0+810 looking east toward  
0+800 poor condition deck  
failed
