### **UNDERWATER INSPECTION REPORT BY WATECH SERVICES INC.**

**UNDERWATER INSPECTION OF LAKE ST. CLAIR SEAWALL  
SEAWALL INSPECTION  
Windsor, Ontario**

**Prepared for:  
LANDMARK ENGINEERS Inc.**

**November 2019**

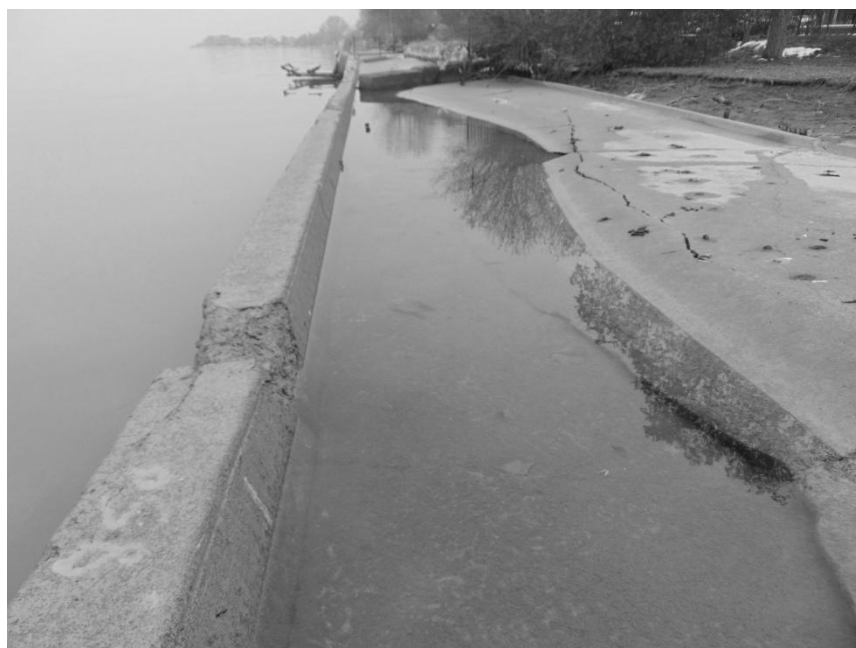
PHOTO # 114

0+840 looking east toward  
0+830 poor condition deck  
failed

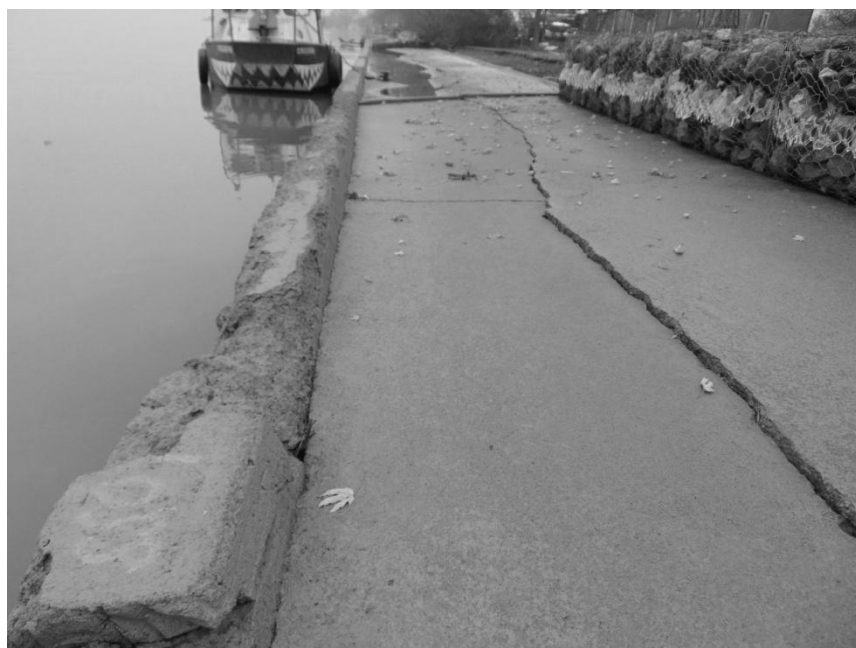
PHOTO # 117

0+870 looking east toward  
0+860 poor condition deck  
failed

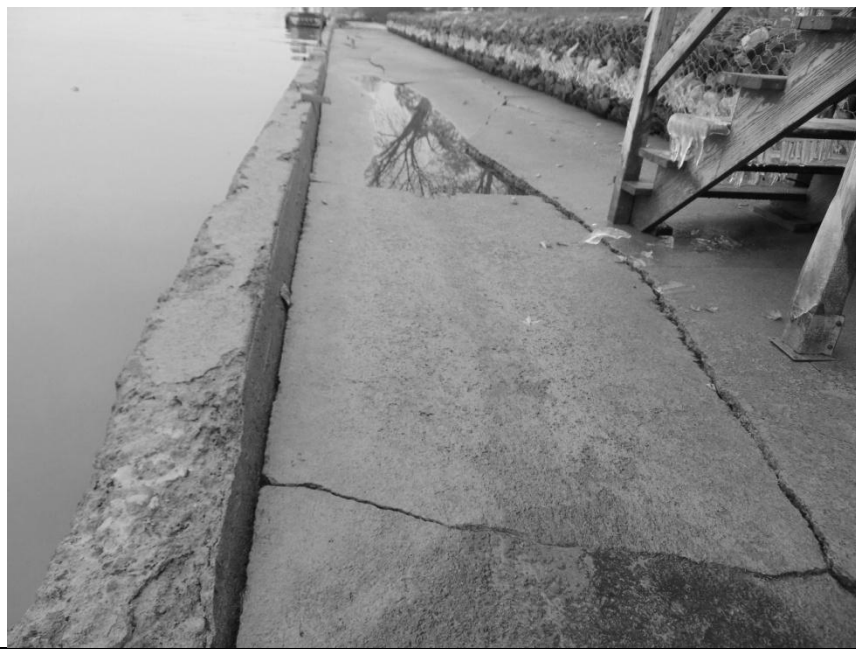
PHOTO # 120

0+900 looking east toward  
0+890 poor condition deck  
failed

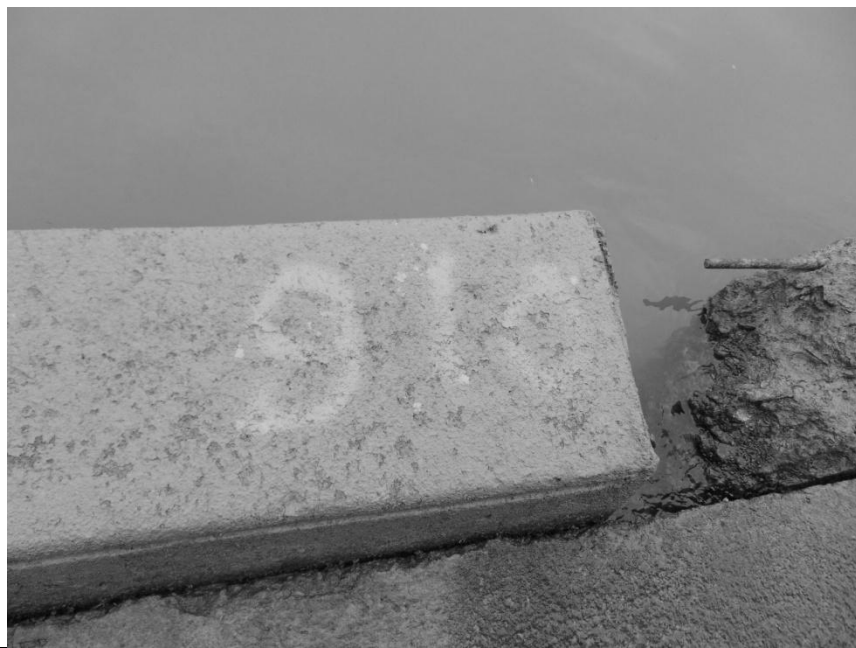
PHOTO # 121

0+910 looking east toward  
0+900 poor condition deck  
failed

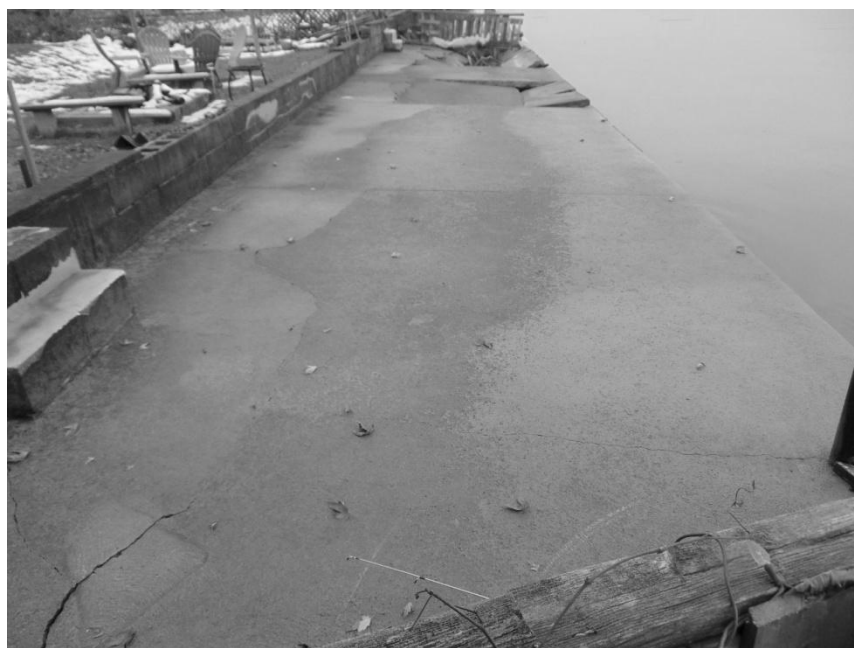
PHOTO # 123

0+910 looking west  
toward 0+917 poor  
condition cracking in the  
deck

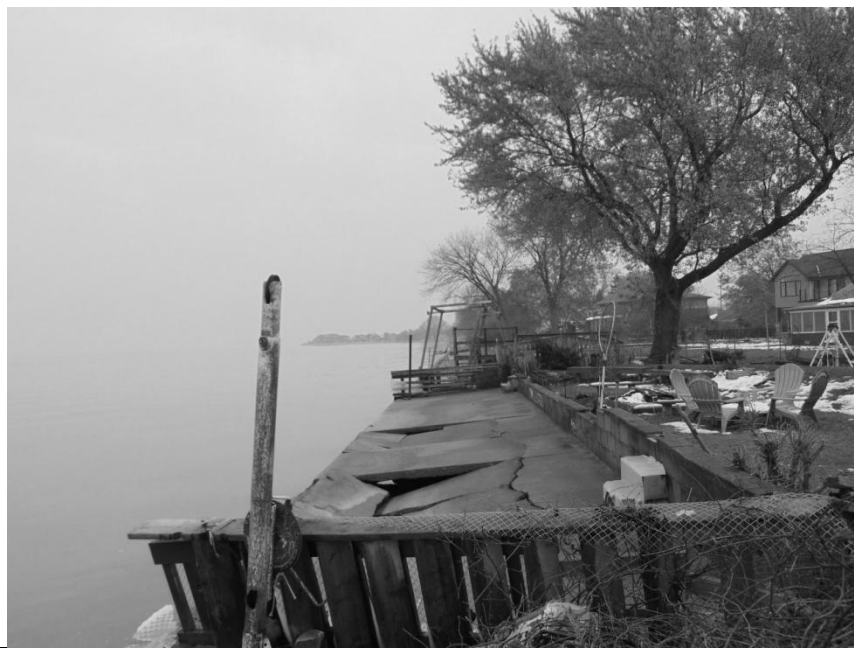
PHOTO # 124

0+ 917 looking west  
toward 0+935 poor  
condition concrete deck  
failed

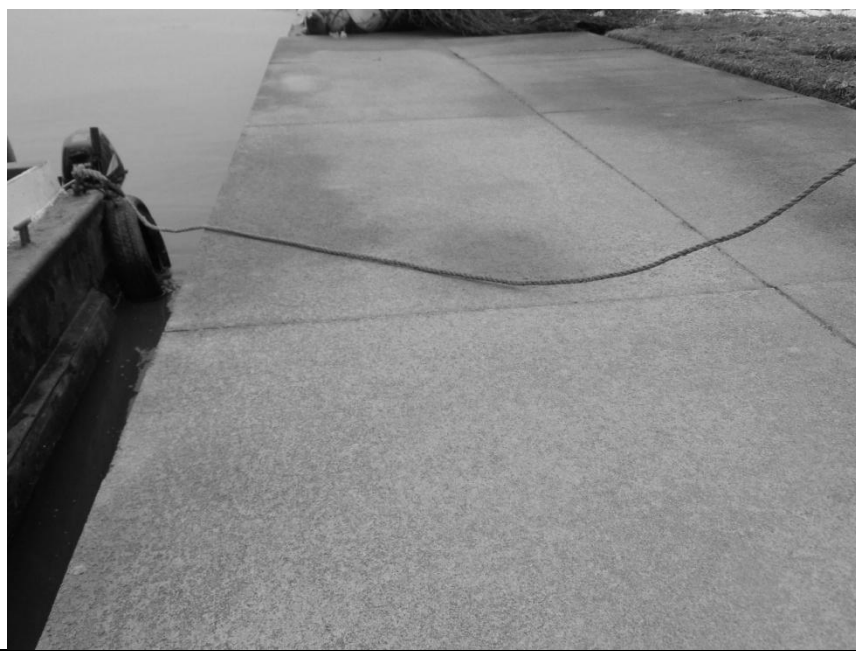
PHOTO # 126

0+940 looking east toward  
0+935 poor condition deck  
failed

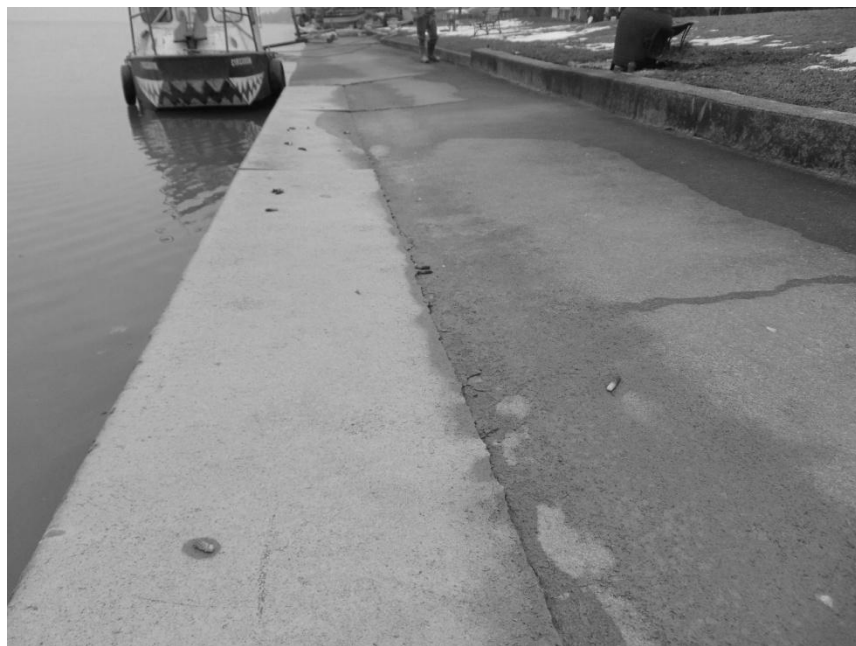
PHOTO # 135

1+040 looking east toward  
1+030 fair condition

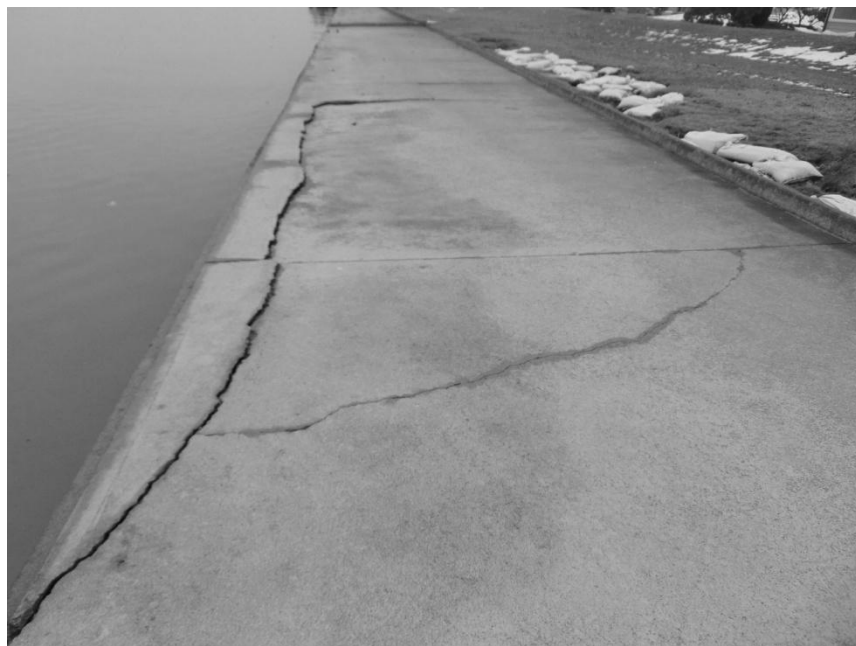
PHOTO # 141

1+100 looking east toward  
1+090 poor condition

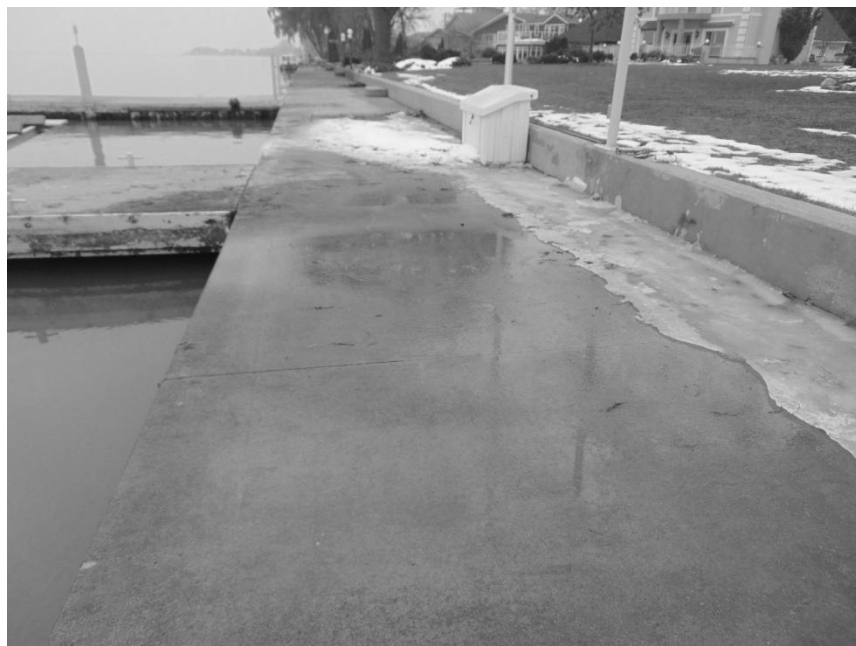
PHOTO # 159

1+260 looking east toward  
1+250 ice covered

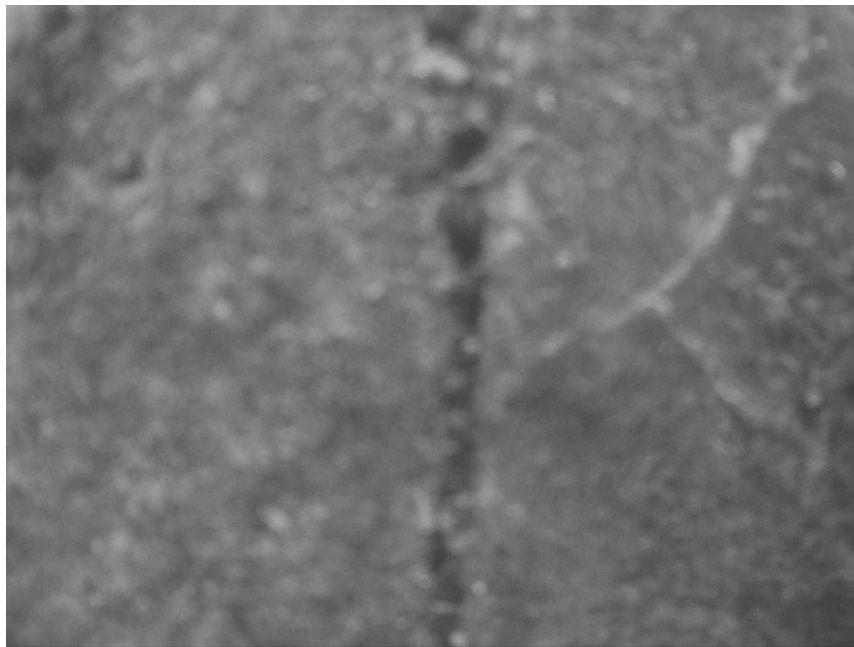
0+338	Drainage hole measuring 100mm in diameter. No drain tile visible void behind wall noted
0+346	Drainage hole measuring 100mm in diameter. No drain tile visible void behind wall noted.
0+354	Drainage hole measuring 100mm in diameter. No drain

PHOTO # 45
	0.1m diameter drainage hole at chainage. 0+370

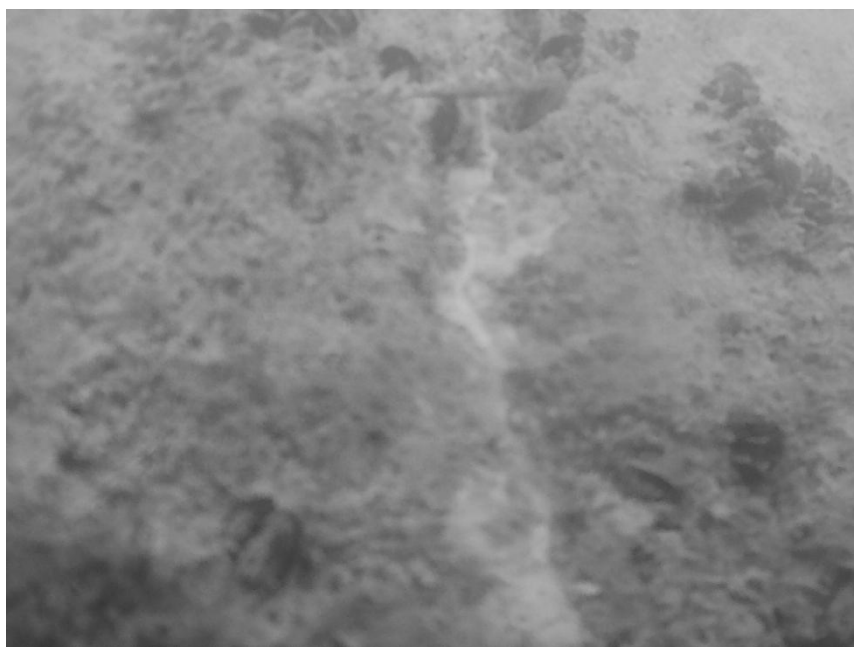
PHOTO # 47

Vertical cracking in concrete panel Station 0+796
