4. INVENTORY OF EXISTING CONDITIONS

4.1 Existing Roadway Engineering Conditions

4.1.2 EXISTING ROADWAY PAVEMENT CONDITION

Existing pavement conditions on Riverside Drive were collected by Stantec Consulting as part of this EA for the seven (7) typical cross sections noted above. Observations and photographs of the area were taken on Monday, June 27, 2005. A summary of these existing conditions observations within the Riverside Drive right-of-way is reported as follows:

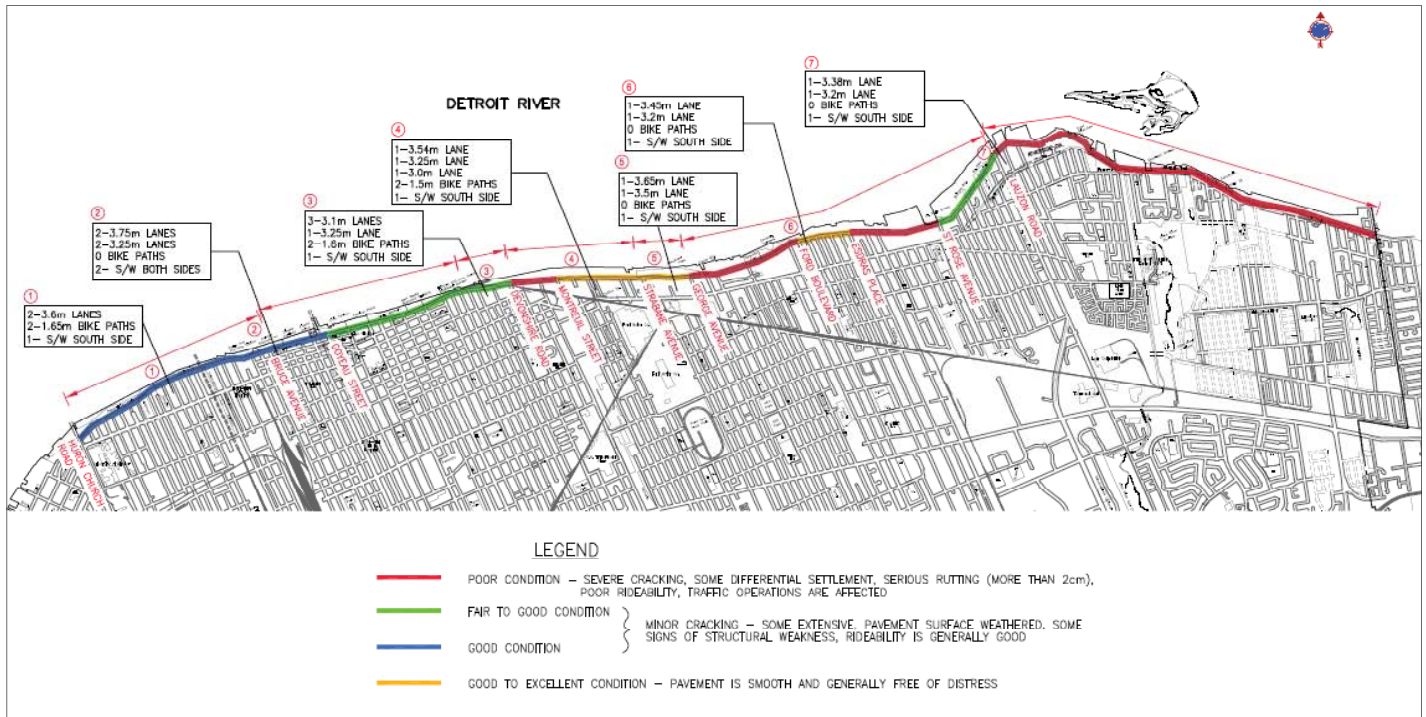
EXHIBIT 4.1 – EXISTING ROADWAY PAVEMENT CONDITIONS

Note: Sections of Riverside Drive between Esdras Place and St. Rose Avenue, and between the Little River bridge and Clover Avenue were resurfaced in 2006. Owing to the lack of curbs and resulting poor drainage, this basic mill and pave resurfacing is expected to have only a 5-7 year lifespan.

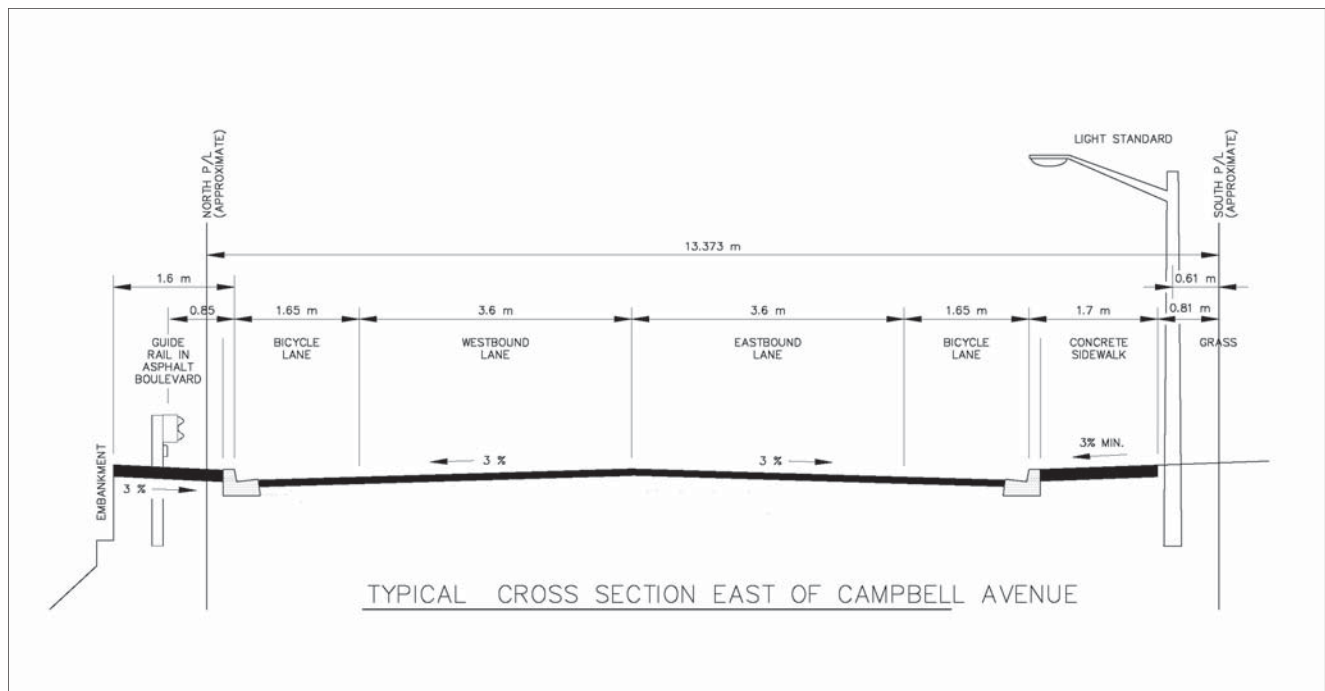
EXHIBIT 4.2

This two lane cross section, including bicycle lanes and sidewalks as shown in Exhibit 4.2, is generally representative of the section of Riverside Drive from Huron Church Road to Bruce Avenue, with the exception of a one block section between Huron Church Road and Vista Place. This one block is a two lane concrete surface, without bicycle lanes. The section shows moderate to severe cracking and spalling, particularly at the transition point between the concrete and asphalt pavement surface, which occurs just westerly of the Vista Place intersection.

The remainder of the section, from Vista Place to Bruce Avenue, shows some moderate transverse and longitudinal cracking evident in both the east and westbound lanes. The pavement condition is generally good.

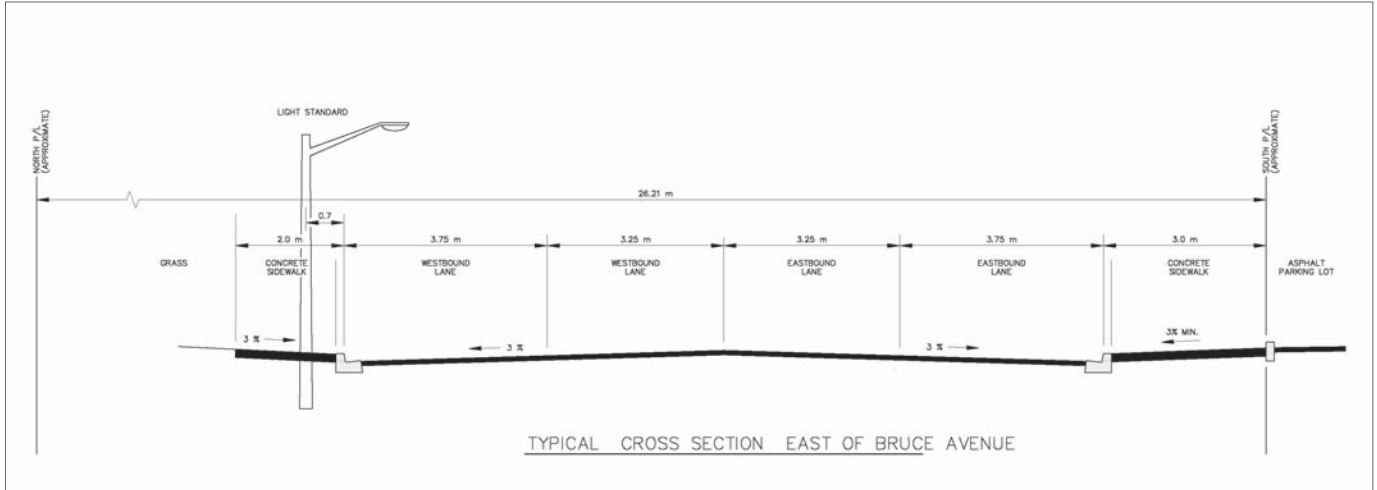
EXHIBIT 4.3

This four lane cross section extends from the intersection of Bruce Avenue easterly to Goyeau Street as concrete pavement, and from Goyeau Street easterly to Devonshire Street as asphalt pavement. Bicycles lanes are currently not included in this section, except for the section east of Lincoln Road. The concrete pavement in this section is in good condition, with some minor crack sealing required. The asphalt pavement in this section shows moderate to severe transverse and wheel track cracking, with some settlement, with fair to good pavement surface conditions. This cross section is shown on Exhibit 4.3.

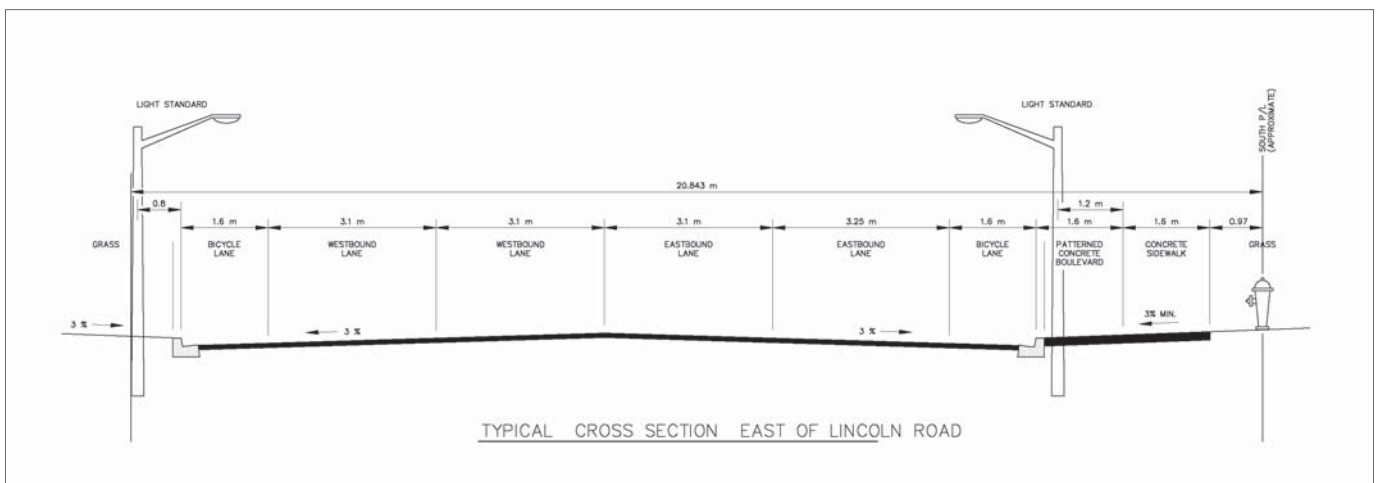
EXHIBIT 4.4

This is also a four lane asphalt cross section which currently includes bicycle lanes. The bicycle lanes begin at the east side of the Lincoln Road intersection, and are indicated in the Exhibit 4.4 cross section. The bicycle lanes extend easterly through this section to Strabane Avenue. The pavement condition in this section is fair to good. The four lane section ends at the intersection of Devonshire Road, where it then becomes a three lane section as described as follows.

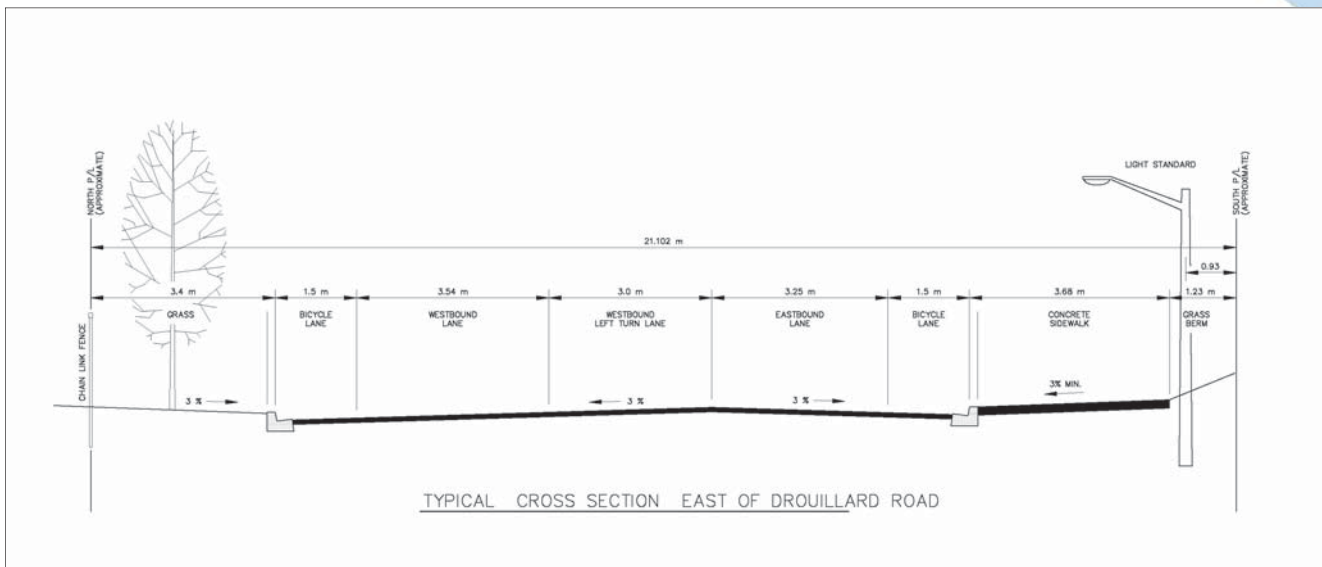
EXHIBIT 4.5

This three lane asphalt cross section extends easterly from Devonshire Road through Cross Section 4 (Drouillard Road), to Strabane Avenue. Bicycle lanes are as indicated in the cross section drawing in Exhibit 4.5.

The pavement section from Devonshire Road easterly to Montreuil Street is in poor condition with significant block and transverse cracking, poor riding surface and some settlement. Pavement condition is poor. The pavement section from Montreuil Street through the cross section easterly to Strabane Avenue has been recently improved and is in good to excellent condition, with no major deficiencies noted.

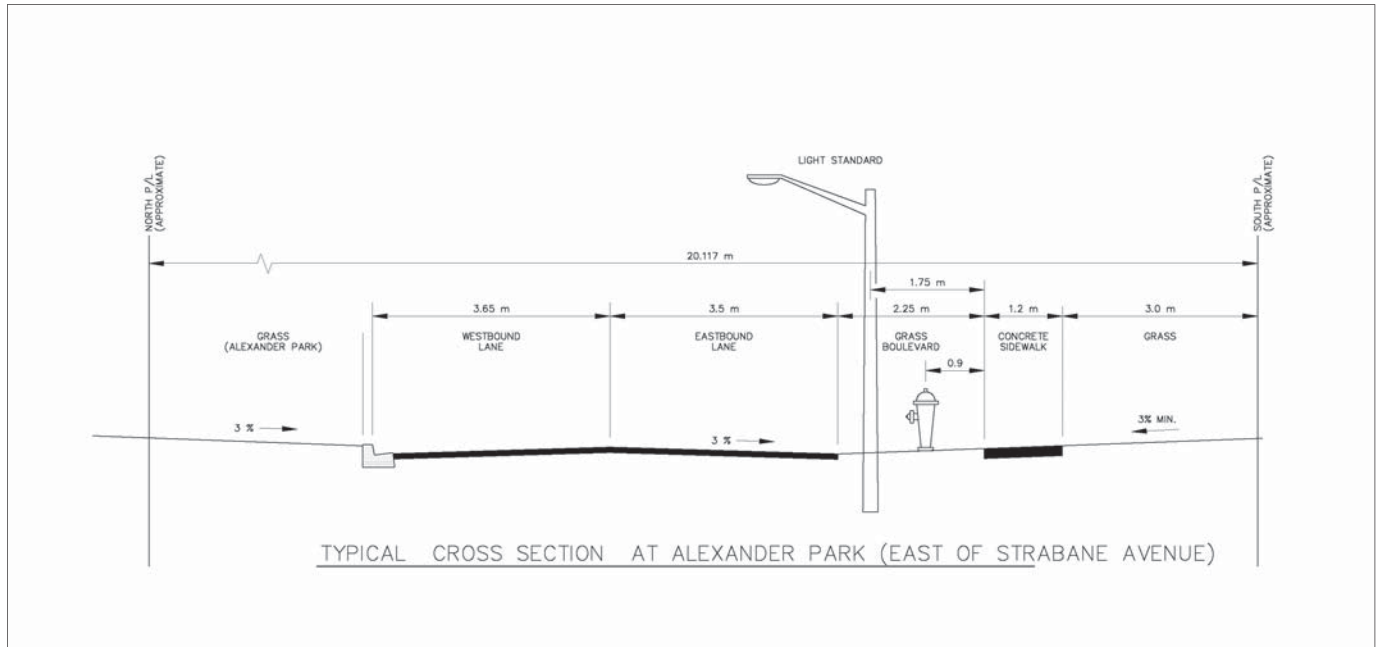
EXHIBIT 4.6

This two lane asphalt cross section extends from Strabane Avenue easterly to George Avenue. A turning lane for westbound traffic into Alexander Park has been provided. This section has recently been improved and is in good to excellent condition, with no major deficiencies noted. This cross-section is shown on Exhibit 4.6

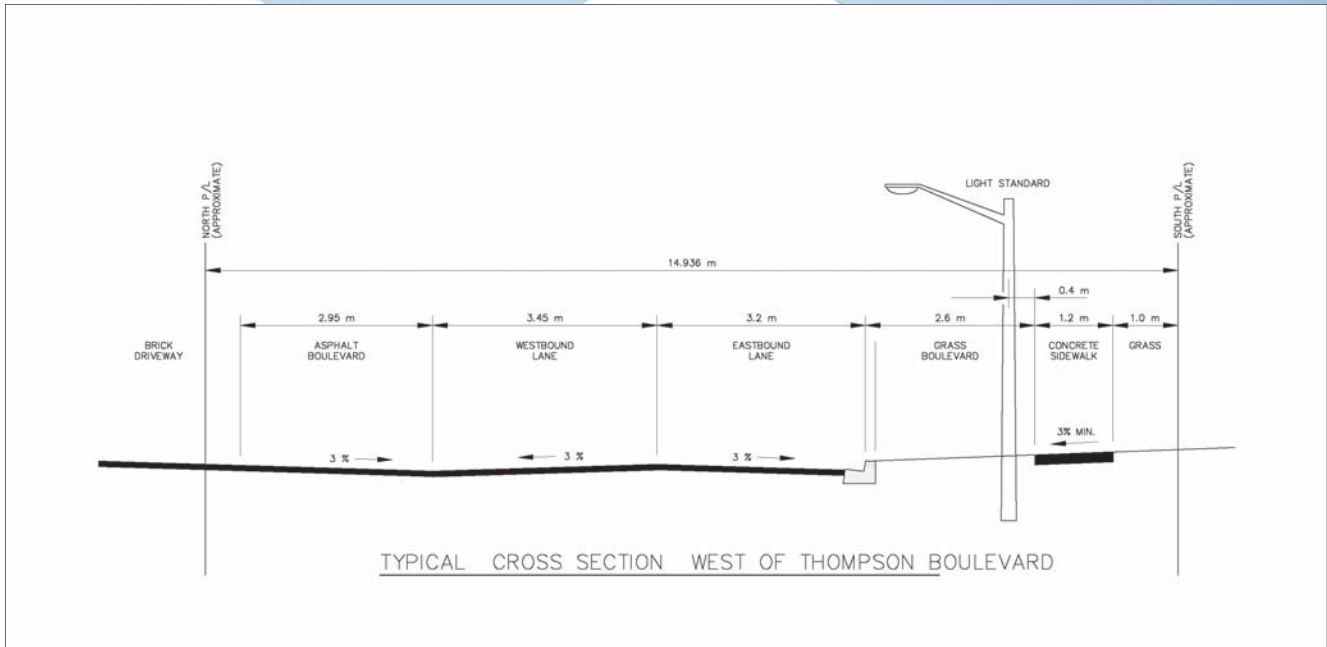
EXHIBIT 4.7

This two lane asphalt cross section is shown on Exhibit 4.7 generally from George Avenue easterly to Lauzon Road. Various pavement conditions exist in this section. The asphalt pavement section from George Avenue to Ford Avenue shows evidence of block cracking, edge cracking and transverse cracking. Pavement condition is poor. The Pillette Road intersection has been reconstructed with concrete pavement, and requires some crack sealing and surface repairs.

The asphalt pavement section from Ford Avenue to Esdras Place has been improved and is in generally good condition. Some minor wheel rutting and wheel track cracking is evident. Overall pavement condition is good.

The asphalt pavement section from Esdras Place to St. Rose Avenue was in poor condition but was resurfaced in 2006 with a basic mill and pave following underground utility improvements. No curb work sidewalk or other improvements were made. The lack of curbs and associated poor drainage are expected to result in a life expectancy for this resurfacing of only 5-7 years. Therefore, this resurfacing is not expected to impact on the ultimate pavement condition rating and improvement scheduling presented in this ESR, although it does provide some short-term implementation scheduling flexibility.

The asphalt pavement section from St. Rose Avenue easterly to Lauzon Road has been improved with a wider platform. Pavement condition is fair to good. Some moderate transverse cracking is evident. Barrier curbing is evident on both sides.

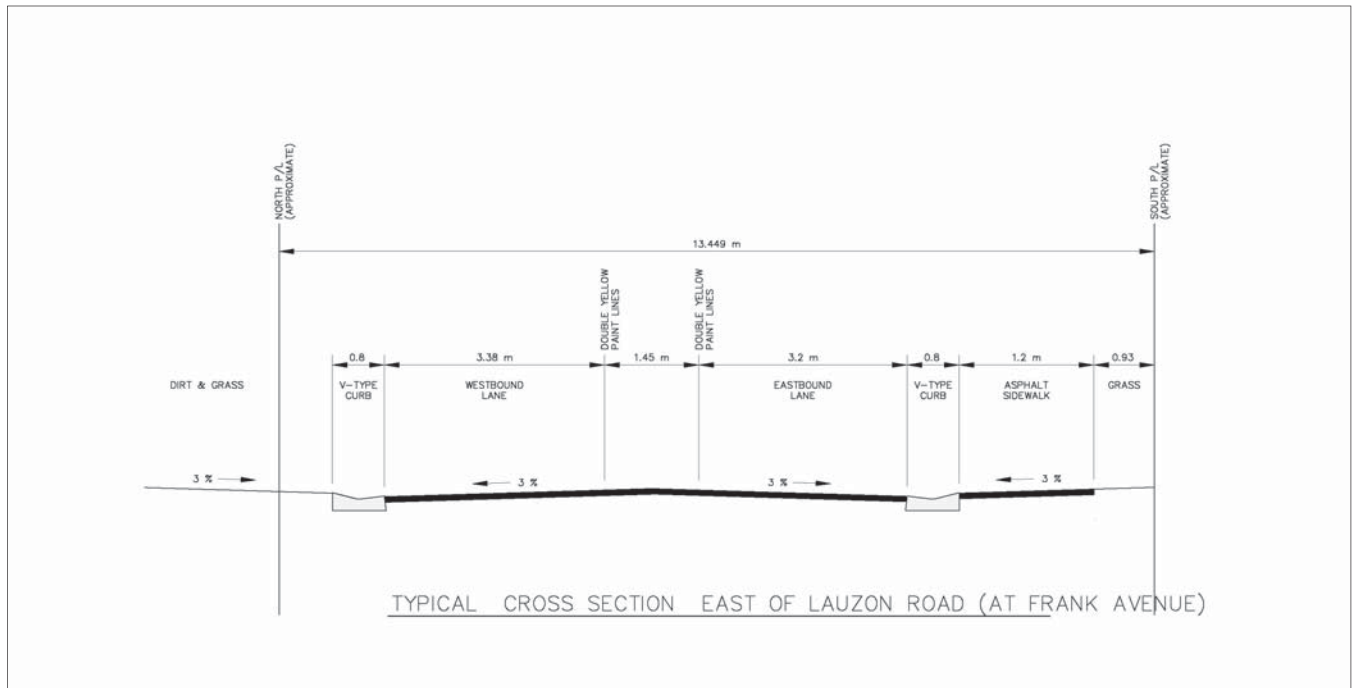
EXHIBIT 4.8

This two lane asphalt cross section generally extends from Lauzon Road easterly to the City of Windsor limits. In the section from Lauzon Road to just west of Riverdale, a double yellow painted median is evident, as indicated in the cross section drawing on Exhibit 4.8. The remainder of the section has no painted median, allowing for a wider traveled portion. V-type or rolled “mountable curbs” are evident in this section.

Pavement condition in this section is generally poor, with numerous areas of block and transverse cracking, patching and settlement. The section from the Little River Bridge to Clover Avenue was resurfaced in 2006, but as with the resurfacing between Esdras Place and St. Rose Avenue, the basic mill and pave resurfacing is expected to have only a 5-7 year lifespan.
