Lauzon Parkway Improvements Class Environmental Assessment

G.W.P. 3117-09-00

EXISTING CONDITIONS DRAINAGE REPORT FINAL

Culvert Inspection Report

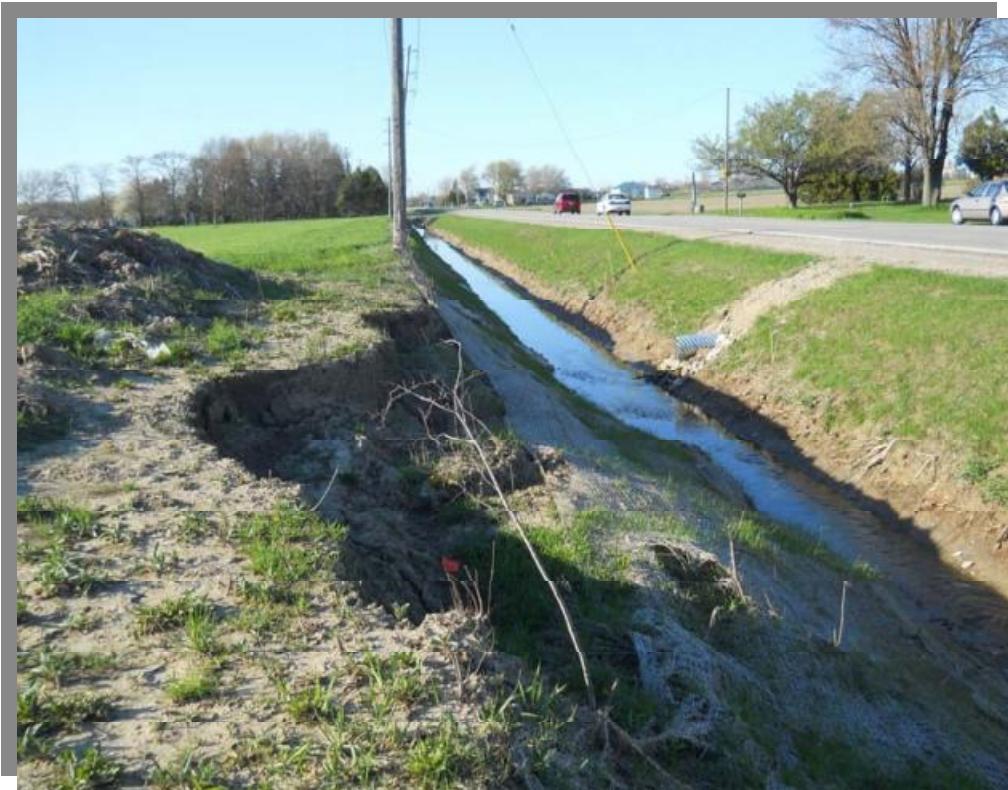
PLC10-3 West Channel Bank Failure (Watson Drain)

| Culvert I.D. | Location | Culvert Size (mm) ⁽¹⁾ | Culvert Type | Observations from Site Reconnaissance: Physical Characteristics of Existing Culverts and Observed Drainage Deficiencies | |
|---|---|---|---|---|--|
| LC11 | Under County Road 17 (approximately 155m north of Culvert LC10) Photographs PLC11 – 1 thru 4 | 450 | CSP | • Large and severe channel bank failure/collapsed just south of Culvert LC10 | • Large and severe channel bank failure/collapsed just south of Culvert LC10 • Upstream end of pipe is crushes and cracked • Perched pipe • Slight channel slope erosion above pipe • Erosion blanket failure/deteriorated on west channel slope at the downstream side |

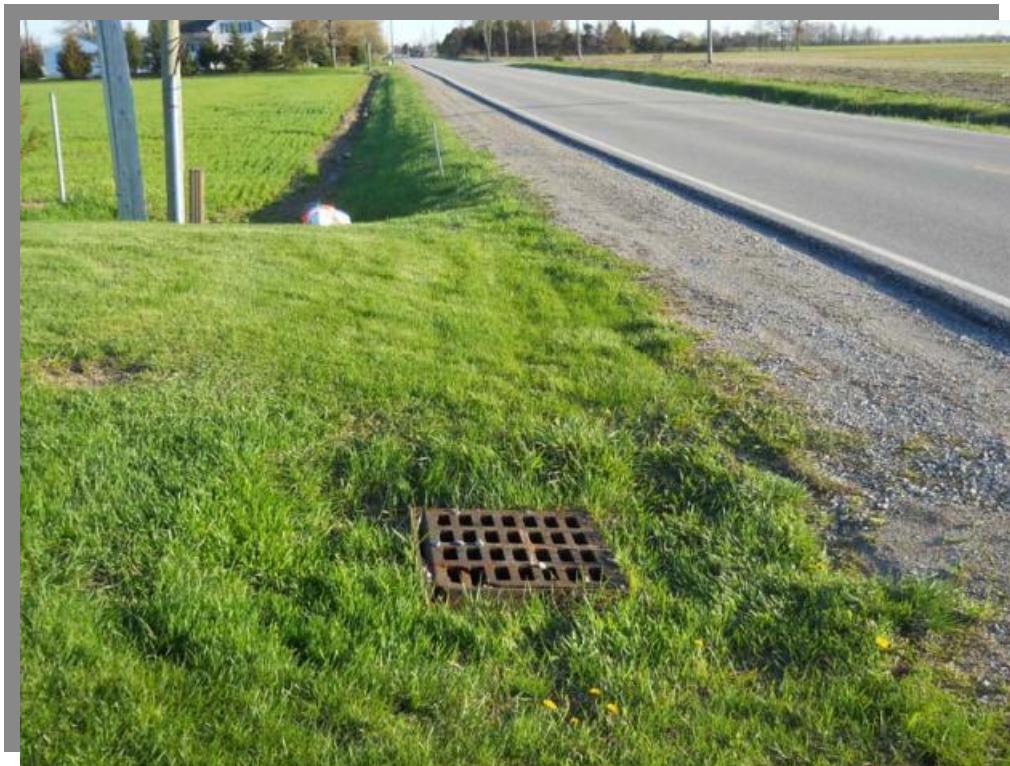
PLC14-2 Upstream End (CB – Looking north)

| Culvert I.D. | Location | Culvert Size (mm) (^①) | Culvert Type | Observations from Site Reconnaissance: Physical Characteristics of Existing Culverts and Observed Drainage Deficiencies | | | |
|---|---|---|---|--|--|--|--|
| LC14 | Under County Road 17 (approximately 110m north of Culvert LC13) Photographs PLC14 – 1 thru 4 | 300 & 450 (from CB) | CSP's | <ul style="list-style-type: none"> Downstream end of 300mm pipe barrel in good condition Downstream end of 450mm pipe barrel slightly deformed The two 300mm and 450mm CSP pipes are connected to a CB located on the other side of road 300mm inlet CSP pipe from south is connected to the CB. This pipe is in poor conditions | | | |

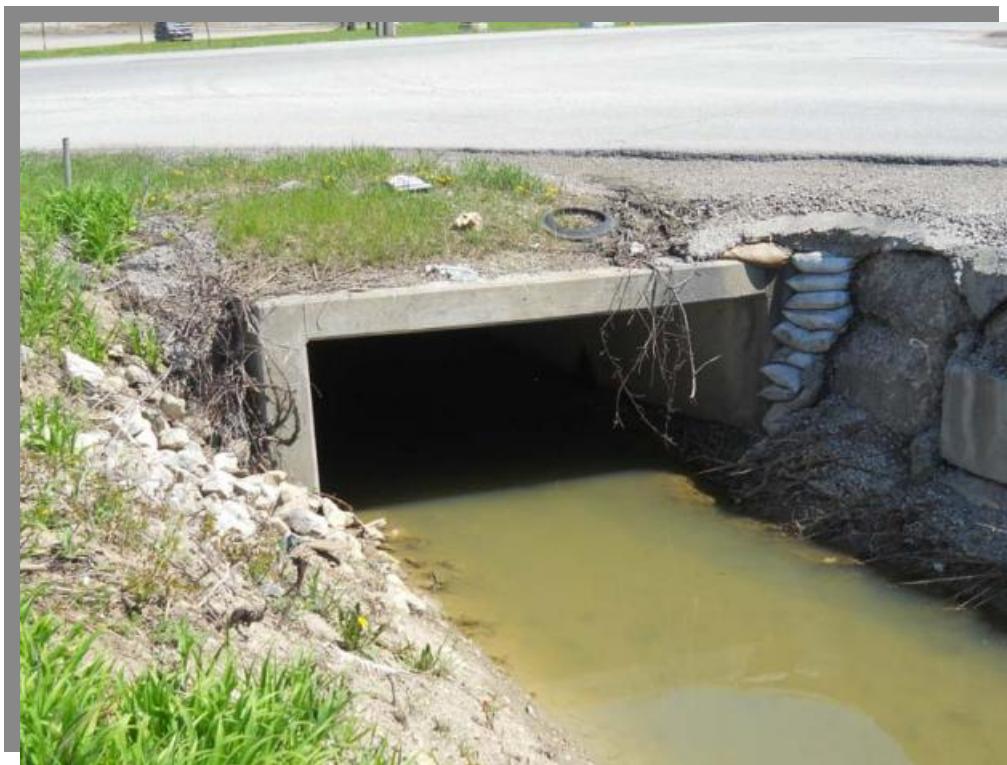
PDC2-1 Downstream Elevation (Spalling at top of culvert-Watson Drain)

Culverts DC2 was found to be in fair condition. The remaining culverts are in good condition.
