**PHASE ONE ENVIRONMENTAL SITE ASSESSMENT**

For the Property Located at  
1880 Assumption Street, Windsor, Ontario

August 22, 2025

24E098

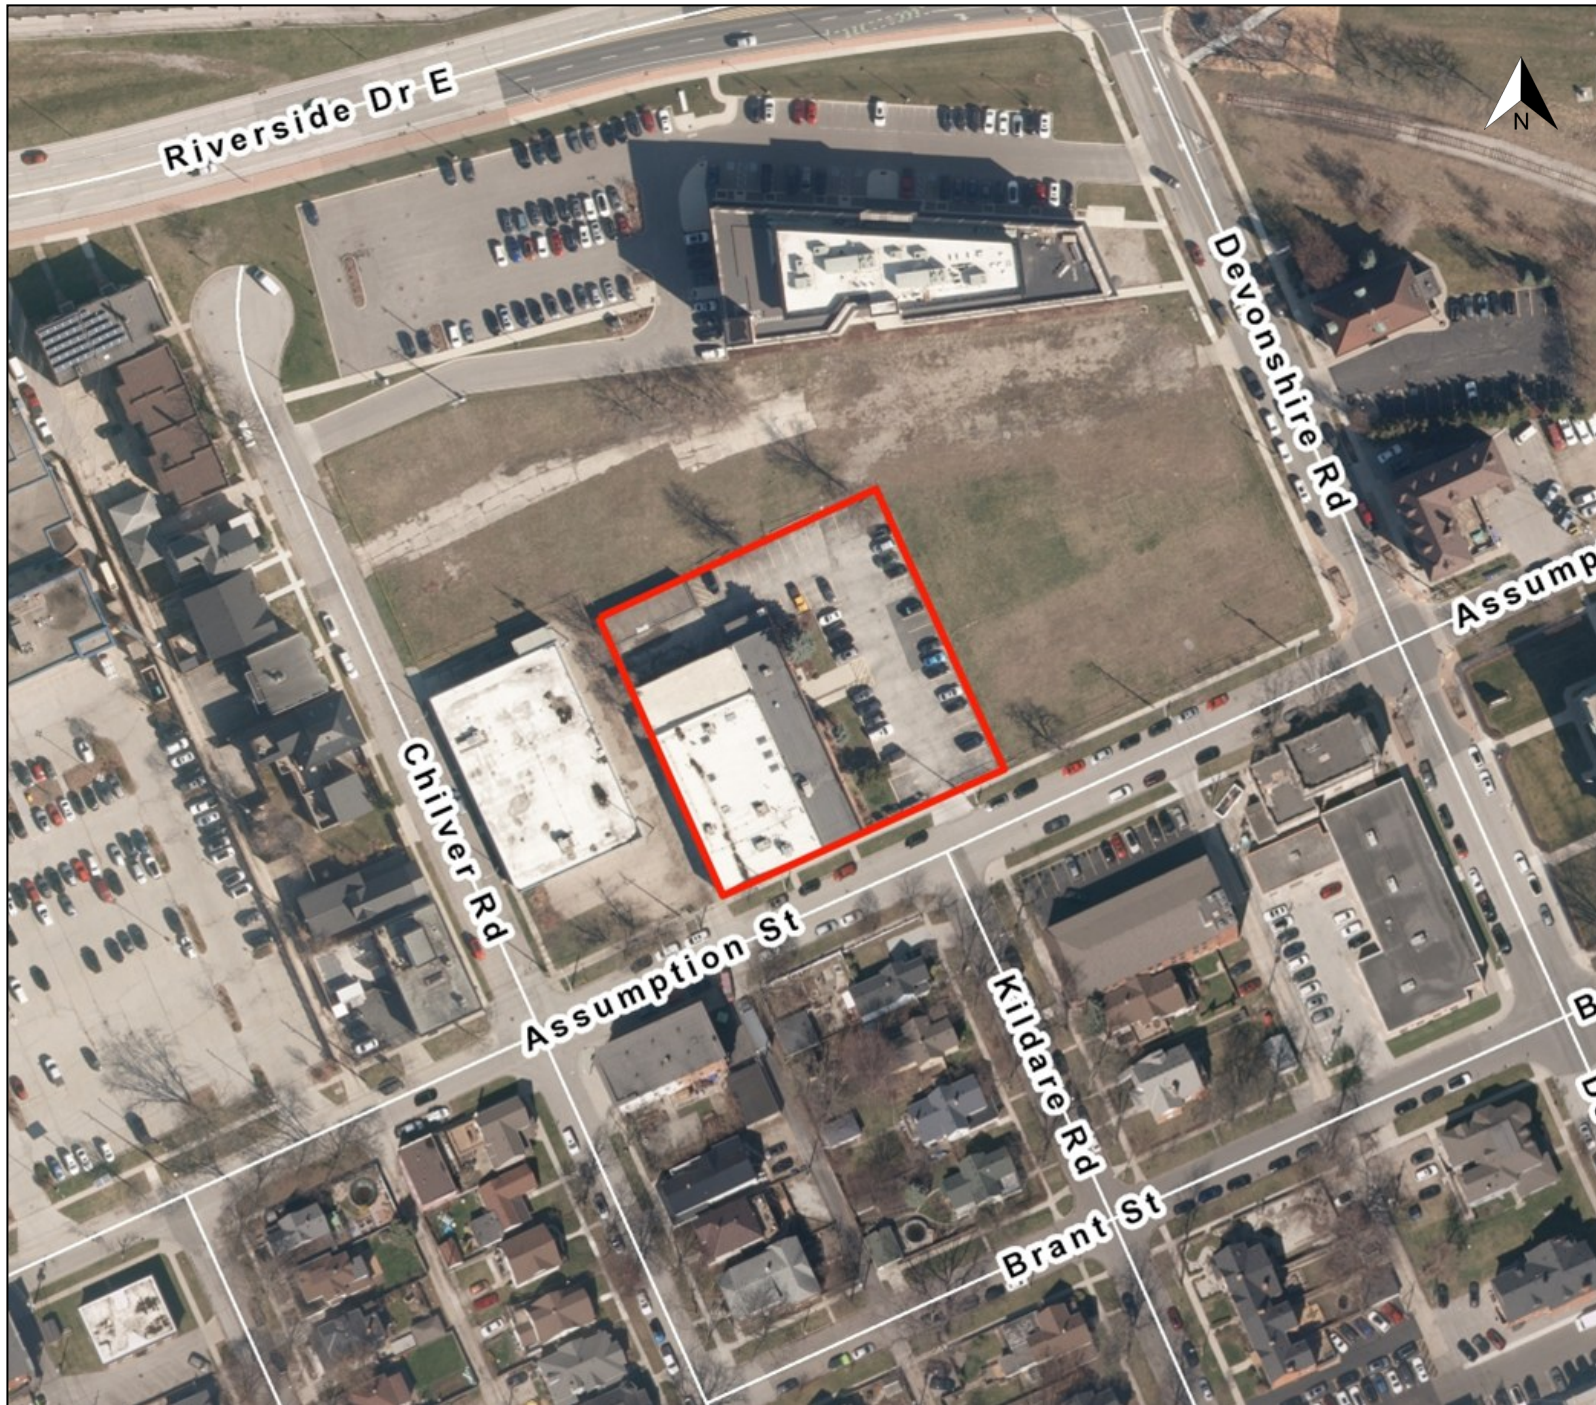
Year: 2024

| Year | Site | North | East | South | West |
|---|---|---|---|---|---|
| 2024 | The site is occupied by a commercial/ industrial building surrounded by a parking lot to the north and east of the building with a black storage building in the northwest corner of the site. | North of the site is undeveloped vacant land with remnants of the location of the former railway tracks (observed paved) followed by a commercial building with a parking lot. Railway tracks are observed further northeast of the site. | Located west adjacent of the side is an alleyway/easement followed by a commercial building with a parking lot to the south. Further west are mixed residential and commercial properties followed by a large parking lot. | Located south of the site is mixed land use consisting of residential dwellings, residential garages and commercial buildings with parking lots. | The property located east adjacent of the site consists of vacant land. Further east are commercial buildings and parking lots. |

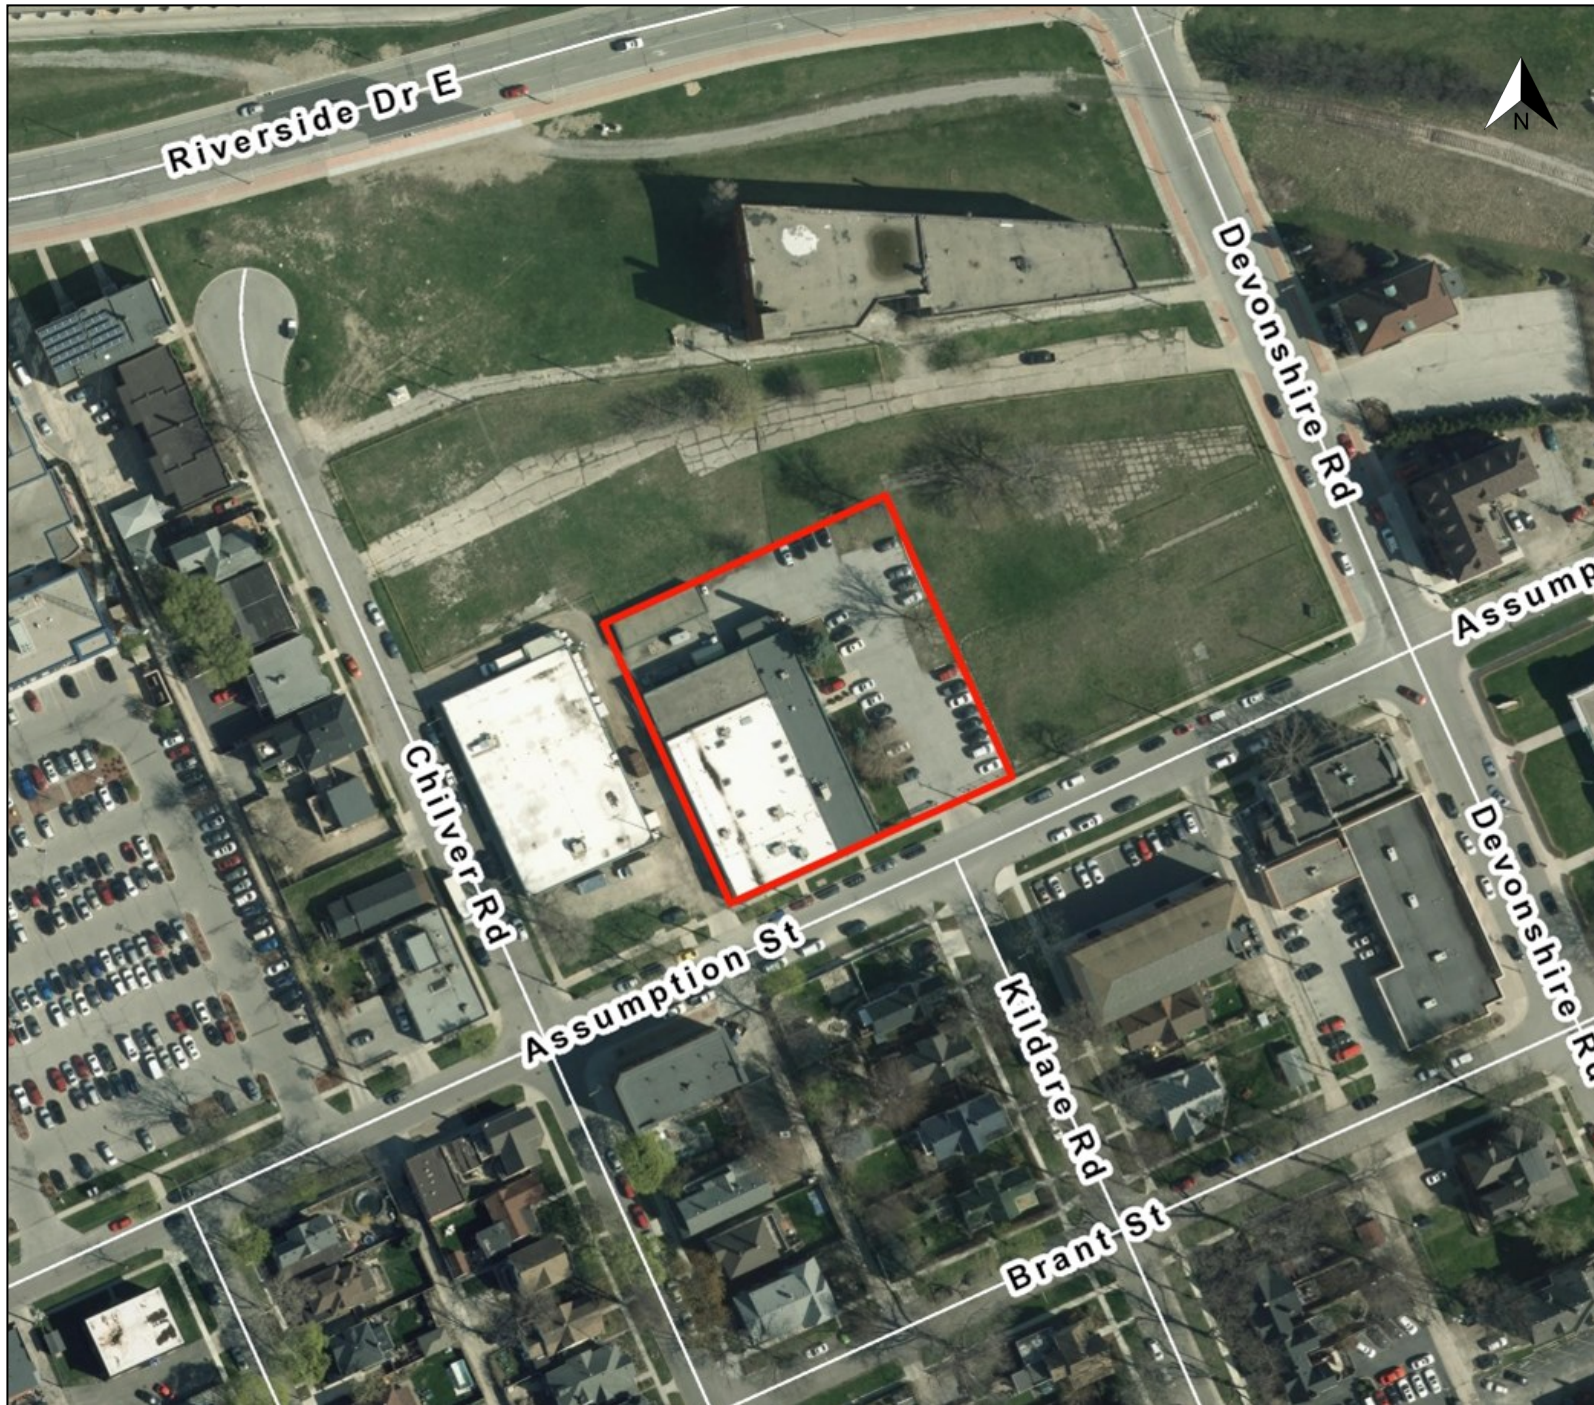
**Year:** 2015

| Year | Site | North | East | South | West |
|---|---|---|---|---|---|
| 2015 | No significant changes to the site or surrounding properties to the north, south or west between 2019 and 2015. The property located east adjacent of the site is observed to have exposed concrete at the surface which was not present in 2019. | | | | |

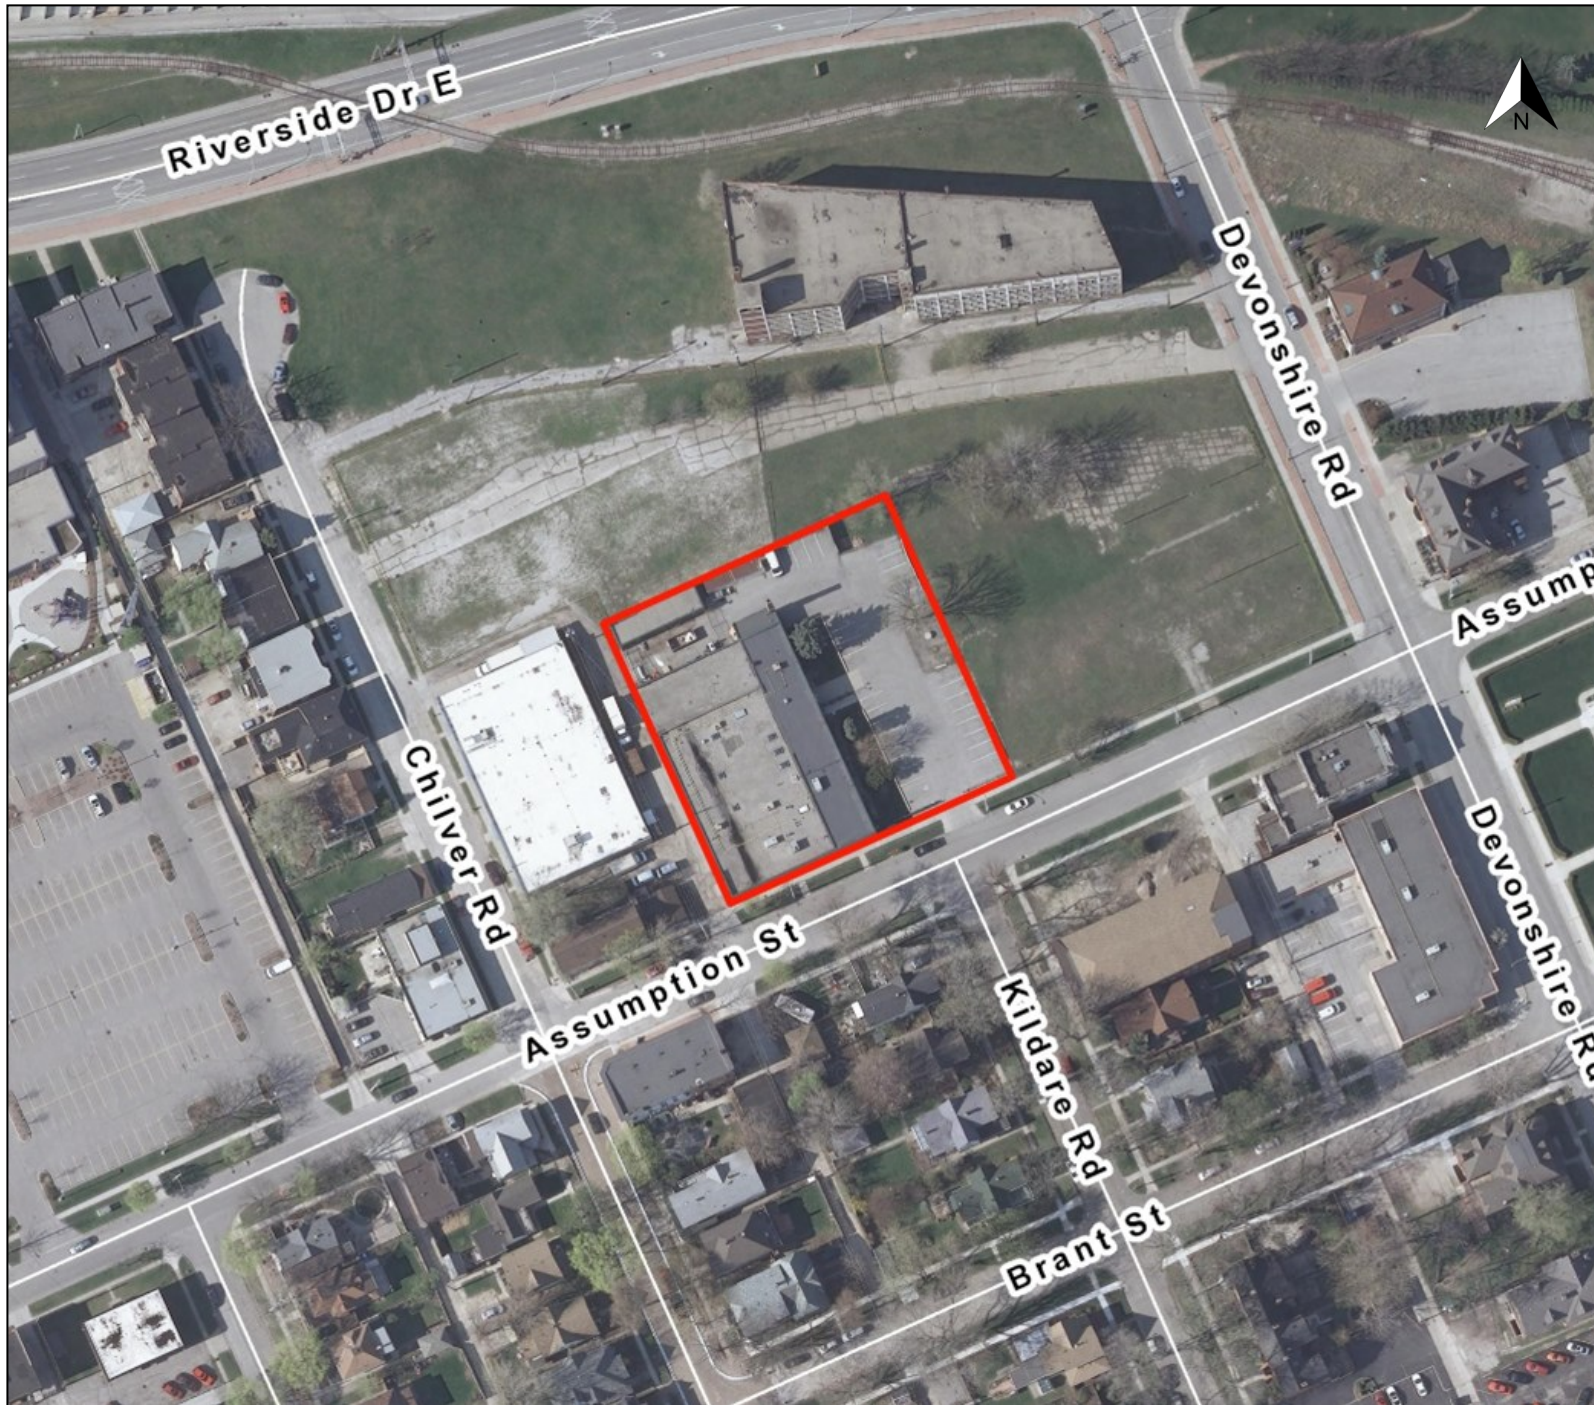
**Year:** 2010

| Year | Site | North | East | South | West |
|---|---|---|---|---|---|
| 2010 | No significant changes to the site or surrounding properties to the east or south between 2015 and 2010. An additional building is observed along Assumption Street at the west adjacent property, south of the existing building identified in 2015. Railway tracks are observed extending through the property to the north and extend through Riverside Drive East. | | | | |

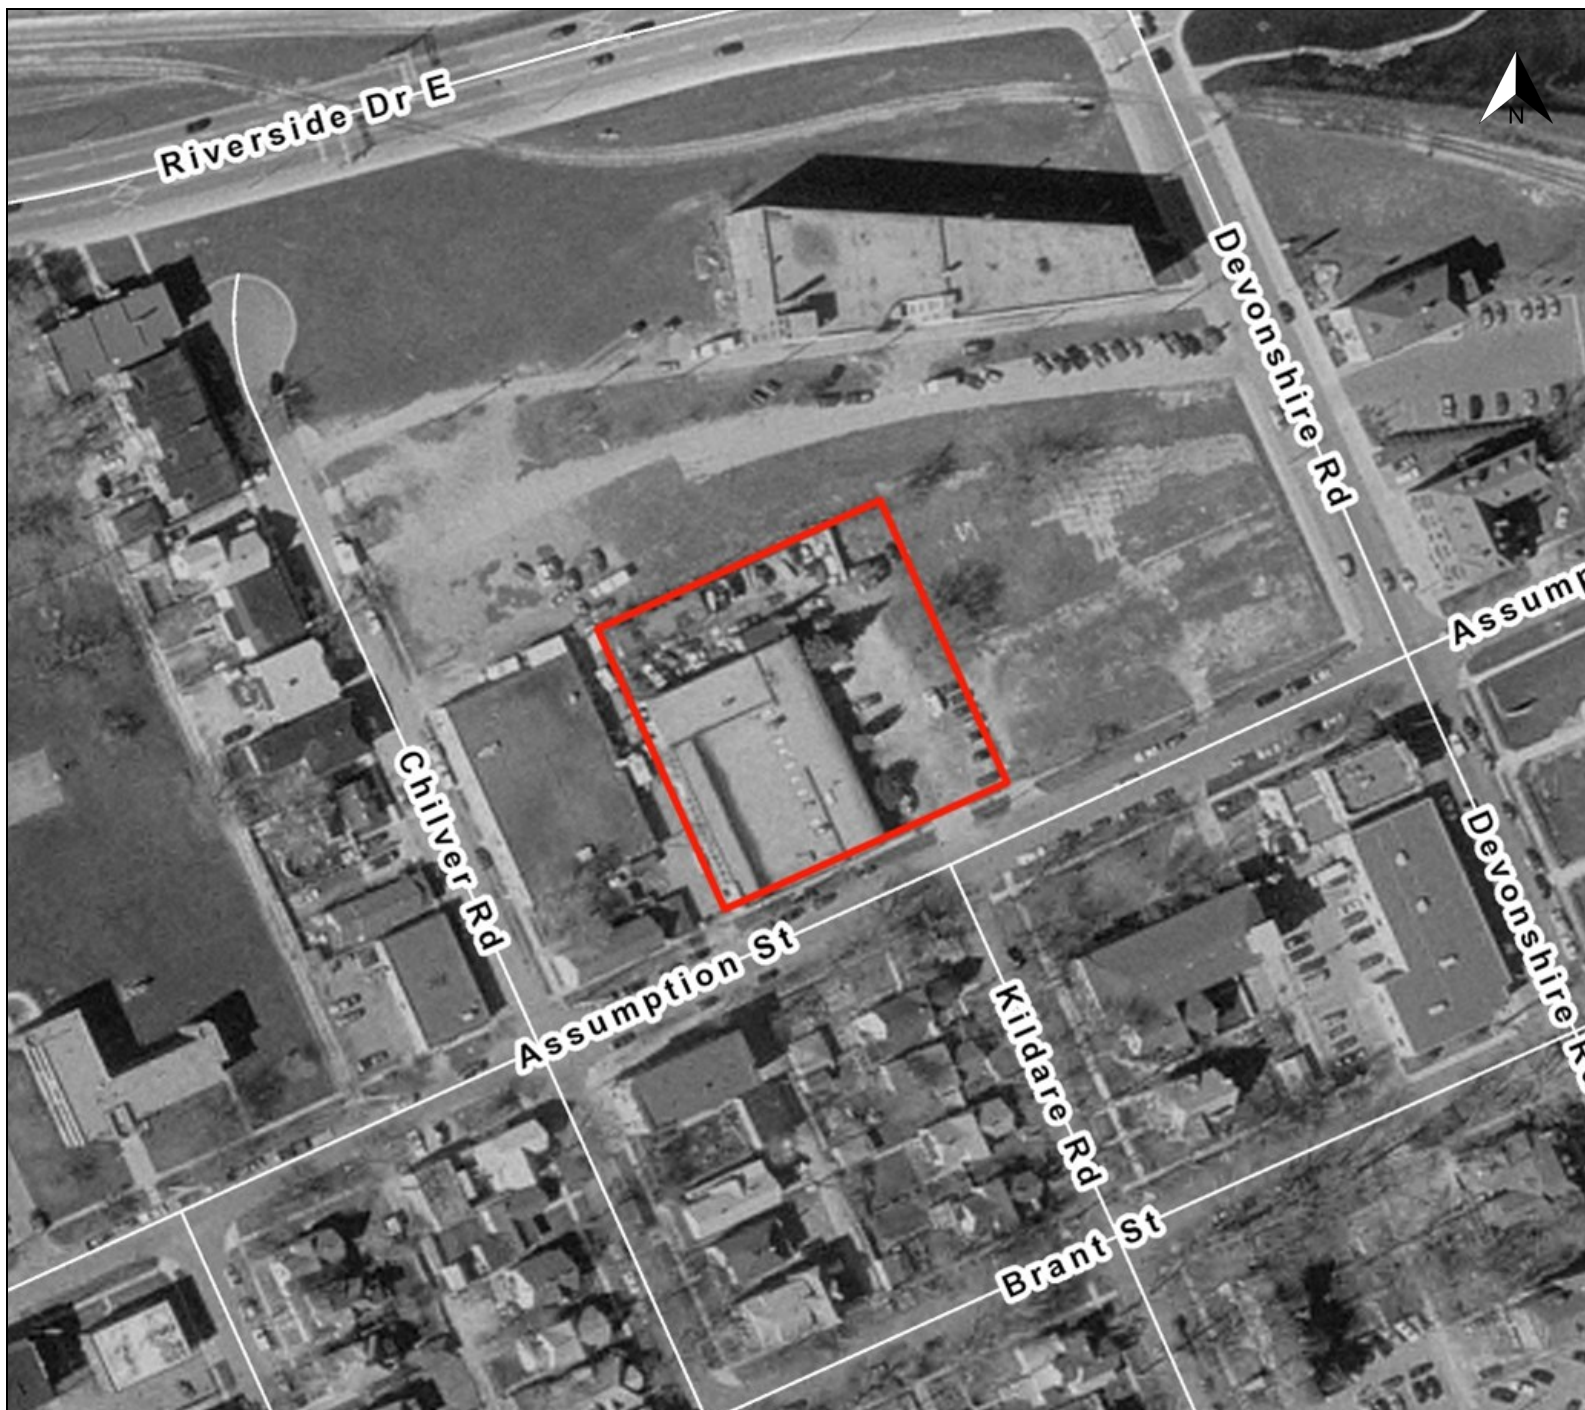
**Year:** 2000

| Year | Site | North | East | South | West |
|---|---|---|---|---|---|
| 2000 | The site is observed in similar configuration to 2006 but is occupying storage of vehicles, materials and miscellaneous items in the north portion of the site. | Located northwest adjacent of the site is vehicular storage. | No significant changes to the east of the site between 2006 and 2000. | No significant changes to the south of the site between 2006 and 2000. | The property located west of Chilver Road is no longer observed to occupy a parking lot. This property occupies an L-shaped building along Assumption Street and the remainder of the property is undeveloped. |

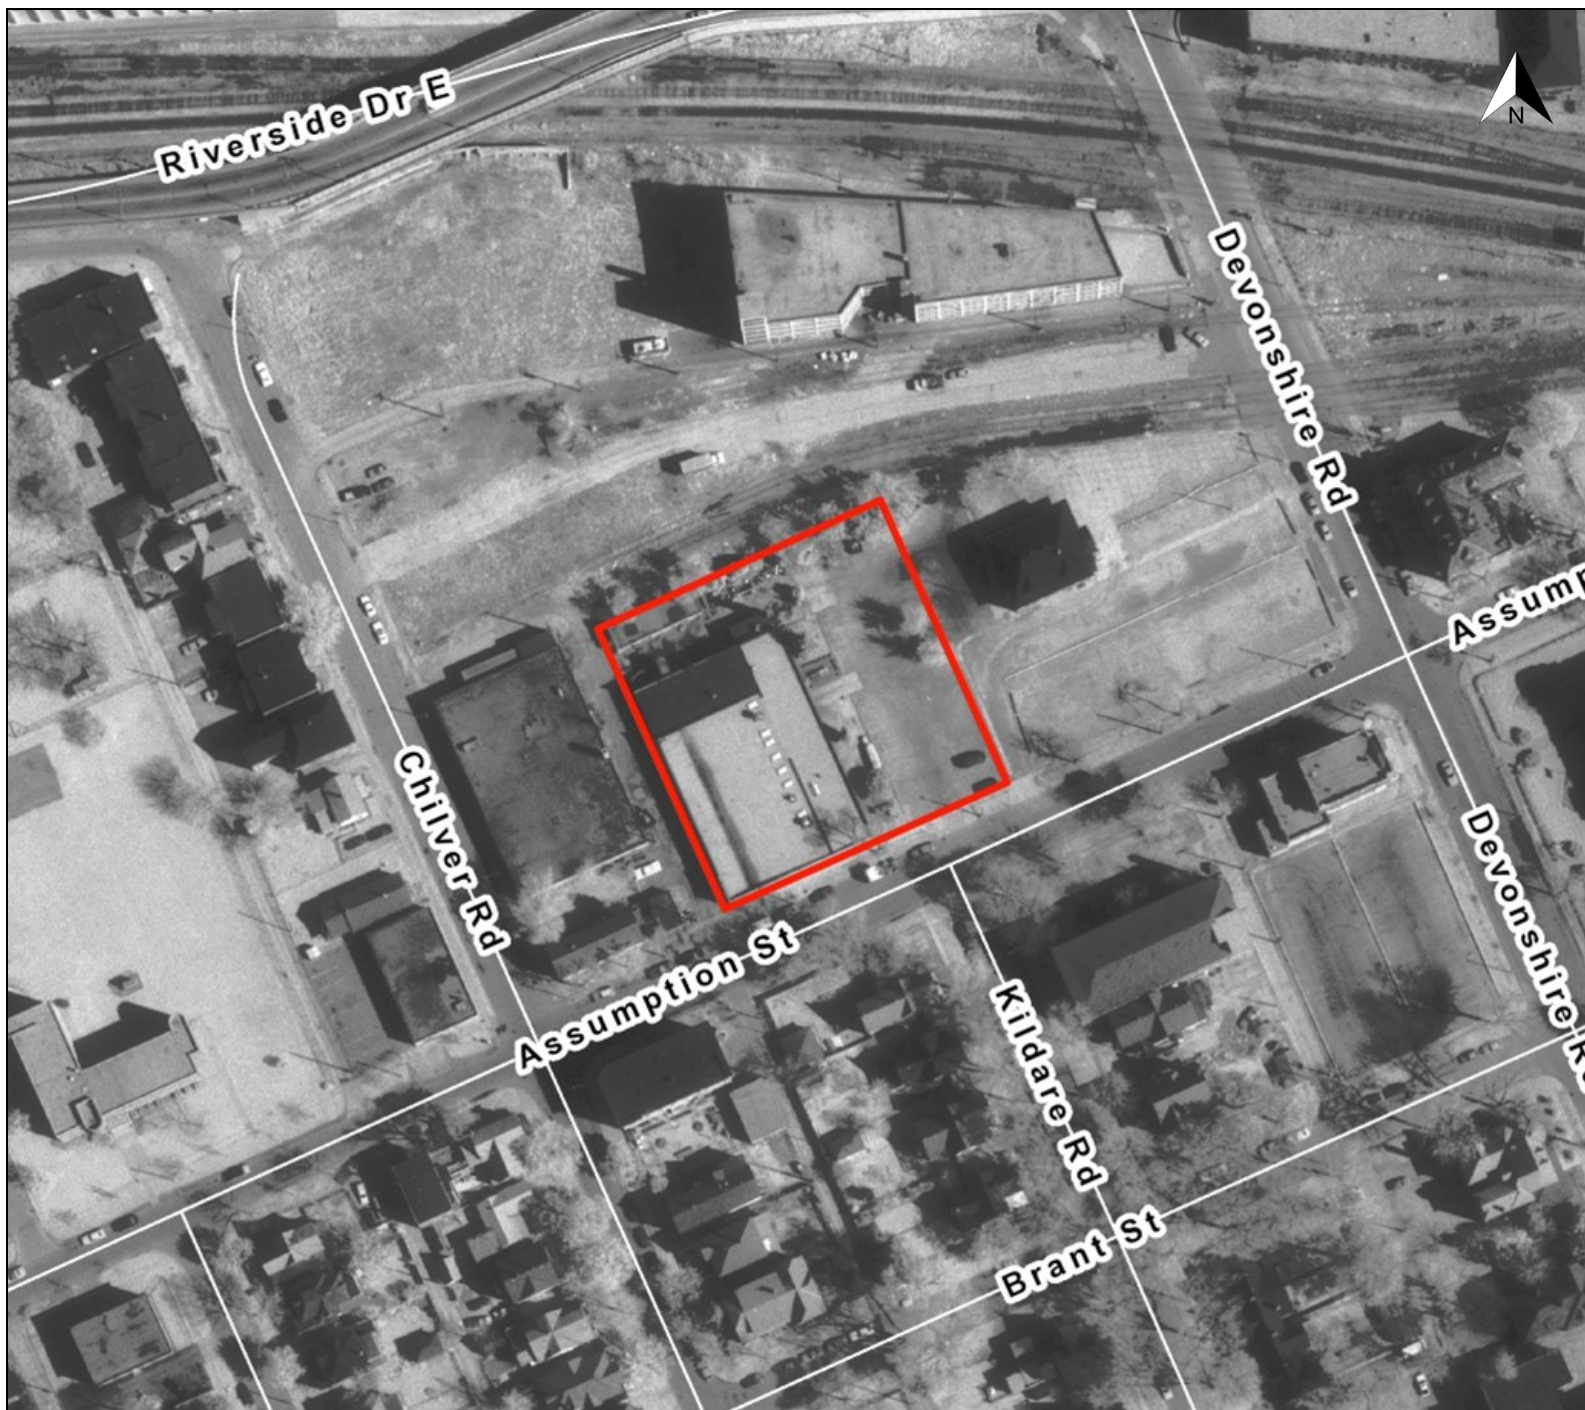
**Year:** 1988

| Year | Site | North | East | South | West |
|---|---|---|---|---|---|
| 1988 | The site remains in similar configuration to 2000, along the north boundary of the site remain parked vehicles. | Several tracks and railway ties are observed extending through the north properties in an east-west direction crossing Devonshire Road extending through the north properties across Riverside Drive East. Riverside Drive East is also observed to occupy an overpass. | A structure is occupying the east adjacent property. Railway ties extend east across Devonshire Road. | A commercial building is no longer observed at the northwest corner of Devonshire and Brant Street. | No significant changes to the west of the site between 2000 and 1988. |

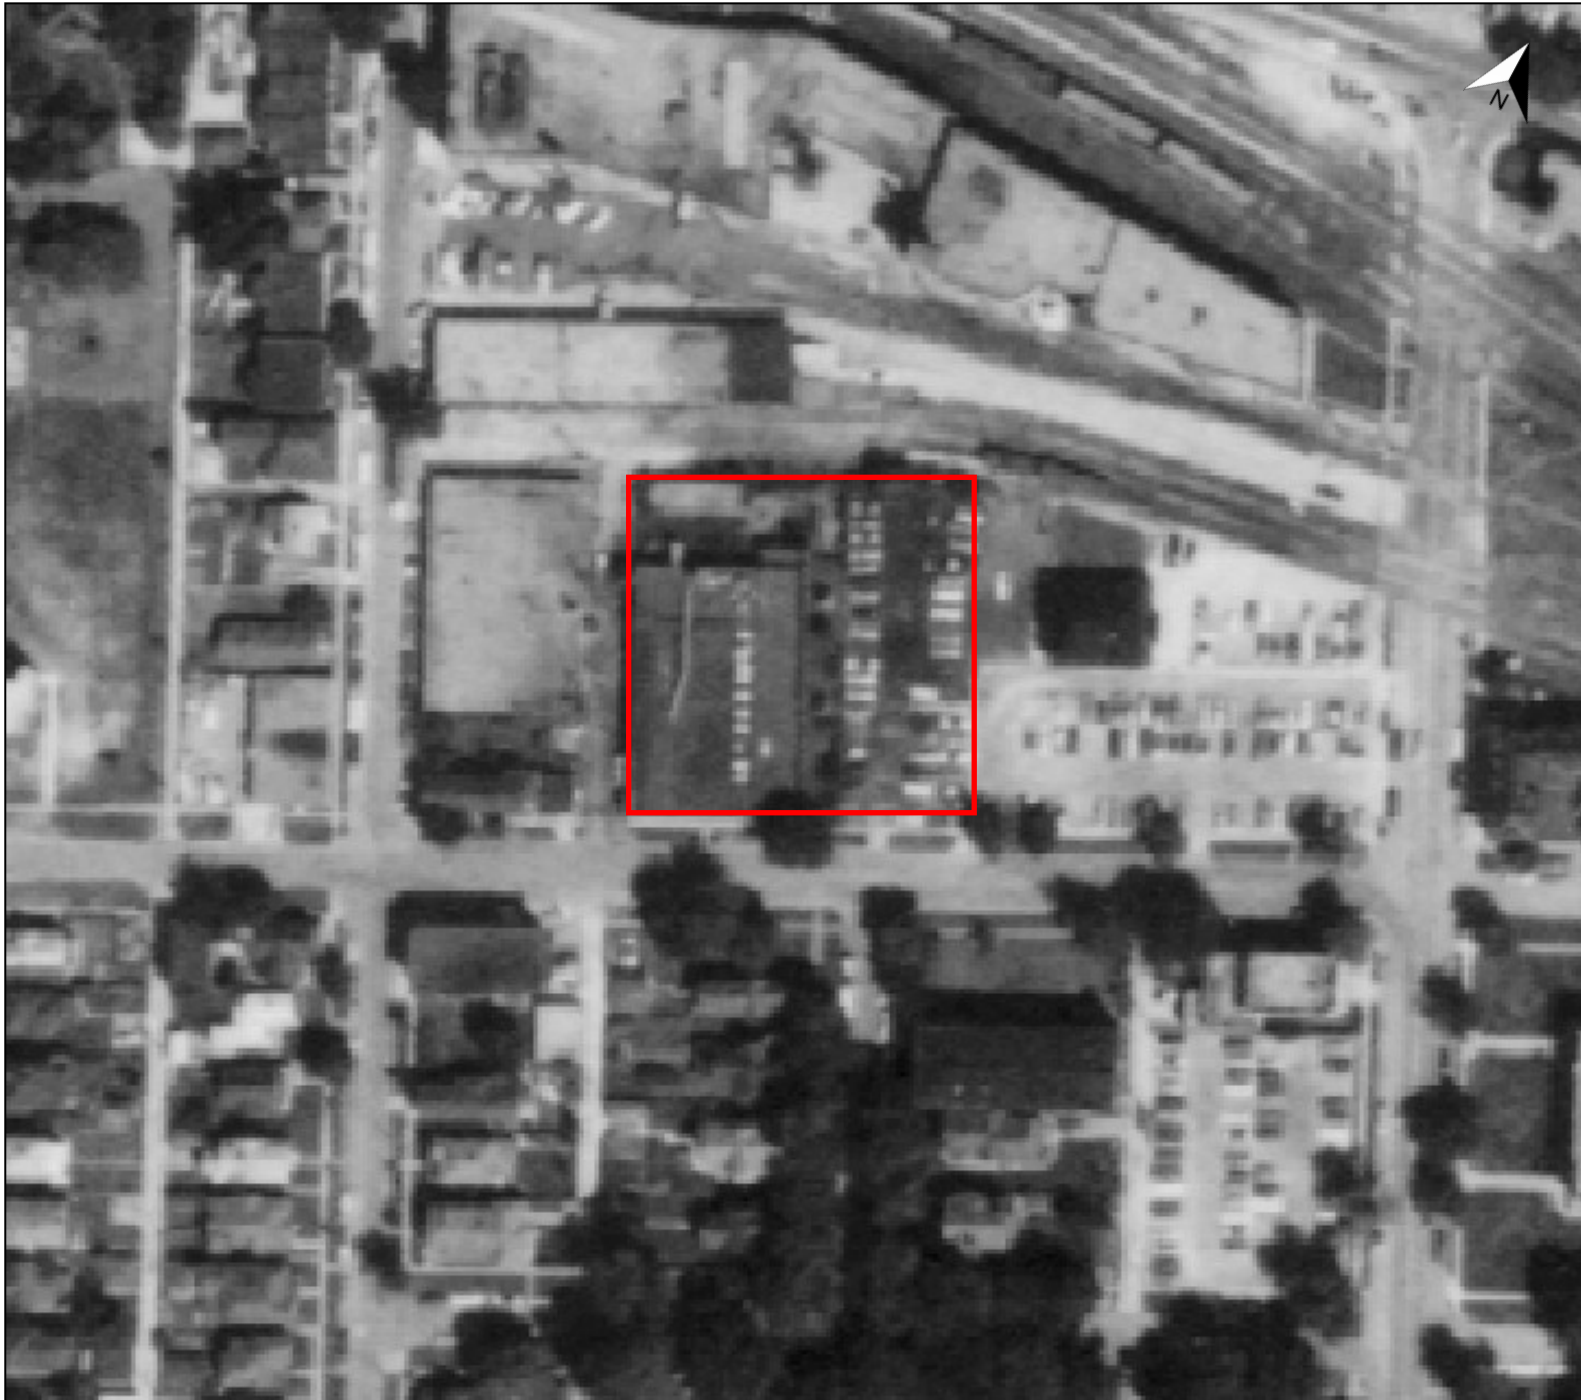
**Year:** 1970

| Year | Site | North | East | South | West |
|---|---|---|---|---|---|
| 1970 | No significant changes to the site between 1988 and 1970. The parking lot is observed to be full of vehicles. | A large industrial building is observed north of the railway tracks in the north adjacent property. Another rectangular building is located north adjacent of the site on the south side of the railway tracks. Railcars are observed along the railway. | The property located east adjacent remains occupied by the commercial building and is observed to be surrounded by a parking lot to the south and east sides. | No significant changes to the south of the site between 1988 and 1970. | No significant changes to the west of the site between 1988 and 1970. |

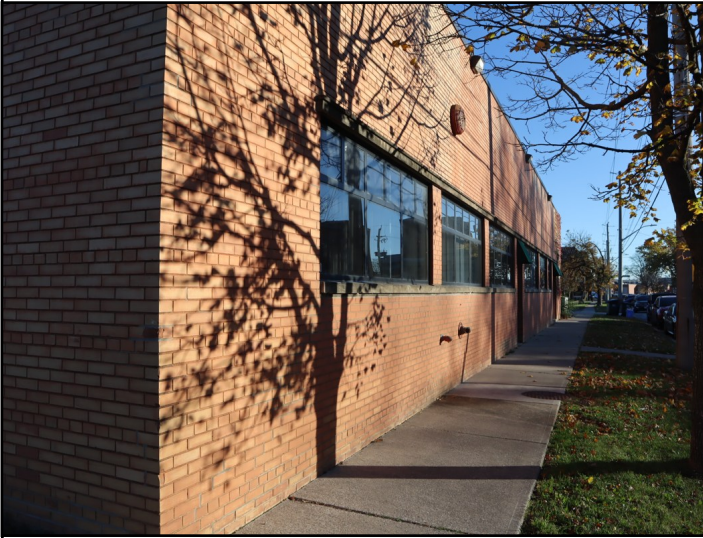
Photograph 1: View of the south side of the site building.

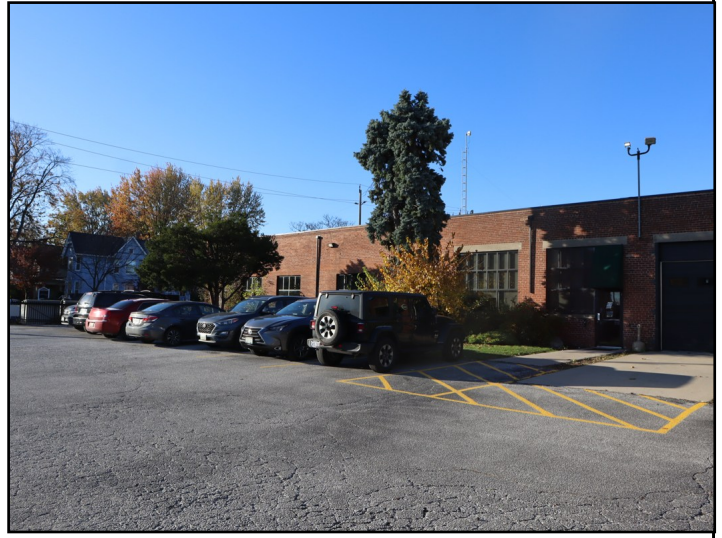
Photograph 2: View of the east side of the site building.

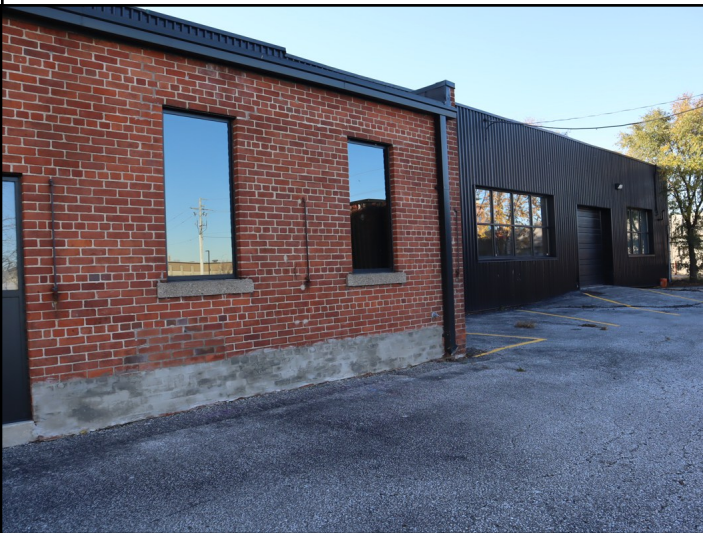
Photograph 3: View of the site building facing southwest.

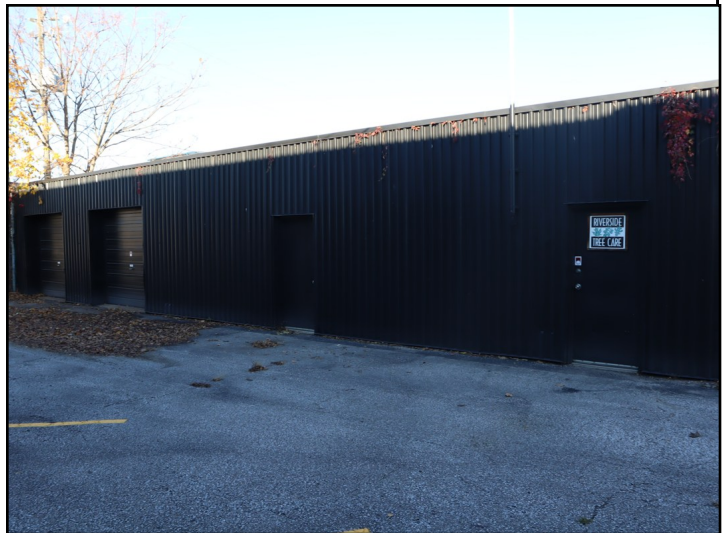
Photograph 4: View of the storage building located in the northwest corner of the site.

A black storage container was observed in the northwest corner of the site. Access was not provided to this storage container however site representative, Christian Conlon of Realtors for Life from the 2023 investigation informed SME that the storage container is used for miscellaneous storage and

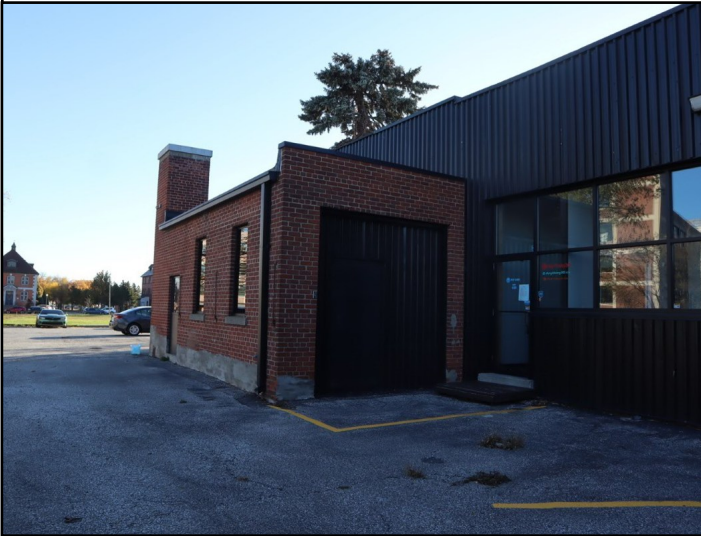
Photograph 5: View of the north side of the site building.

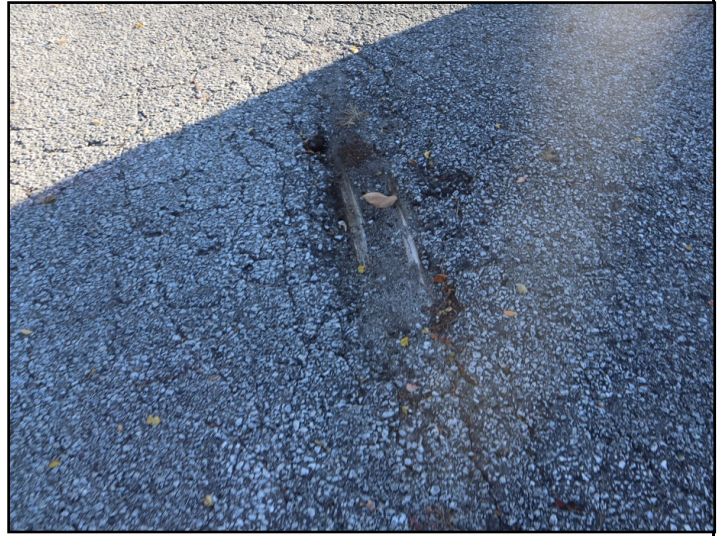
Photograph 6: Exposed portion of a railway spur located in the north portion of site within the asphalt parking lot.

Based on the Phase I ESA site visit and a review of historical documents and the site visit conducted; remnants of a rail spur were observed exposed through the asphalt of the parking lot. Based on a review of historical photos, aerial photographs railway tracks were observed north adjacent to the site (formerly Pere Marquette Railway/ Chesapeake & Ohio Railway) until approximately 2000. Located approximately 60 m north railway tracks were observed along Riverside Drive East (Canadian National Railway) until 2015. Additionally, rail spurs were observed connecting to 1950 – 2072 Riverside Drive East based on a 1952 FIP.

The building consists of concrete block foundations, red brick walls overlain by black siding along the north and west sides, glass windows, and a flat-top roof. The site building is 1,445 square meters and was constructed slab-on-grade and is one (1) – storey. A total of three (3) bay doors are located on the site building, two (2) along the north wall and one (1) along the west wall. The area surrounding the site building to the south is landscaped with grass and sidewalks. Located north and east of the site building is asphalt groundcover used as a parking lot. Railway ties were observed exposed from the surface of the asphalt within the northern portion of the parking lot.

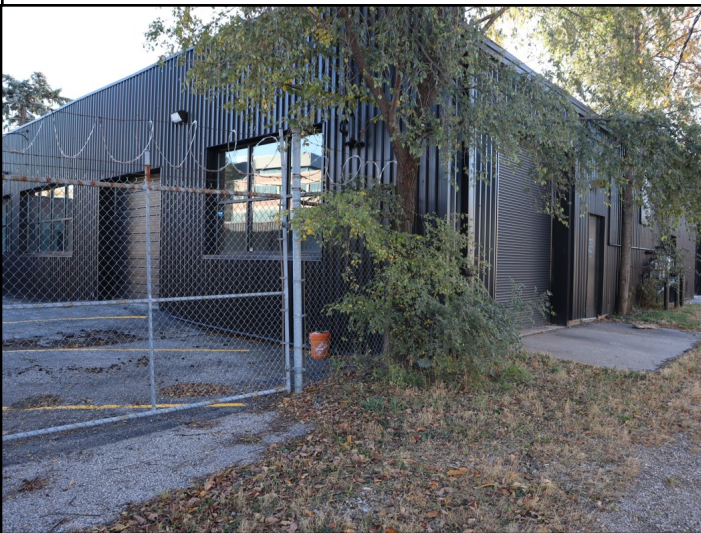
Photograph 7: View of the northwest corner of the site building. Image taken from the west adjacent alleyway.

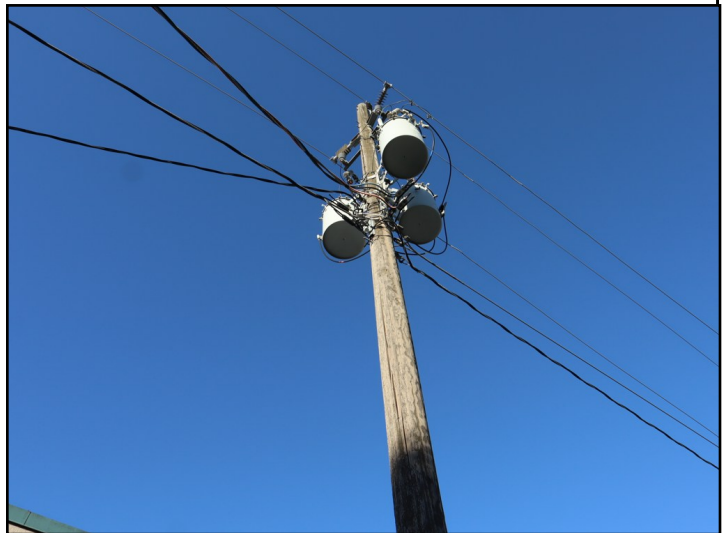
Photograph 8: View of a transformer located west adjacent to the site within the alleyway.

One (1) transformer was observed west adjacent of the site within the alleyway at the time of the Phase One ESA site visit. The bottom of the utility pole appeared to be stained and surrounded by a back sand/stone. However, any contamination observed surrounding the pole is anticipated to remain localized to the area.

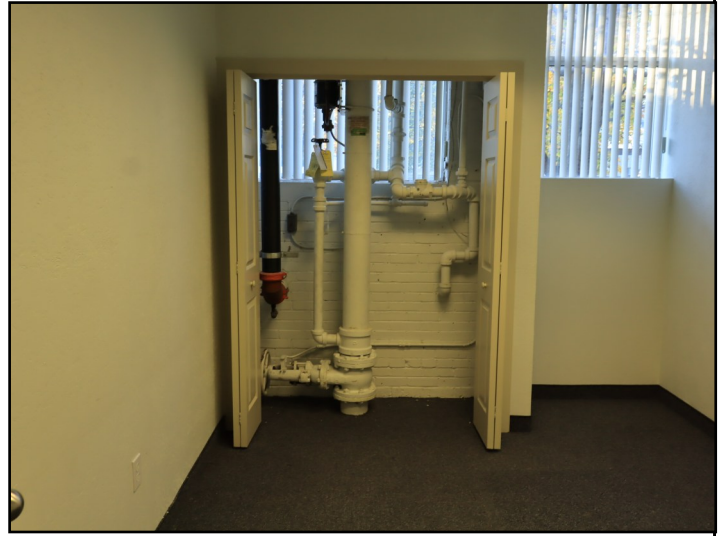
Photograph 14: View of a vacant room and piping observed in a closet of Unit #200.

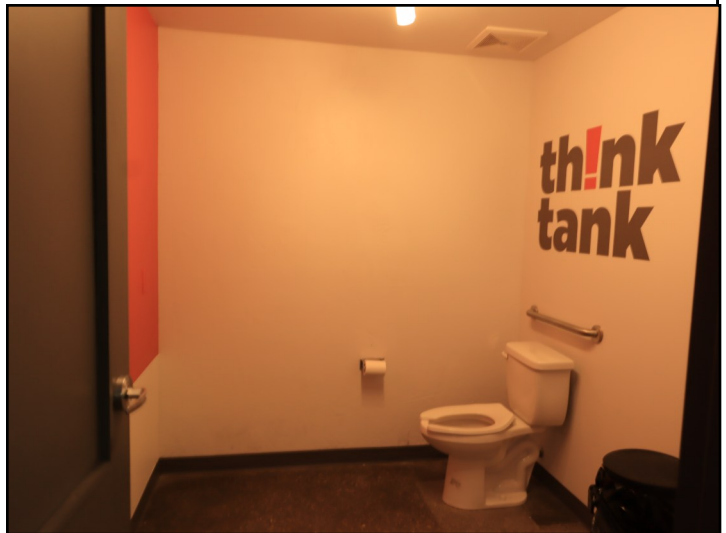
Photograph 20: View of one (1) of two (2) washrooms located in Tango Creative Group. Drains were observed in both washrooms.

Drains were observed in the washrooms of unit #300. Municipal sewers were observed within the roadway adjacent to the site.
