# Transit Windsor Garage Feasibility Study

Future Facility Strategy

Prepared for the City of Windsor  
by IBI Group

October 28, 2021

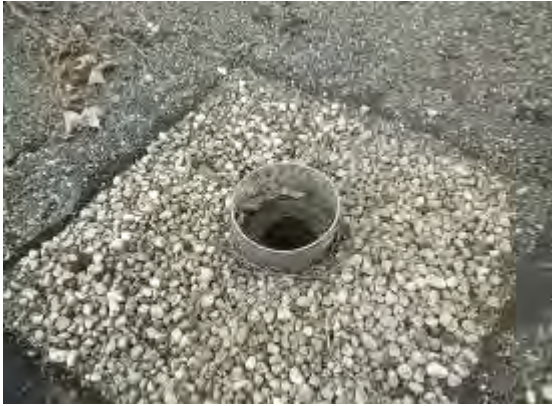
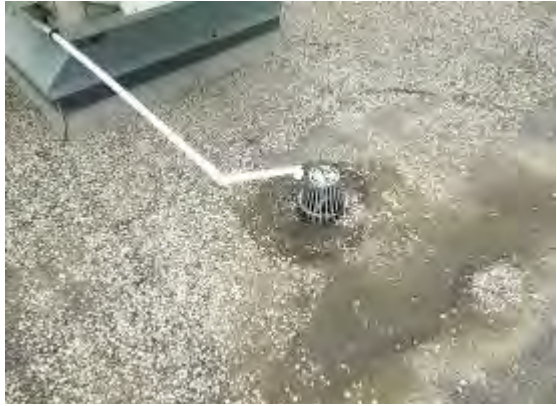
<p><b>Description</b></p> <p>The building's main water drainage system consists of roof drains strategically placed to allow water and melted snow to drain into the building's leader lines which were mostly hidden behind interior finishes. Various types of roof drains were observed throughout the main roof which suggests that the roof drains have been replaced on an as-needed basis. Minor deficiencies include exposed roof drains and damaged drain caps. There were no reported problems with the actual drainage system. Overall, the roof drains appeared to be in fair condition with normal signs of wear. No significant signs of deterioration were present.</p>		
<p><b>Component Rating:</b> Fair (3)</p>		<p><b>Installation Date:</b> 1979</p>
<p><b>Typical Life Span:</b> 35</p>	<p><b>Remaining Life:</b> 2</p>	<p><b>Current Effective Age:</b> 33</p>
<p><b>Recommendations</b></p> <p>This item has been deferred, where possible, to extend its normal life span. Based on a normal life span for this component, repairs and/or replacements are anticipated during the study period. Exposed roof drains are recommended to be replaced immediately to prevent drainage problems. This is considered under on-going routine maintenance.</p>

<p>Exposed roof drain on flat roof</p>	<p>Roof drain on flat roof</p>

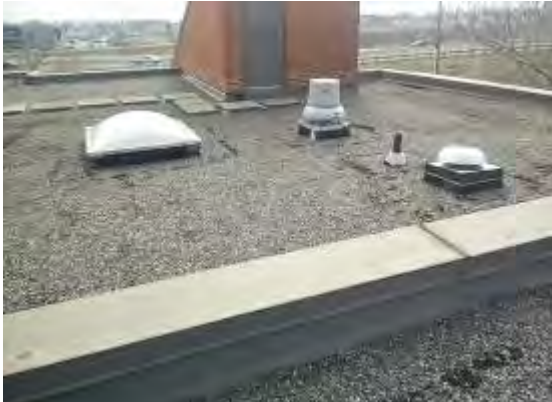
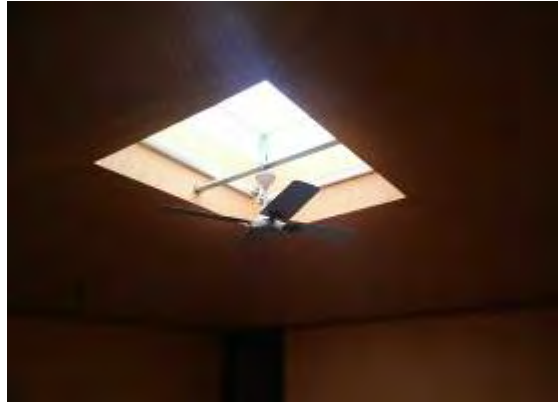
<p><b>Description</b>          There is one (1) skylight located above the main reception desk. The skylight is made up of a translucent plexiglass dome with a metal frame and is mounted on an 8” curb. The skylight appeared to be original to the building and was in poor condition with extensive wear from the exterior elements. There are no issues with the skylight however, it has well passed its typical life span and is recommended to be replaced.</p>		
<p><b>Component Rating:</b> Poor (4)</p>		<p><b>Installation Date:</b> 1979</p>
<p><b>Typical Life Span:</b> 20</p>	<p><b>Remaining Life:</b> 1</p>	<p><b>Current Effective Age:</b> 19</p>
<p><b>Recommendations</b>          This item has been deferred, where possible, to extend its normal life span. Based on a normal life span for this component, repairs and/or replacements are anticipated during the study period. This is considered under on-going routine maintenance.</p>

<p>Single skylight above reception desk</p>	<p>Skylight seen from interior</p>

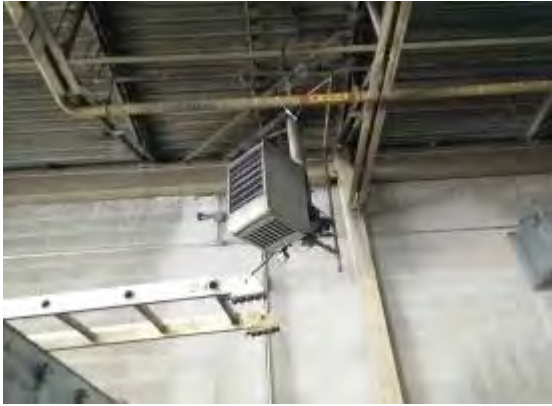
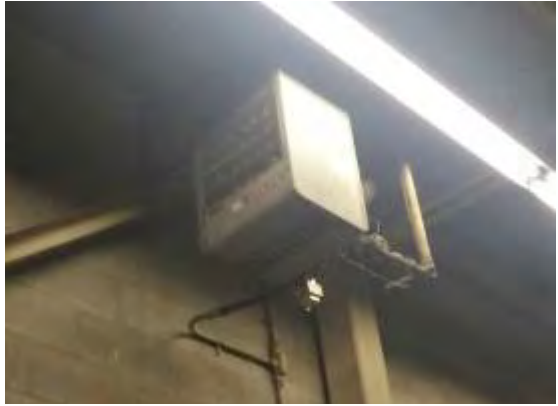
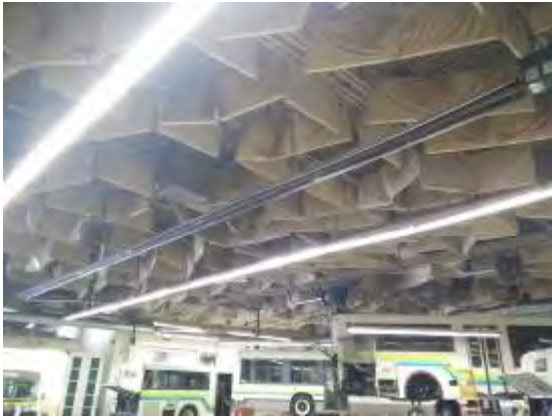
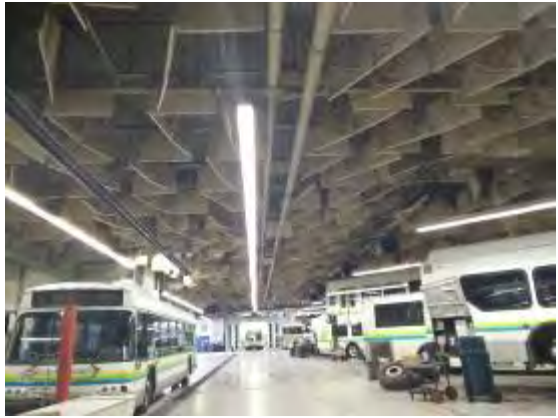
<p><b>Description</b>          Several gas-fired unit heaters were found within the bus storage. Suspended gas-fired tube heaters were found within the bus maintenance areas which ran the length of the space. The units were observed from ground level and specifications could not be determined however, appeared to be in good and working condition. No significant signs of deterioration were present. No issues were reported by the site representative.</p>		
<p><b>Component Rating:</b> Good (2)</p>		<p><b>Installation Date:</b> 1979</p>
<p><b>Typical Life Span:</b> 20</p>	<p><b>Remaining Life:</b> 5</p>	<p><b>Current Effective Age:</b> 15</p>
<p><b>Recommendations</b>          Its typical lifespan is 25 years however it has already passed its typical life expectancy as is still observed to be in good condition. Replacement can be deferred to year 5. All unit/tube heaters can be replaced on an as-needed basis.</p>

<p>Unit heater</p>	<p>Unit heater</p>

<p>Gas-fired tube heaters</p>	<p>Gas-fired tube heaters</p>

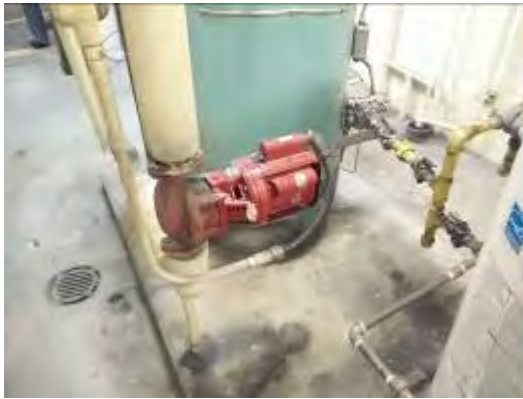
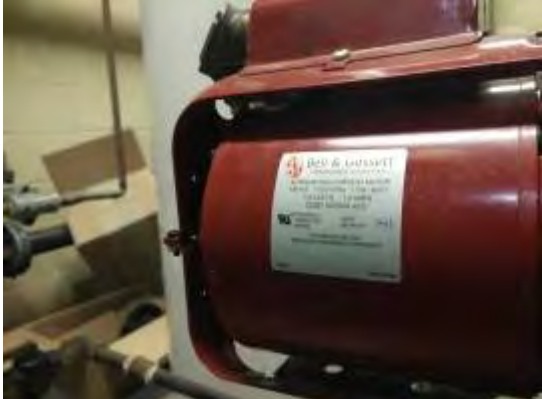
<p><b>Description</b>          A “Bell &amp; Gossett” circulating pump was found within the mechanical room. The pump was found pushing the heated water supply to other mechanical components. The pump was rated 1/6HP and appeared to be in good and working condition. No significant signs of deterioration were present. No issues were reported by the site representative.</p>		
<p><b>Component Rating:</b> Fair (3)</p>		<p><b>Installation Date:</b> 1999</p>
<p><b>Typical Life Span:</b> 20</p>	<p><b>Remaining Life:</b> 2</p>	<p><b>Current Effective Age:</b> 18</p>
<p><b>Recommendations</b>          Based on a normal life span for this component, repairs and/or replacements are anticipated during the study period. This is considered under on-going routine maintenance.</p>		
<p><b>Project Breakdown</b></p>	<p><b>QTY:</b> N/A</p>	<p><b>Capital Cost:</b> N/A</p>

<p>Circulating pump</p>		<p>Pump specification label</p>

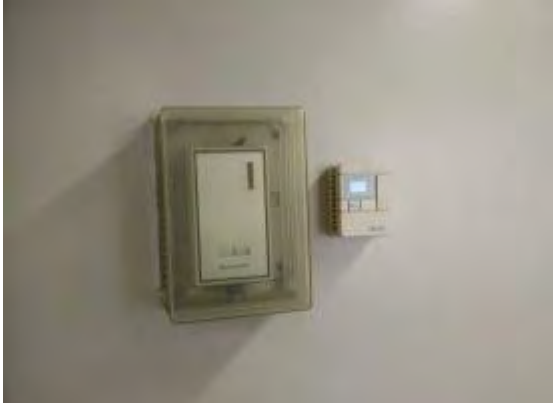
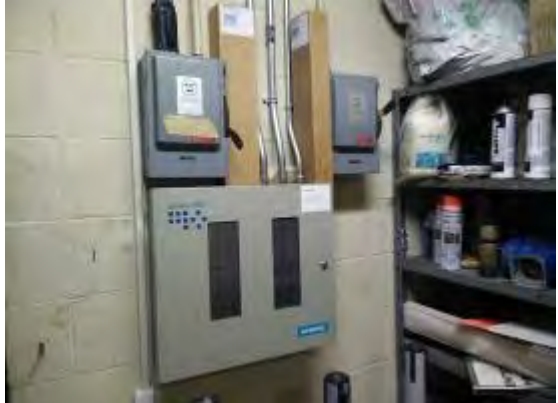
<p><b>Description</b>          The building HVAC system is controlled by wall mounted programmable thermostats. All hydronic heating is controlled by BAS, while all packaged heating/cooling rooftop units &amp; interior make up air units are individually controlled by wall mounted thermostats. A unitary controller was found in the mechanical room which is a programmable unit to adjust HVAC settings. Overall, the systems appeared to be in good and working condition. No significant signs of deterioration were present. No issues were reported by the site representative.</p>		
<p><b>Component Rating:</b> Good (2)</p>		<p><b>Installation Date:</b> 1979</p>
<p><b>Typical Life Span:</b> 30</p>	<p><b>Remaining Life:</b> 5</p>	<p><b>Current Effective Age:</b> 25</p>
<p><b>Recommendations</b>          This item has been deferred, where possible, to extend its normal life span. Based on a normal life span for this component, repairs and/or replacements are anticipated during the study period. An allowance is carried.</p>

<p>Protected thermostat</p>	<p>Unitary controller</p>

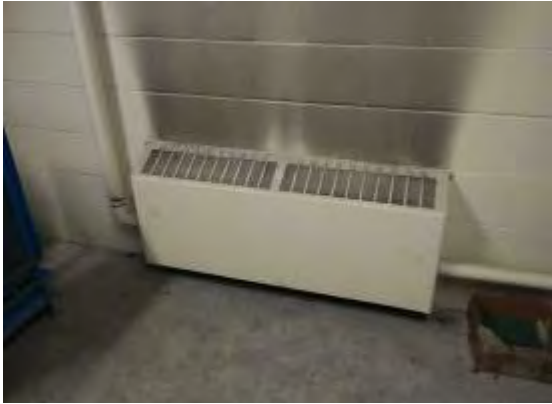
<p><b>Description</b></p> <p>The building is equipped with galvanized ductwork for supply and return exhaust distribution systems typically found within the administrative and maintenance areas. The majority of the galvanized ductwork was visible within the bus maintenance areas.</p> <p>Supply air diffusers were found throughout the building and were found in various sizes as shown in the pictures below. Typical diffusers include and silhouette type found on the second floor administrative area. The distribution system where visible, appeared to be in good condition. No significant signs of deterioration were present.</p> <p>The majority of the hydronic distribution system was hidden behind interior finishes and could not be evaluated. Where visible, the distribution lines were insulated. With no issues reported, it is assumed that the system is working as intended. It has been noted that excessive residue was observed above the fin tube radiator located in the sprinkler room. Further investigation is recommended.</p>

Excessive residue above heat emitting radiator	Fin tube radiators

<b>Component Rating:</b> Fair (3)		<b>Installation Date:</b> 1979
<b>Typical Life Span:</b> 35	<b>Remaining Life:</b> 3	<b>Current Effective Age:</b> 32
<p><b>Recommendations</b></p> <p>Replacement of ductwork does not truly occur unless damages have been observed or the sizing is insufficient for the air handling unit provided. This item is anticipated for repairs and/or replacement during the study period. An allowance is carried for general repairs and/or replacements to the hydronic distribution system over the study period.</p>		
<b>Project Breakdown</b>	<b>QTY:</b> Allowance	<b>Capital Cost:</b> \$30,000

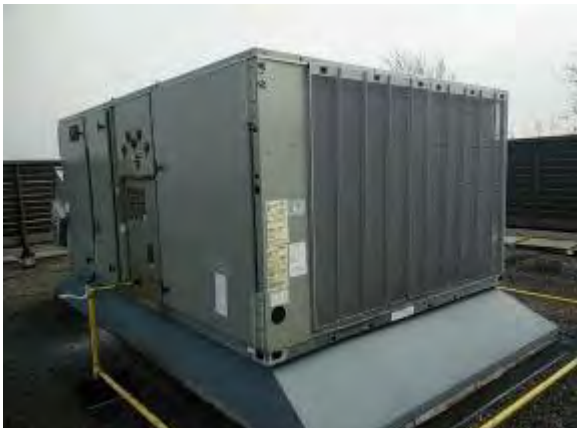
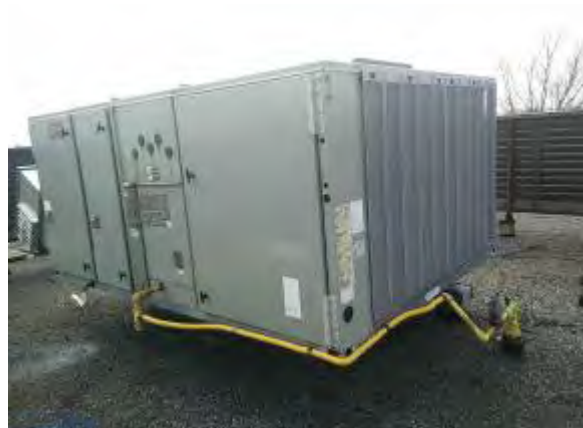
<p><b>Description</b>          There are two (2) gas-fired “Trane” rooftop units located on the high rooftop of the facility. The units have a maximum output of 324MBH. The components appear to be in good and working condition with normal signs of wear from exterior elements. Minor surface corrosion was observed between the mounting curb and bottom of RTU flashing. No significant signs of deterioration were present. No issues were reported by the site representative.          All HVAC equipment is connected to the building automation system (BAS).</p>		
<p><b>Component Rating:</b> Good (2)</p>		<p><b>Installation Date:</b> 2009</p>
<p><b>Typical Life Span:</b> 25</p>	<p><b>Remaining Life:</b> 15</p>	<p><b>Current Effective Age:</b> 8</p>
<p><b>Recommendations</b>          Based on a normal life span for this component, repairs and/or replacements are anticipated during the study period. Appropriate costs are carried. Regular maintenance such as air filter replacement can be done on an as-needed basis.</p>

<p>Rooftop unit</p>	<p>Rooftop unit</p>

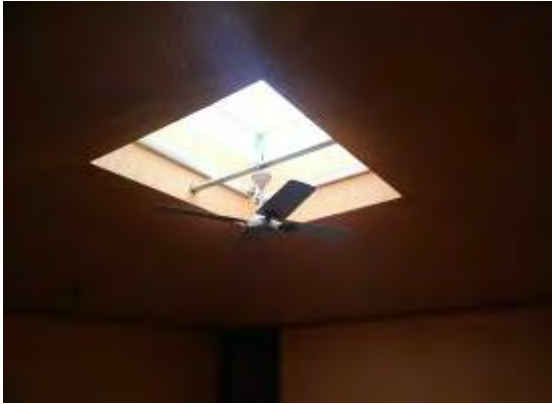
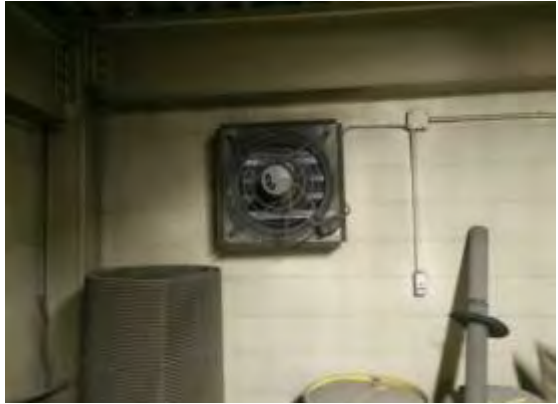
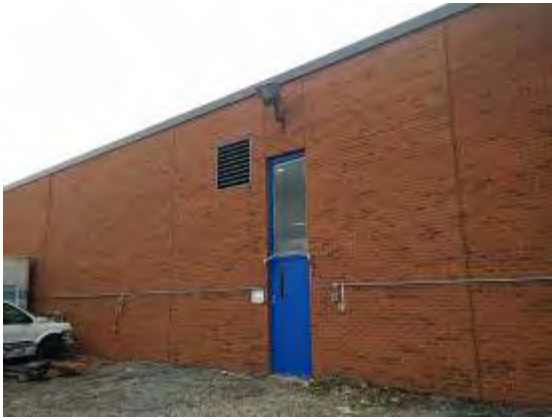
<p><b>Description</b>          Several fans were found within the facility. A ceiling fan was located above the main reception desk to circulate air within the area. Other fans typically exhaust stale air from the mechanical rooms to the exterior of the building. The component condition is in good working order. No significant signs of deterioration were present. No issues were reported by the site representative.</p> <p>Exterior louvers were constructed of a pre-manufactured metal system and generally appeared to be in good condition.</p>		
<p><b>Component Rating:</b> Good (2)</p>		<p><b>Installation Date:</b> 1979</p>
<p><b>Typical Life Span:</b> 25</p>	<p><b>Remaining Life:</b> 5</p>	<p><b>Current Effective Age:</b> 20</p>
<p><b>Recommendations</b>          This item has been deferred, where possible, to extend its normal life span. Based on a normal life span for this component, repairs and/or replacements are anticipated during the study period. An allowance is carried for components to be replaced.</p>

<p>Fan above reception desk</p>	<p>Exhaust fan to exterior</p>

<p>Louver</p>

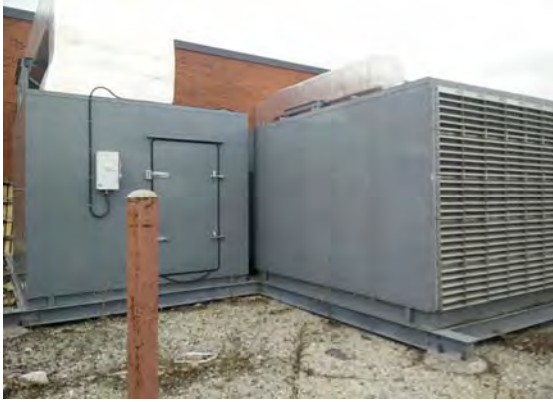
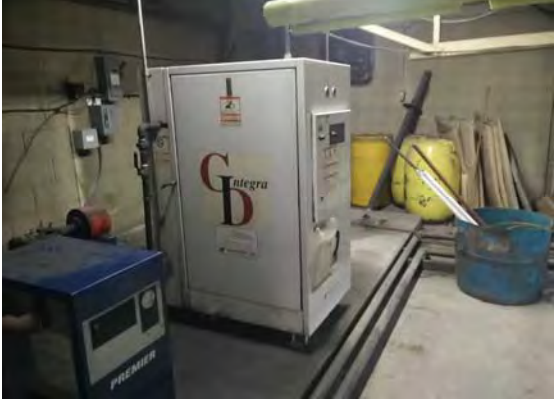
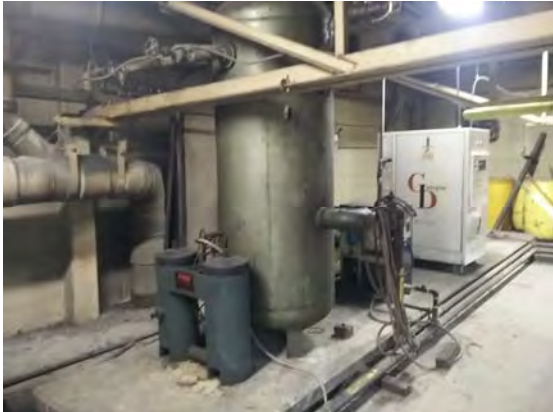
<p><b>Description</b></p> <p>There are two commercial size heat recovery ventilators (HRV) located on the east side of the facility. The units appear to be in good and working condition.</p> <p>A rotary screw air compressor system was found above the oil room and provides the facility with compressed air for pneumatic tools within the bus maintenance area. The system consists of a control panel, compressor tank, pressure check and release valves. The system appeared to be in good and working condition.</p> <p>Facility fuel storage tanks were found in the oil room and consist of 8 tanks with a total capacity of 90,000L. The tanks appeared to be in good condition with normal wear.</p>		
<b>Component Rating:</b> Good (2)		<b>Installation Date:</b> 2008
<b>Typical Life Span:</b> 25	<b>Remaining Life:</b> 16	<b>Current Effective Age:</b> 9
<p><b>Recommendations</b></p> <p>The life spans for this component vary due to the various mechanical components, repairs and/or replacements are anticipated during the study period. A general allowance is carried for replacement of the other mechanical components. The components can be replaced on an as-needed basis.</p>

Commercial size HRV		Compressor system

Compressor system		Fuel storage tanks

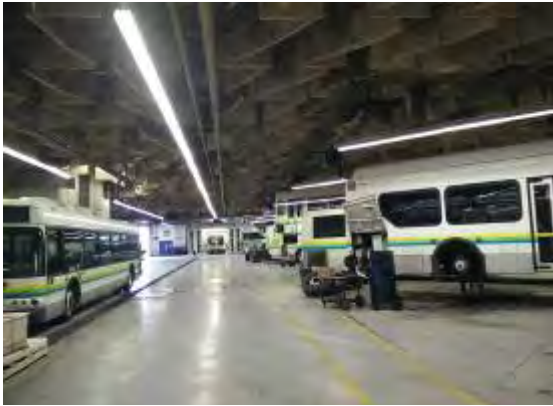
<p><b>Description</b>          The building's substructure could not be assessed throughout the facility due to interior flooring finishes. No visible foundation walls were observed on the exterior of the building. The building's footings are not visible as they are concealed below grade level. While the condition of the footings and foundation walls could not be confirmed, it is assumed that the substructure is functioning as intended.</p>		
<p><b>Component Rating:</b> Good (2)</p>		<p><b>Installation Date:</b> 1979</p>
<p><b>Typical Life Span:</b> 75</p>	<p><b>Remaining Life:</b> 37</p>	<p><b>Current Effective Age:</b> 38</p>
<p><b>Recommendations</b>          This item is not anticipated for repairs or replacement during the study period. Minor repairs (if any) are considered under on-going routine maintenance.</p>		
<p><b>Project Breakdown</b></p>	<p><b>QTY:</b> N/A</p>	<p><b>Capital Cost:</b> N/A</p>

<p>Covered concrete slab on grade</p>

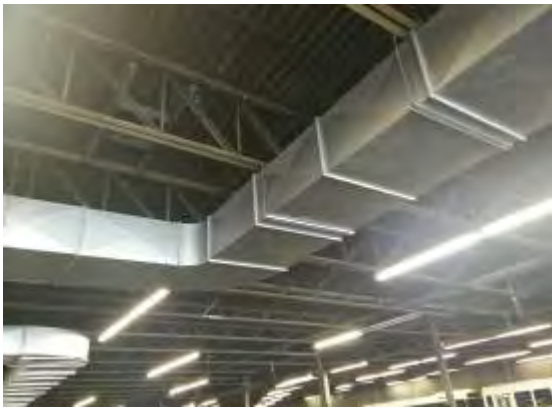
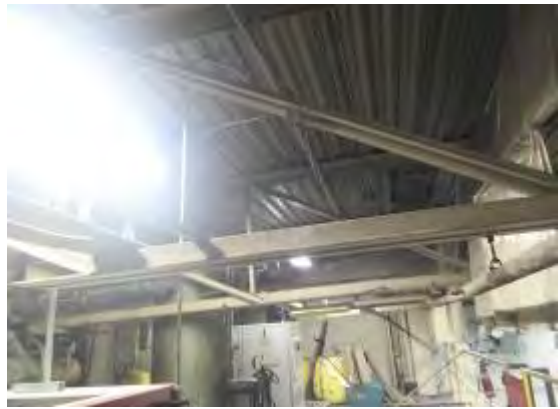
<p><b>Description</b></p> <p>The building's superstructure where visible consists of a concrete block wall system around the exterior and a structural steel column system within the interior of the building. The concrete block superstructure wherever observed was found to be in good condition. No major step cracking or deficiencies were observed.</p> <p>Large steel columns mounted on painted concrete bases were observed in the bus storage area. These steel columns are in good condition with no major signs of deficiencies. No deficiencies were noted in the metal deck system, so the superstructure is believed to be in stable condition.</p> <p>Other superstructure components found on site include concrete floor slabs that are seen within the bus maintenance and storage areas. The concrete floor slab within the storage area appears to be exposed with bus guidelines and the floor slab within the maintenance area was noted to be coated with waterproofing. The concrete elements were in good condition. Overall, no anomalies were observed or reported that would suggest the structural components are not functioning as intended.</p> <p>The roof superstructure where visible consisted of an open web steel joist (OWSJ) complete with a metal decking system. No issues were reported with the roof. No significant signs of deterioration were present. No issues were reported by the site representative.</p>

Open web steel joist and metal decking system		Close up of OWSJ in mechanical mezzanine

<b>Component Rating:</b> Good (2)		<b>Installation Date:</b> 1979
<b>Typical Life Span:</b> 75	<b>Remaining Life:</b> 37	<b>Current Effective Age:</b> 38
<p><b>Recommendations</b></p> <p>This item is not anticipated for repairs or replacement during the study period. Minor repairs (if any) are considered under on-going routine maintenance.</p>		
<b>Project Breakdown</b>	<b>QTY:</b> N/A	<b>Capital Cost:</b> N/A

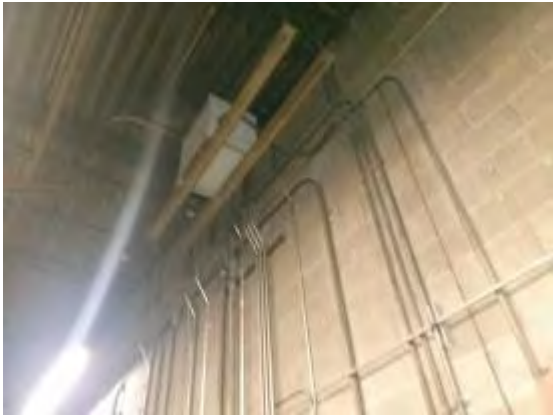
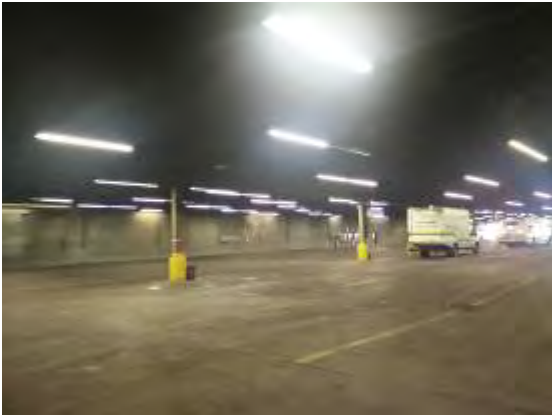
<p>Structural concrete block wall</p>	<p>Highlighted steel columns in garage bay</p>

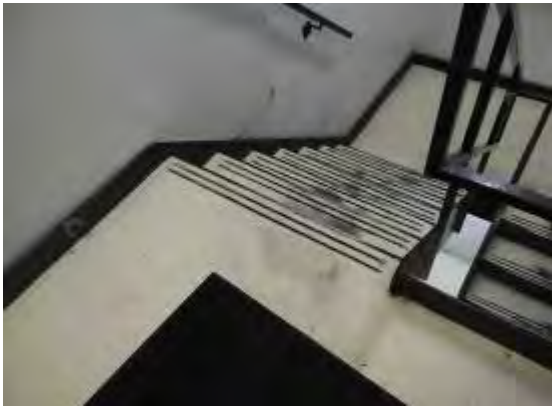
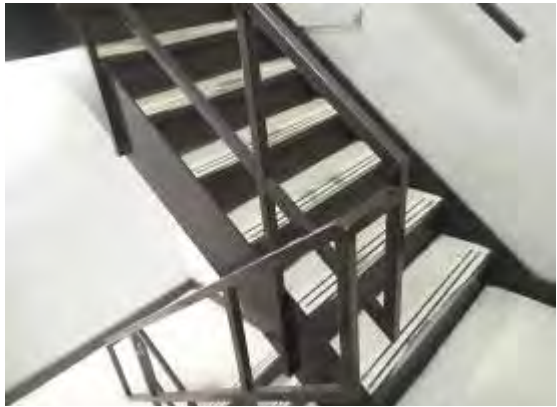
<p><b>Description</b></p> <p>There are two staircases provided for the facility. The staircase structures are constructed of a prefinished metal stringer system. The main staircase was finished with ceramic tile treads. The secondary staircase was finished with vinyl tile treads and abrasive stripping to provide additional traction. The handrail system was constructed of prefinished metal handrails installed on both sides of the staircase. Both staircases provided access from the first floor to roof level. There were no visible signs of deficiencies noted during the site visit. Overall, no anomalies exist that would suggest the staircase structure is not functioning as intended.</p>		
<p><b>Component Rating:</b> Good (2)</p>		<p><b>Installation Date:</b> 1979</p>
<p><b>Typical Life Span:</b> 75</p>	<p><b>Remaining Life:</b> 37</p>	<p><b>Current Effective Age:</b> 38</p>
<p><b>Recommendations</b></p> <p>This item is not anticipated for repairs or replacement during the study period. Minor repairs and replacement (if any) are considered under on-going routine maintenance.</p>

<p>Interior stairs</p>	<p>Interior stairs</p>

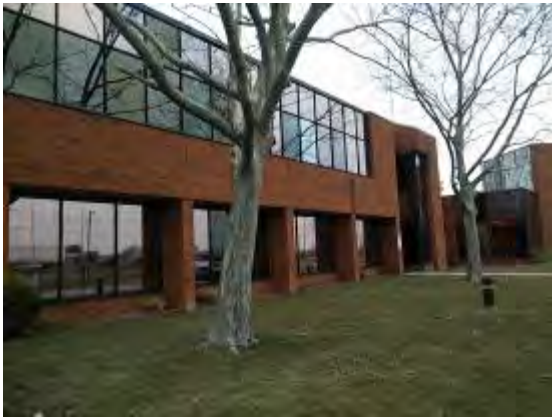
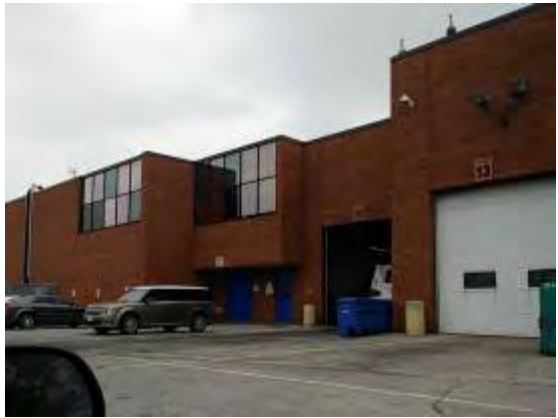
<p><b>Description</b></p> <p>The exterior cladding system predominately consists of a masonry brick veneer. Control joints were installed at appropriate intervals to allow building envelope movement. The brick veneer overall was in good condition. Minor mortar deterioration was noted at the lower brick courses at the east employee entrance.</p> <p>Masonry ties within the wall assembly are not visible for review. However, intrusive testing would be required to conform if there are latent defects that were not visible during our site review.</p>		
<p><b>Component Rating:</b> Good (2)</p>		<p><b>Installation Date:</b> 1979</p>
<p><b>Typical Life Span:</b> 35</p>	<p><b>Remaining Life:</b> 5</p>	<p><b>Current Effective Age:</b> 30</p>
<p><b>Recommendations</b></p> <p>This item has been deferred, where possible, to extend its normal life span. Brick repointing can be done on an as-needed basis. An allowance is carried.</p>

<p>Brick veneer at front of building with control joints</p>	<p>Brick veneer on side of building</p>

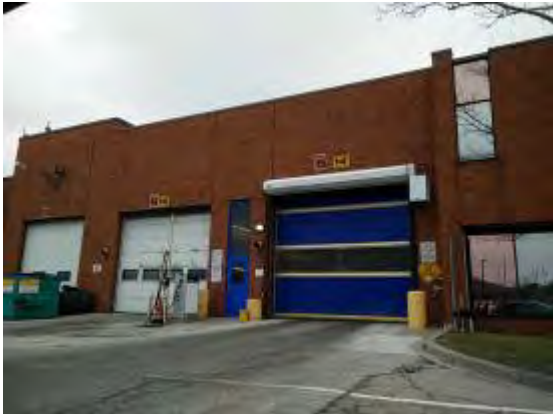
<p><b>Description</b></p> <p>The majority of the exterior doors consist of large overhead garage doors to accommodate the transit buses. A public entrance was found on the southwest side of the building and typically consists of an aluminum framed insulated storefront style unit with a dual leaf vestibule configuration. The employee entrance located on the southeast side of the building was of similar construction and appeared to be in good condition. Other exterior doors include hollow metal doors in a metal frame which provide access to various mechanical rooms and means of egress.</p> <p>Overall, the exterior doors are generally original to the building and were in fair condition where reviewed. All sensors and door opening mechanisms appear to be functional wherever tested and normal signs of wear and tear were observed on the public entrance doors. No anomalies existed that would suggest immediate replacement. No significant signs of deterioration or damage were present. No issues were reported by the site representative.</p>

Large overhead garage doors for buses on west perimeter

<p><b>Component Rating:</b> Fair (3)</p>		<p><b>Installation Date:</b> 1979</p>
<p><b>Typical Life Span:</b> 35</p>	<p><b>Remaining Life:</b> 3</p>	<p><b>Current Effective Age:</b> 32</p>
<p><b>Recommendations</b></p> <p>This item has been deferred, where possible, to extend its normal life span. Based on a normal life span for this component, repairs and/or replacements are anticipated during the study period. Appropriate costs are carried.</p>		
<p><b>Project Breakdown</b></p>	<p><b>QTY:</b> 25</p>	<p><b>Capital Cost:</b> \$90,000</p>

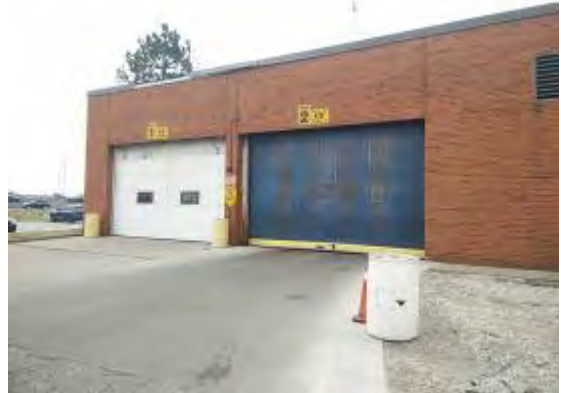
Large overhead garage doors on east perimeter

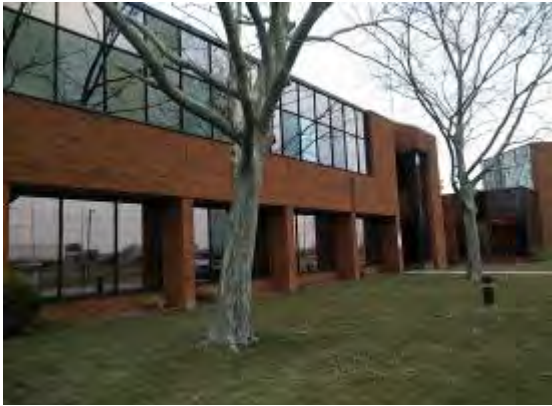
<p><b>Description</b></p> <p>The exterior windows consist of mixture of a window wall system predominately installed on the south and west perimeters of the building. The windows are aluminum framed with insulated glazing units. The majority of the windows are fixed and non-operational. Overall, the windows appeared to be in good condition.</p> <p>No wide-spread window pane failure was observed for the sampling of windows that were observed on site. No significant signs of deterioration were present. No issues were reported by the site representative.</p>		
<p><b>Component Rating:</b> Good (2)</p>		<p><b>Installation Date:</b> 1997</p>
<p><b>Typical Life Span:</b> 35</p>	<p><b>Remaining Life:</b> 5</p>	<p><b>Current Effective Age:</b> 30</p>
<p><b>Recommendations</b></p> <p>This item has been deferred, where possible, to extend its normal life span. The exterior windows are anticipated for replacement during the study period. An allowance is carried.</p>

<p>Overview of windows at front of building</p>		<p>West perimeter window wall system</p>

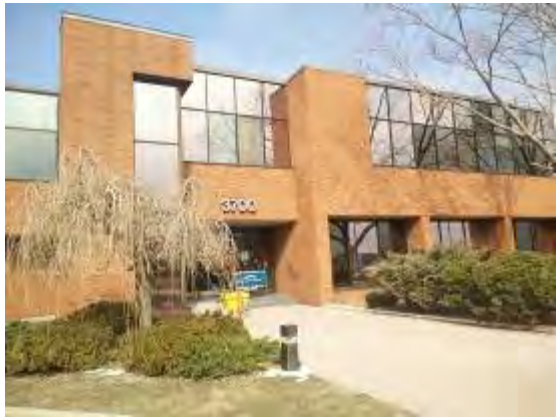
<p>Second floor window wall looking out to roof</p>		<p>Window wall system at front entrance</p>

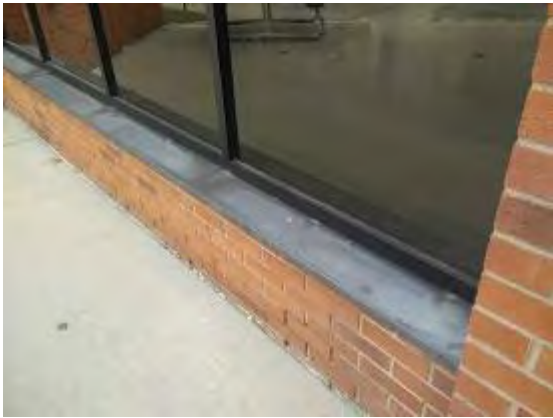
<p><b>Description</b></p> <p>The sealants at the building joints and around the perimeter of the windows, doors and louvers were observed to in fair condition with normal wear observed. All exterior sealants observed on the window wall system from grade level that were significantly higher than eye level were not evaluated. With no issues reported, it is assumed that the exterior sealants are functioning as intended. No significant signs of deterioration were present. No other issues were reported by the site representative.</p>		
<p><b>Component Rating:</b> Fair (3)</p>		<p><b>Installation Date:</b> 1994</p>
<p><b>Typical Life Span:</b> 15</p>	<p><b>Remaining Life:</b> 2</p>	<p><b>Current Effective Age:</b> 13</p>
<p><b>Recommendations</b></p> <p>This item has been deferred, where possible, to extend its normal life span. Based on a normal life span for this component, repairs and/or replacements are anticipated during the study period. Appropriate costs are carried.</p>

<p>Sealant window frame and flashing</p>

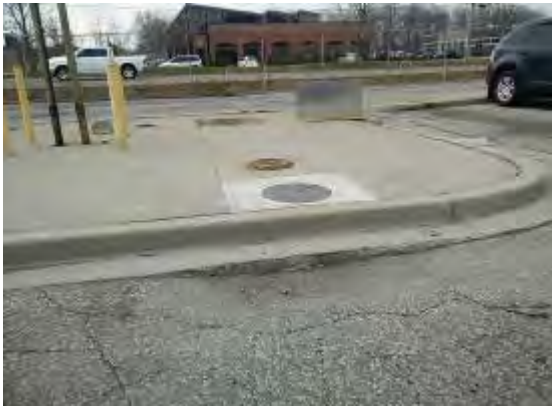
<b>Description</b>		
The sanitary piping exits the building below grade. The pipes are concealed below grade and not accessible for visual evaluation. No anomalous conditions were observed or reported that would suggest this systems is not functioning as intended.		
<b>Component Rating:</b> Good (2)	<b>Installation Date:</b> 1997	
<b>Typical Life Span:</b> 40	<b>Remaining Life:</b> 5	<b>Current Effective Age:</b> 35
<b>Recommendations</b>		
This item has been deferred, where possible, to extend its normal life span. We recommend that the drains be flushed and scoped routinely. This maximizes the service life of the piping and also helps identify repair needs. A budget for repairs has been included in year 5.		
<b>Project Breakdown</b>	<b>QTY:</b> Allowance	<b>Capital Cost:</b> \$30,000

Sanitary sewer

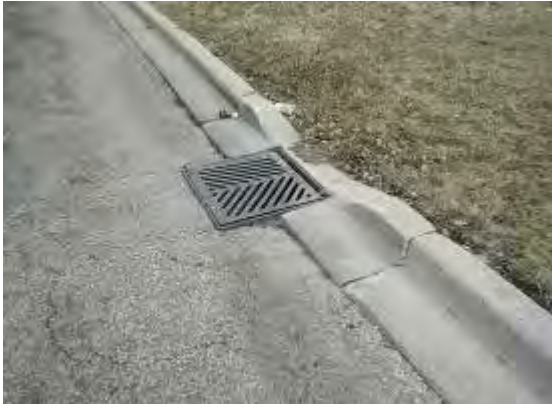
<p><b>Description</b>          The storm sewer connects to the main municipal connection below grade. The condition of the buried and concealed piping cannot be evaluated visually. Catch basins were observed within the employee and public parking areas of the property. No significant signs of deterioration were observed. No anomalous conditions were observed or reported that would suggest this systems is not functioning as intended.</p>		
<p><b>Component Rating:</b> Good (2)</p>		<p><b>Installation Date:</b> 1979</p>
<p><b>Typical Life Span:</b> 40</p>	<p><b>Remaining Life:</b> 5</p>	<p><b>Current Effective Age:</b> 35</p>
<p><b>Recommendations</b>          This item has been deferred, where possible, to extend its normal life span. We recommend that the drains be flushed and scoped routinely. This maximizes the service life of the piping and also helps identify repair needs. A budget for repairs has been included in year 5.</p>

<p>Sanitary sewer</p>

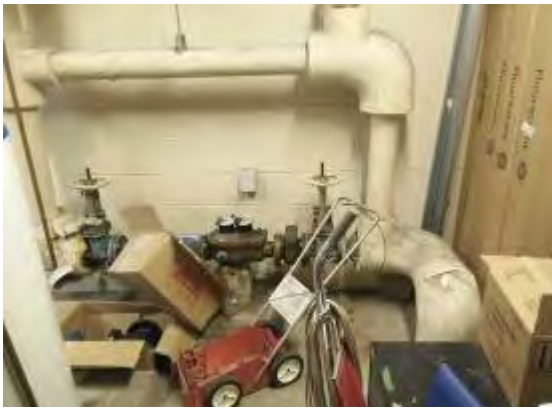
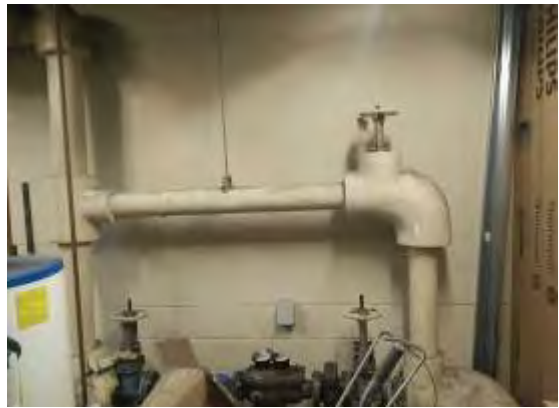
<p><b>Description</b>          The incoming domestic water main service enters the building below grade in storage room located in the southwest corner of the building. The water main then feeds to the main shut-off and meter assembly and then is distributed throughout the building. The domestic water service has a backflow preventer (BFP) assembly installed. No signs of deterioration were observed on the water piping or main shut off.</p>		
<p><b>Component Rating:</b> Good (2)</p>		<p><b>Installation Date:</b> 1979</p>
<p><b>Typical Life Span:</b> 40</p>	<p><b>Remaining Life:</b> 5</p>	<p><b>Current Effective Age:</b> 35</p>
<p><b>Recommendations</b>          Based on a normal life span for this component, repairs and/or replacements are anticipated during the study period. Appropriate costs are carried.</p>		
<p><b>Project Breakdown</b></p>	<p><b>QTY:</b> Allowance</p>	<p><b>Capital Cost:</b> \$8,000</p>

<p>Incoming domestic water shut off</p>		<p>Immediate water distribution</p>

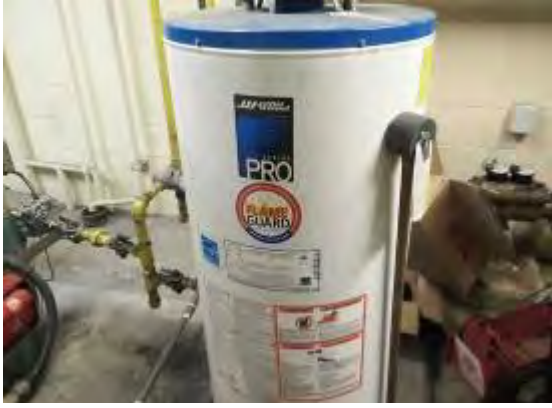
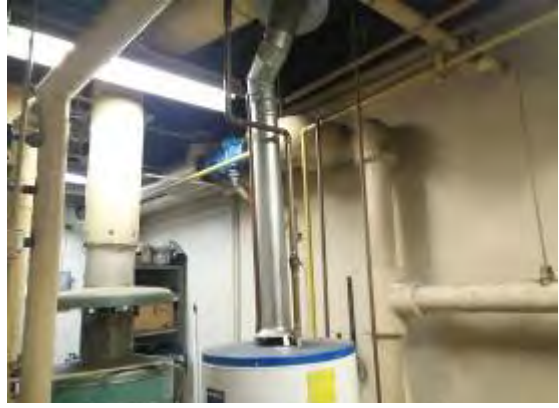
<p><b>Description</b>          The domestic hot water (DHW) is supplied by a gas-fired “John Wood” hot water tank located in the utility room. The tank has a capacity of 151L. All immediate piping, valves and fittings appear to be in good condition. The immediate piping was noted to not be insulated. No anomalous conditions were observed or reported that would suggest this system is not functioning as intended.</p>		
<p><b>Component Rating:</b> Good (2)</p>		<p><b>Installation Date:</b> 2010</p>
<p><b>Typical Life Span:</b> 15</p>	<p><b>Remaining Life:</b> 8</p>	<p><b>Current Effective Age:</b> 7</p>
<p><b>Recommendations</b>          It is recommended to insulate all immediate hot water distribution lines from the hot water tank in the immediate year to increase efficiency. Based on a normal life span for this component, repairs and/or replacements are anticipated during the study period. This is considered under on-going routine maintenance.</p>

<p>Domestic water heater</p>		<p>Exhaust vent from HWT</p>

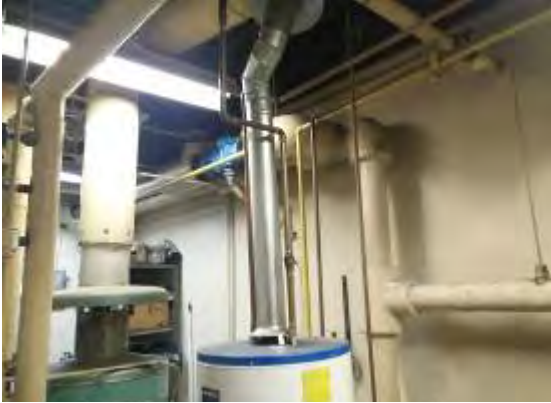
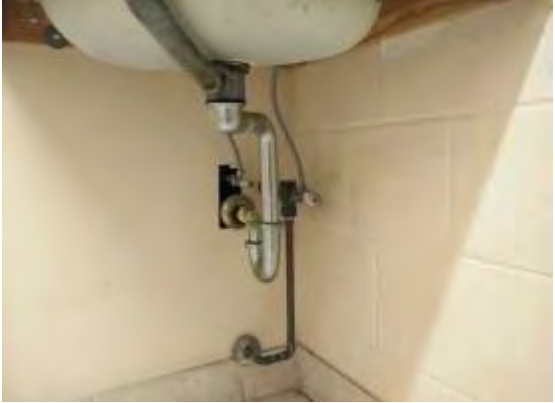
<b>Description</b>		
The plumbing piping system consists of copper piping to distribute hot and cold water throughout the building's plumbing fixtures. The majority of the lines were hidden behind interior finishes or insulated throughout and were not readily available for review. All plumbing piping where visible typically within the washrooms, valves and fittings appear to be in good condition. No anomalous conditions were observed or reported that would suggest this system is not functioning as intended.		
<b>Component Rating:</b> Good (2)		<b>Installation Date:</b> 1979
<b>Typical Life Span:</b> 35	<b>Remaining Life:</b> 5	<b>Current Effective Age:</b> 30
<b>Recommendations</b>		
This item has been deferred, where possible, to extend its normal life span. Based on a normal life span for this component, repairs and/or replacements are anticipated during the study period. A general allowance has been carried for isolated repairs and/or replacements over the study period.

Immediate distribution lines	Flexible piping under sink

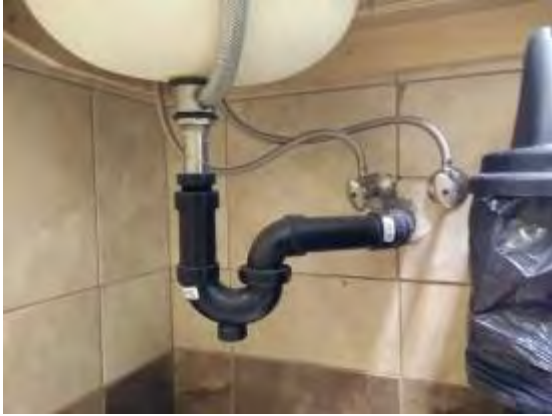
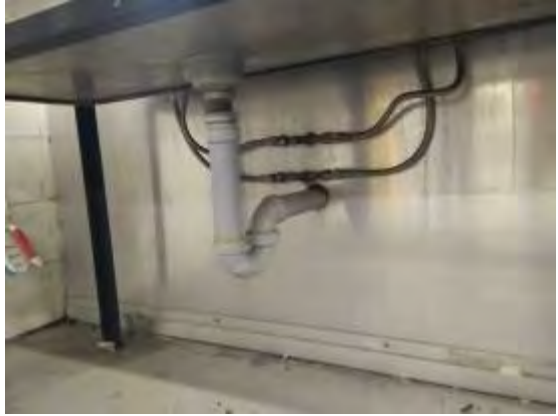
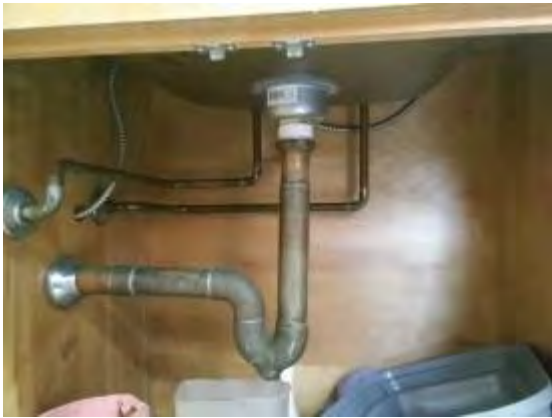
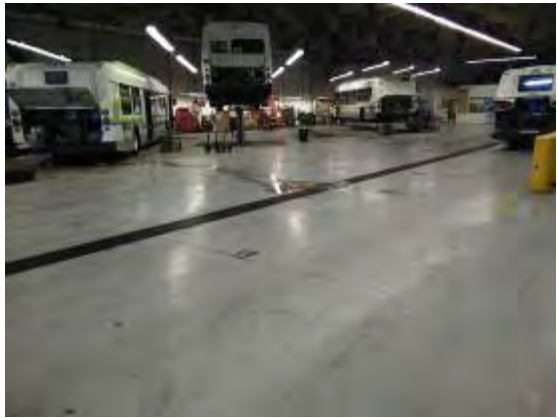
<p><b>Description</b>          The building's sanitary waste management system consists of ABS plastic and copper piping where visible underneath washroom sinks. The majority of the sanitary lines not visible as they are hidden below grade.          Specialty sanitary drains were located within the bus maintenance area. The waste collection from these drains is collected in a buried oil interceptor and is then merged with the sanitary drain system leaving the building.          No significant signs of deterioration were present. No issues were reported by the site representative therefore it is assumed that the system is draining appropriately.</p>		
<p><b>Component Rating:</b> Good (2)</p>		<p><b>Installation Date:</b> 1979</p>
<p><b>Typical Life Span:</b> 35</p>	<p><b>Remaining Life:</b> 5</p>	<p><b>Current Effective Age:</b> 30</p>
<p><b>Recommendations</b>          This item has been deferred, where possible, to extend its normal life span. Based on a normal life span for this component, repairs and/or replacements are anticipated during the study period. A general allowance has been carried for isolated repairs and/or replacements over the study period.</p>

<p>Sanitary lines</p>	<p>Sanitary lines</p>

<p>Sanitary lines</p>	<p>Specialty drainage system in bus maintenance area</p>

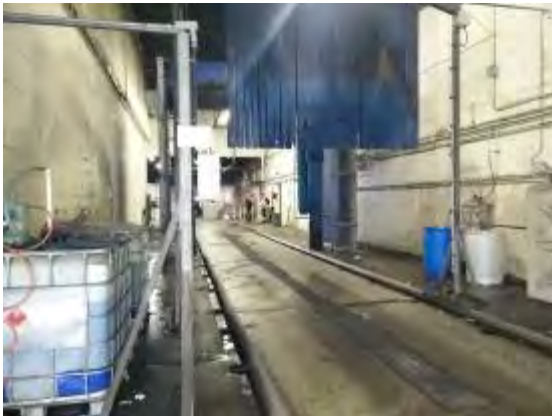
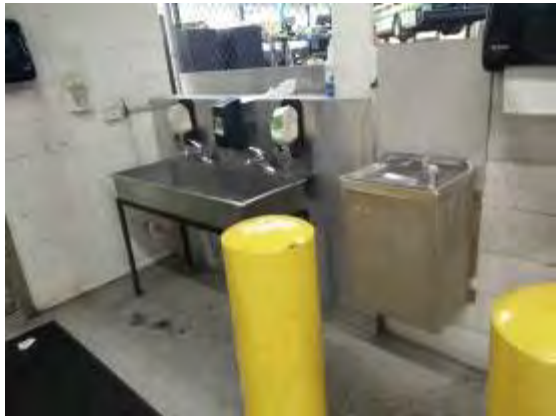
<p><b>Description</b></p> <p>The domestic water system is distributed to a variety of fixtures which typically include countertop mounted sinks, toilets, urinals water fountains and a bus wash bay. All lavatories were noted to be manual faucets.</p> <p>All plumbing fixtures were in good condition and working condition with minimal signs of wear and tear. Plumbing fixtures were noted to be replaced on an as-needed basis. No significant signs of deterioration were present. No issues were reported by the site representative.</p>		
<p><b>Component Rating:</b> Good (2)</p>		<p><b>Installation Date:</b> 1979, 2009</p>
<p><b>Typical Life Span:</b> 35</p>	<p><b>Remaining Life:</b> 5, 27</p>	<p><b>Current Effective Age:</b> 35, 8</p>
<p><b>Recommendations</b></p> <p>Original plumbing fixtures have been deferred, where possible, to extend its normal life span. Appropriate costs have been carried. Costs have been carried in section 5.11.7 – <i>Common Area Washrooms</i> and 5.11.10 – <i>Private Washrooms</i>. New plumbing fixtures are not anticipated for repairs or replacement during the study period. Minor repairs (if any) are considered under on-going routine maintenance.</p>

<p>Bus wash</p>	<p>Commercial sink and water fountain</p>

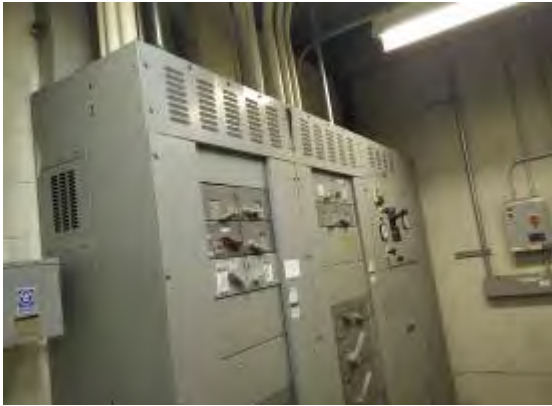
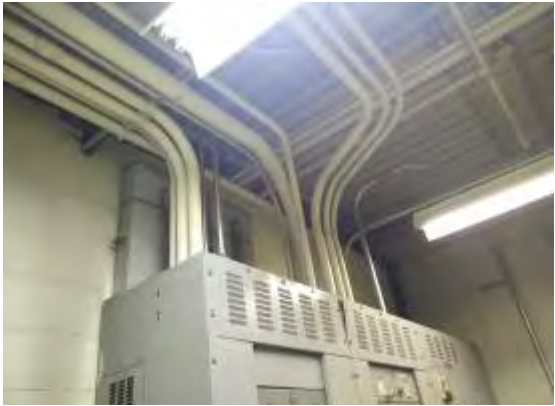
<b>Description</b> The main incoming electrical service enters the building from below grade and into a closed electrical room. The main mechanical room includes an 800A main switchgear that provides power to the building. The power is then distributed to other multiple electrical panels installed within the mechanical room and throughout the facility. No significant signs of deterioration were present. No issues were reported by the site representative.		
<b>Component Rating:</b> Fair (3)		<b>Installation Date:</b> 1979
<b>Typical Life Span:</b> 40	<b>Remaining Life:</b> 2	<b>Current Effective Age:</b> 38
<b>Recommendations</b> We recommend infrared thermograph scanning of all electrical equipment (i.e. main, distribution etc.) to find “hot spots”. In additional, general housekeeping of equipment (i.e. tagging and removal of miscellaneous items too close to equipment). This is considered under normal operations and maintenance as below the threshold limit. All electrical equipment should be checked regularly under operations and maintenance to ensure good working operation. Replacement and installation should be carried out in accordance with the manufacturer’s recommendations. This item is anticipated for repairs or replacement during the study period. An allowance is carried.

Main switchgear	Distribution lines

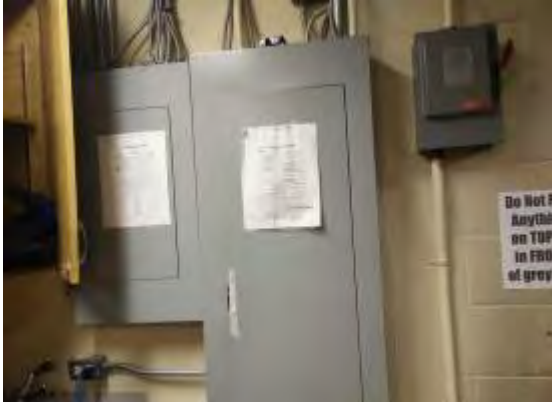
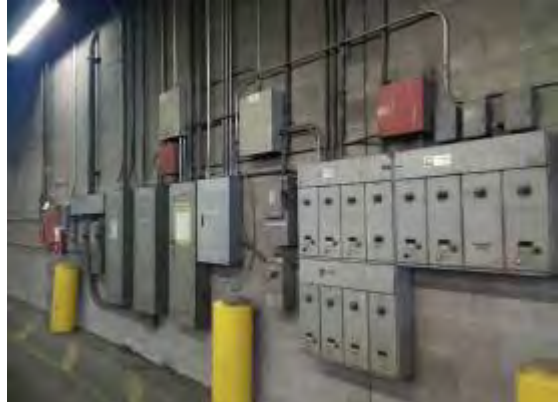
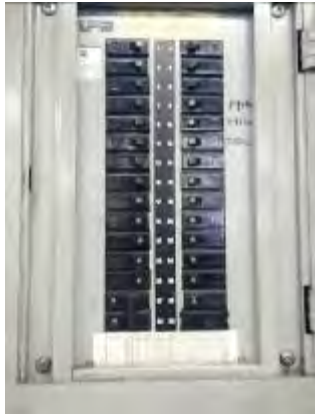
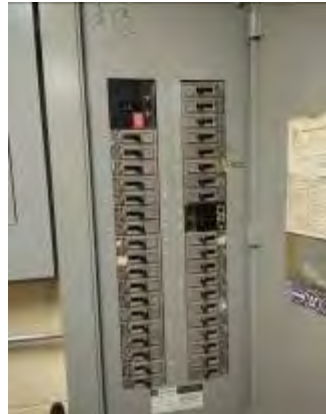
<p><b>Description</b>          There are several secondary panel boards located in the mechanical room, administrative areas and bus storage &amp; maintenance areas that were rated between 100A and 225A. Overall, the majority of panels appeared to be original to the building and in good and working condition. No significant signs of deterioration were present. No issues were reported by the site representative.</p>		
<p><b>Component Rating:</b> Fair (3)</p>		<p><b>Installation Date:</b> 1979</p>
<p><b>Typical Life Span:</b> 40</p>	<p><b>Remaining Life:</b> 2</p>	<p><b>Current Effective Age:</b> 38</p>
<p><b>Recommendations</b>          Based on a normal life span for this component, repairs and/or replacements are anticipated during the study period. Appropriate costs are carried. Newer panel boards are not anticipated for replacement during the study period.</p>		
<p><b>Project Breakdown</b></p>	<p><b>QTY:</b> 131,696sf</p>	<p><b>Capital Cost:</b> \$121,000</p>

<p>Intermediate panels</p>	<p>Various intermediate panels and breakers</p>

<p>Intermediate panel</p>	<p>Intermediate panel</p>

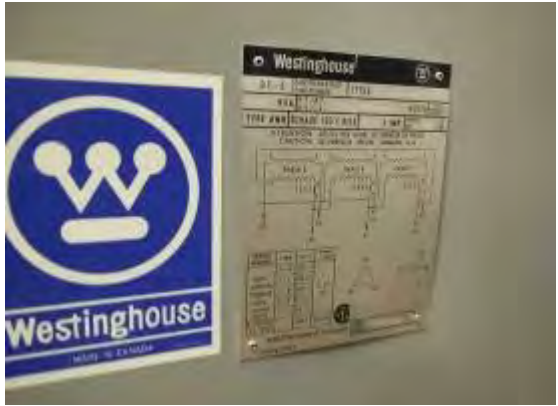
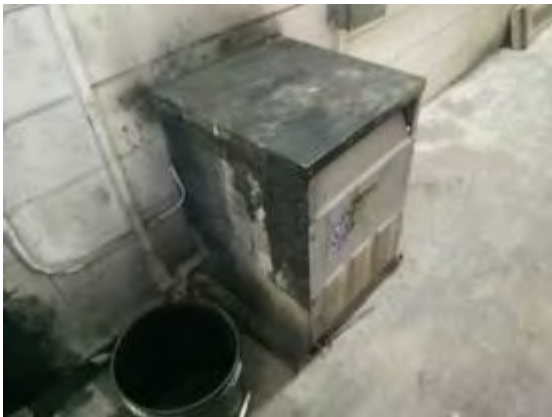
<p><b>Description</b></p> <p>There are two (2) “Rex Manufacturing” dry-type transformers found in room 115 of the building. The transformers are rated 45kVA. Several other transformers were found within the building which includes a 10kVA “Westinghouse” transformer adjacent to the bus repair booth and 75kVA “Westinghouse” transformer found within the main electrical room. A transformer was found on the west perimeter of the building which was enclosed in a chain link fence. Overall, the transformers appeared to be in good and working condition. No significant signs of deterioration were present. No issues were reported by the site representative.</p>		
<p><b>Component Rating:</b> Good (2)</p>		<p><b>Installation Date:</b> 1979, 2007</p>
<p><b>Typical Life Span:</b> 30</p>	<p><b>Remaining Life:</b> 2, 20</p>	<p><b>Current Effective Age:</b> 28, 10</p>
<p><b>Recommendations</b></p> <p>Original transformers have been deferred, where possible, to extend its normal life span. Based on a normal life span for this component, repairs and/or replacements are anticipated during the study period. Appropriate costs are carried. Transformers that have been replaced in 2007 are anticipated for replacement in year 20. The exterior transformer is owned by the city and is not included in capital costs.</p>

<p>Westinghouse transformer</p>		<p>Information label</p>

<p>Westinghouse transformer</p>		<p>Exterior transformer</p>
