# Transit Windsor Garage Feasibility Study

Future Facility Strategy

Prepared for the City of Windsor  
by IBI Group

October 28, 2021

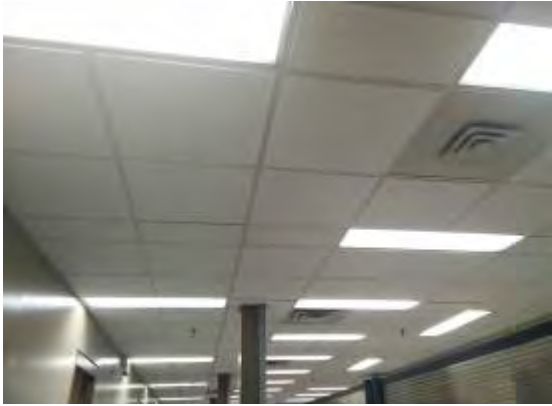
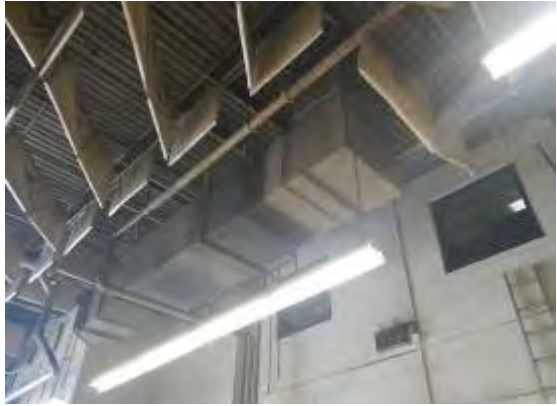
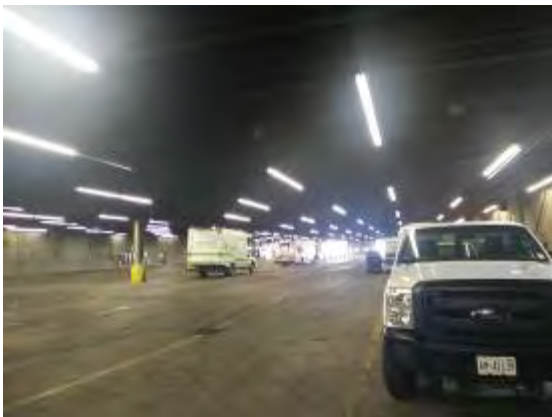
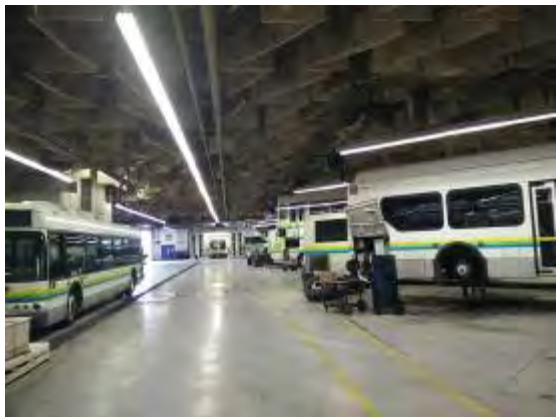
<p><b>Description</b>          Interior lighting within the facility was comprised of mostly suspended fluorescent light fixtures. The fixtures were generally in good and working condition wherever reviewed with normal wear observed. We did not find any major issues with the lighting system during the site visit that would warrant immediate replacement. Although light level measurements were not taken, lighting levels are adequate.</p>		
<p><b>Component Rating:</b> Good (2)</p>		<p><b>Installation Date:</b> 1979</p>
<p><b>Typical Life Span:</b> 25</p>	<p><b>Remaining Life:</b> 5</p>	<p><b>Current Effective Age:</b> 20</p>
<p><b>Recommendations</b>          The interior lighting has been deferred, where possible, to extend its normal life span. A major interior lighting retrofit is recommended in year 5 of this report. An allowance is carried. Expended light bulbs can be replaced on an as-needed basis. All existing incandescent and T12 fluorescent lights should be upgraded to more energy-efficiency bulbs such as compact fluorescents and T8s. Energy efficiencies items are considered upgrades and not included.</p>

<p>Fluorescent lighting in administrative area</p>		<p>Fluorescent lighting in bus maintenance area</p>

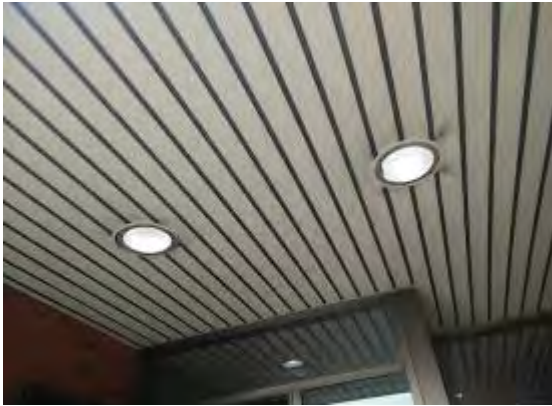
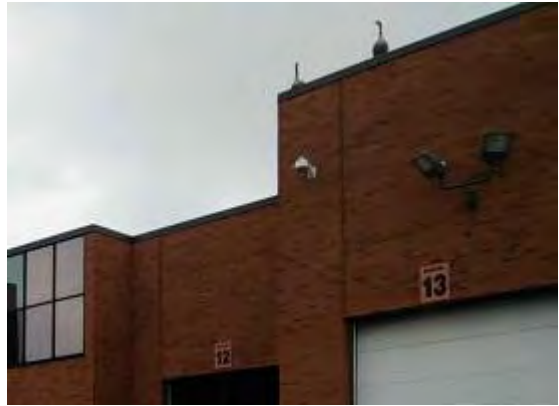
<p><b>Description</b>          The exterior lighting system consists of recessed pot lights found on the underside of the soffit at the public and employee entrances. Other lights include single and dual head high-pressure sodium (HPS) wall mounted light fixtures typically found above garage doors or private entrances. The majority of lights were not on during the site visit and only recessed lights were observed to be on. Overall, the fixtures were in good condition with normal wear and tear observed. No significant signs of deterioration were present. No issues were reported by the site representative.</p>		
<p><b>Component Rating:</b> Fair (3)</p>		<p><b>Installation Date:</b> 1979</p>
<p><b>Typical Life Span:</b> 25</p>	<p><b>Remaining Life:</b> 3</p>	<p><b>Current Effective Age:</b> 22</p>
<p><b>Recommendations</b>          This item has been deferred, where possible, to extend its normal life span. A major exterior lighting retrofit is recommended in year 3 of this report. An allowance is carried. Expended light bulbs can be replaced on an as-needed basis. Energy efficiencies items are considered upgrades and not included.</p>

<p>Recessed pot lights</p>	<p>Dual head exterior light fixture</p>

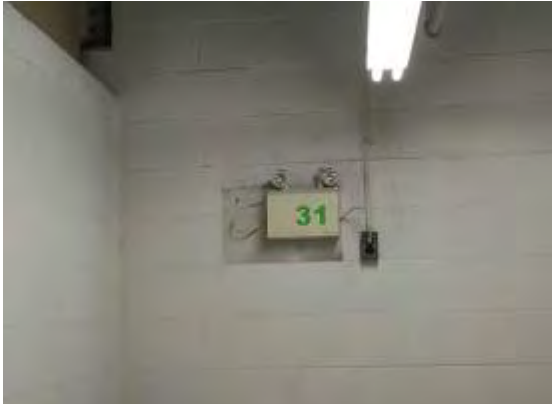
<p><b>Description</b>          Emergency lighting systems installed within the facility include emergency exit signs, dual head emergency lights and battery packs or a combination of. The exit signs are typically installed above egress doors and are illuminated with incandescent fixtures. Battery packs were observed to have numbers indicated on them. Various types of emergency exit signs were found throughout the facility indicating that the several signs have been replaced on an as-needed basis. The systems were in good and working order. No significant signs of deterioration were present. No issues were reported by the site representative.</p>		
<p><b>Component Rating:</b> Fair (3)</p>		<p><b>Installation Date:</b> 1979</p>
<p><b>Typical Life Span:</b> 20</p>	<p><b>Remaining Life:</b> 2</p>	<p><b>Current Effective Age:</b> 18</p>
<p><b>Recommendations</b>          It is recommended to replace non-operational emergency lighting systems immediately as it is a life safety system. This can be done at a cost below the threshold limit of this report.</p>

<p>Battery Pack</p>	<p>Emergency exit sign</p>

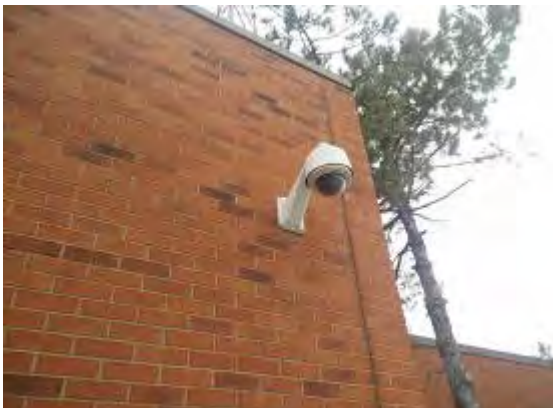
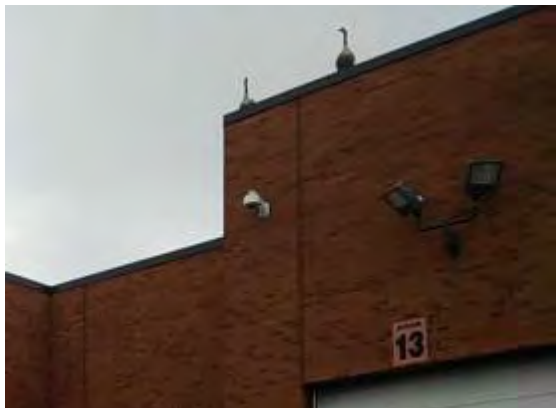
<b>Description</b> The building surveillance system is provided by strategically placed closed circuit system and consists of small dome cameras found throughout the interior and exterior of the facility. The information is then transferred to a video monitoring system. Overall, the cameras were in good and working condition. Monitoring and network equipment were reported to be in good condition. No significant signs of deterioration were present. No issues were reported by the site representative.		
<b>Component Rating:</b> Good (2)		<b>Installation Date:</b> 2009
<b>Typical Life Span:</b> 15	<b>Remaining Life:</b> 7	<b>Current Effective Age:</b> 8
<b>Recommendations</b> Based on a normal life span for this component, repairs and/or replacements are anticipated during the study period. Appropriate costs are carried.		
<b>Project Breakdown</b>	<b>QTY:</b> Allowance	<b>Capital Cost:</b> \$40,000

Dome camera on exterior wall	Dome camera beside door 13

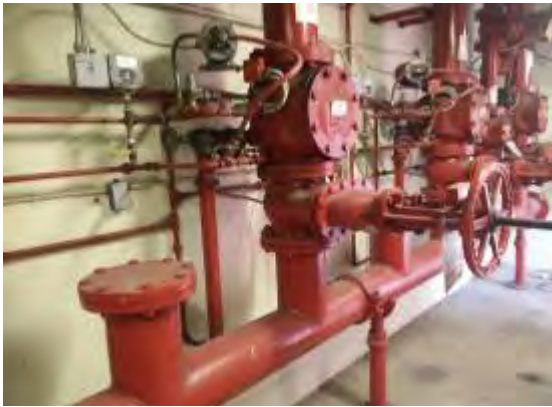
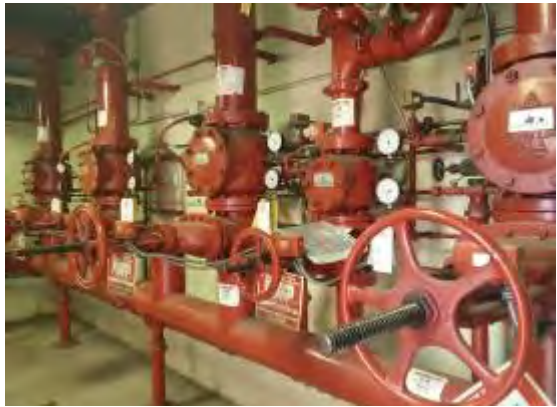
<b>Description</b>		
<p>A partial “Grinnell” sprinkler system is installed in the sprinkler room. The sprinkler system was observed to be installed within the administrative areas only. A standpipe system and connection was also found on the south perimeter of the building. All T-bar ceiling panel sprinkler heads are pendant-type and all exposed ceiling has upright sprinkler heads. Where randomly observed, tags around the sprinkler system were found to be recently signed-off for inspection. Overall, the sprinkler system appeared to be in good and working condition. No significant signs of deterioration were present. No issues were reported by the site representative.</p>		
<b>Component Rating:</b> Good (2)		<b>Installation Date:</b> 1979
<b>Typical Life Span:</b> 35	<b>Remaining Life:</b> 5	<b>Current Effective Age:</b> 30
<b>Recommendations</b>		
<p>All fire protection devices should be checked regularly under operations and maintenance to ensure good working operation. Replacement and installation should be carried out in accordance with manufacturer’s recommendations. Based on the typical life span of this component, repairs and/or replacements are anticipated within the study period. Appropriate costs are carried.</p>

Main sprinkler system	Main sprinkler system

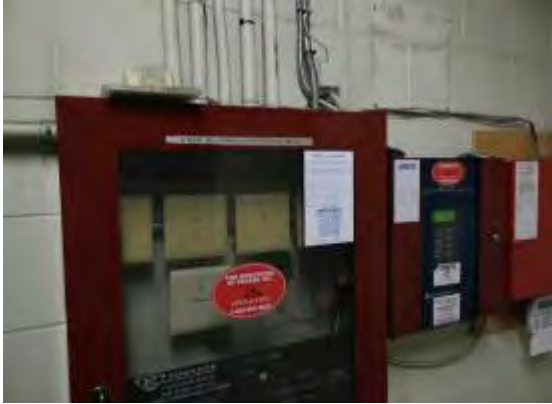
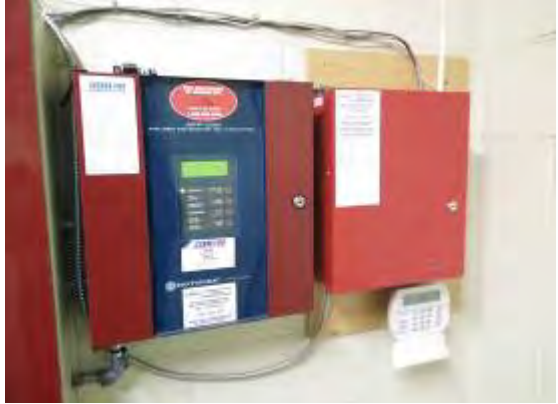
<p><b>Description</b>          A “Simplex” fire alarm system is installed in the mechanical room of the facility and consists of the main fire alarm control panel, junction boxes, pull stations and bells. An annunciator panel was found at the south entrance vestibule. The smoke and heat detectors are connected to the fire alarm system as well. The system is reported to be tested on a monthly basis and is monitored by “Access Fire” and “Fire Monitoring of Canada Inc.”. Overall, the fire alarm system appears to be in good and working condition.</p>		
<p><b>Component Rating:</b> Good (2)</p>		<p><b>Installation Date:</b> 2009</p>
<p><b>Typical Life Span:</b> 20</p>	<p><b>Remaining Life:</b> 12</p>	<p><b>Current Effective Age:</b> 8</p>
<p><b>Recommendations</b>          All fire protection devices should be checked regularly under operations and maintenance to ensure good working operation. Replacement and installation should be carried out in accordance with manufacturer’s recommendations. Based on the typical life span of this component, repairs and/or replacements are anticipated within the study period. Appropriate costs are carried.</p>

<p>Fire alarm junction box</p>		<p>Fire alarm control panel</p>

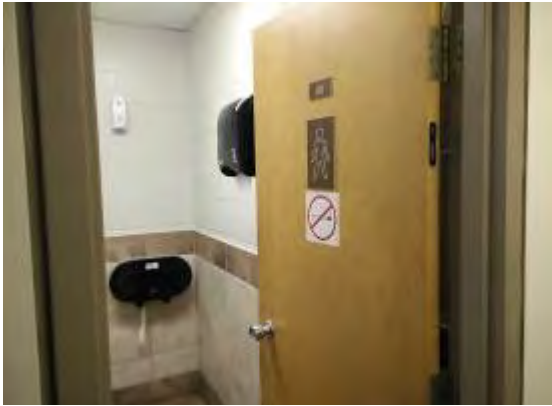
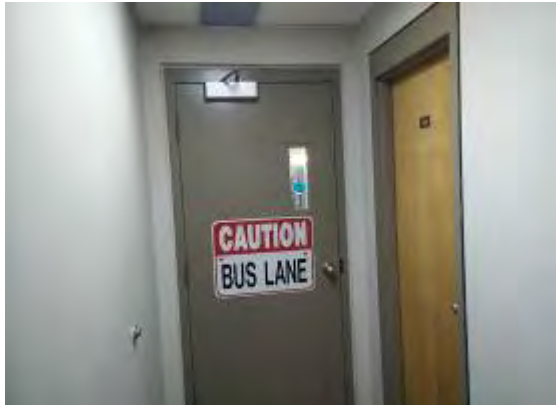
<p><b>Description</b></p> <p>The interior doors consist of hollow wood doors in metal frames found throughout the first floor and hollow metal doors with small glass inserts in metal frames separating the common area to the bus maintenance area. Door features include door signs on office doors and automatic door closers at fire separations.</p> <p>Hollow metal doors in metal frames were observed on the second floor maintenance area and generally appeared to be in good condition.</p> <p>Overall, the interior doors appeared to be in good condition and working condition. No significant signs of deterioration were present. No issues were reported by the site representative.</p>		
<b>Component Rating:</b> Good (2)		<b>Installation Date:</b> 1979
<b>Typical Life Span:</b> 40	<b>Remaining Life:</b> 5	<b>Current Effective Age:</b> 35
<p><b>Recommendations</b></p> <p>This item has been deferred, where possible, to extend its normal life span. This item is anticipated for repairs or replacement during the study period. An allowance is carried.</p>

Men's washroom interior door		Various interior doors

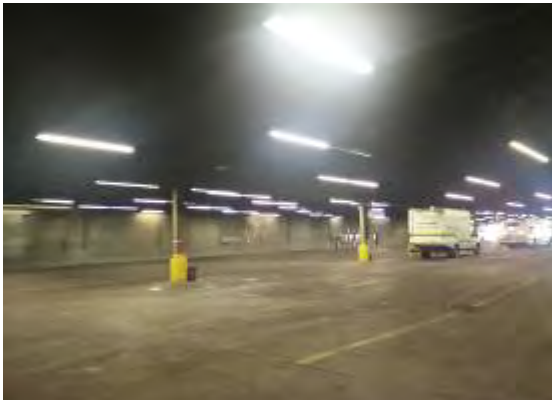
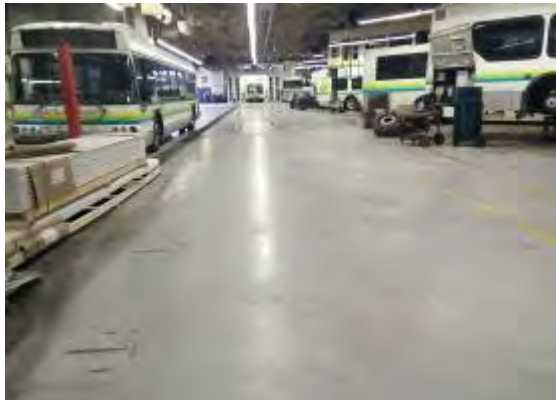
<p><b>Description</b></p> <p>Private spaces make up the majority of the building area and consist of the bus storage &amp; maintenance areas, mechanical rooms, utility &amp; administrative area on the second floor. Typical finishes include ceramic tile floor finishes within the private corridors, carpet in offices, painted gypsum walls and acoustic ceiling panels throughout the administrative area.</p> <p>Finishes within the bus storage &amp; maintenance areas were generally minimal, consisting of polished concrete floor slabs (bus maintenance area only), painted concrete block walls and ceiling suspended soundproof acoustic panels.</p> <p>Overall, the finishes appeared to be in good condition with normal wear observed. No significant signs of deterioration were present. No issues were reported by the site representative.</p>		
<b>Component Rating:</b> Good (2)		<b>Installation Date:</b> 1979

Bus storage area		Waterproofed concrete slab on grade

<b>Typical Life Span:</b> 20	<b>Remaining Life:</b> 5	<b>Current Effective Age:</b> 15
<p><b>Recommendations</b></p> <p>Based on a normal life span for the finishes, repairs and/or replacements are anticipated during the study period. A cost breakdown of the capital expenditures is included below. Waterproof coatings and polishing within the bus maintenance &amp; storage areas are included in the pricing.</p> <p>Concrete polishing in bus maintenance area - \$100,000 (Year 7)</p> <p>Floor finishes in administrative area - \$82,000 (Year 3)</p> <p>A budget of \$75,000 has been allocated for general maintenance of wall and ceiling finishes within the private area. This can be done on an as-needed basis.</p>		
<b>Project Breakdown</b>	<b>QTY:</b> Allowance	<b>Capital Cost:</b> \$257,000

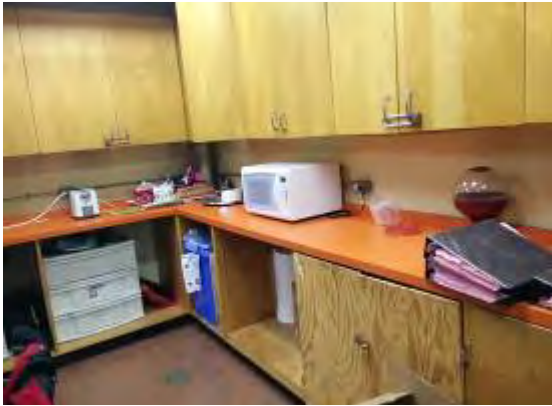
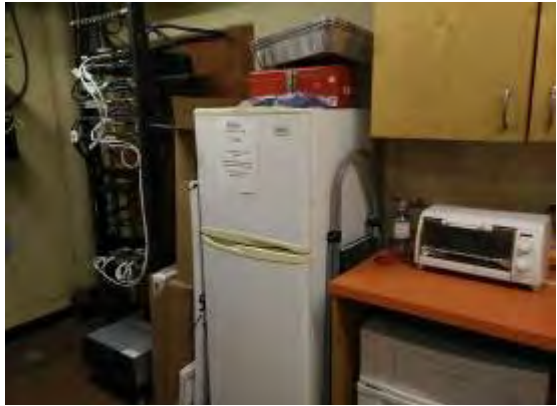
<p><b>Description</b>          Two kitchenettes are provided for the facility. One is located on the first floor shared with the IT room. The second kitchenette is found on the second floor administrative area. The kitchens consist of a stainless steel sink, vinyl laminated countertops and upper &amp; lower cabinetry. Other small appliances include a microwave, toaster oven and coffee machines. Kitchen finishes include sheet vinyl (first floor) and ceramic tile (second floor) flooring and 2'x2' acoustic ceiling tile. Overall, kitchen finishes appeared to be in fair condition and somewhat dated however, cabinetry doors were in fully functional state. Kitchen appliances appear to be in working condition.</p>		
<p><b>Component Rating:</b> Fair (3)</p>		<p><b>Installation Date:</b> 1979</p>
<p><b>Typical Life Span:</b> 35</p>	<p><b>Remaining Life:</b> 3</p>	<p><b>Current Effective Age:</b> 32</p>

<p>Kitchenette on first floor</p>	<p>Kitchenette on first floor</p>

<p><b>Recommendations</b>          This item has been deferred, where possible, to extend its normal life span. This item is anticipated for repairs or replacement during the study period. An allowance is carried.</p>		
<p><b>Project Breakdown</b></p>	<p><b>QTY:</b> 2</p>	<p><b>Capital Cost:</b> \$20,000</p>

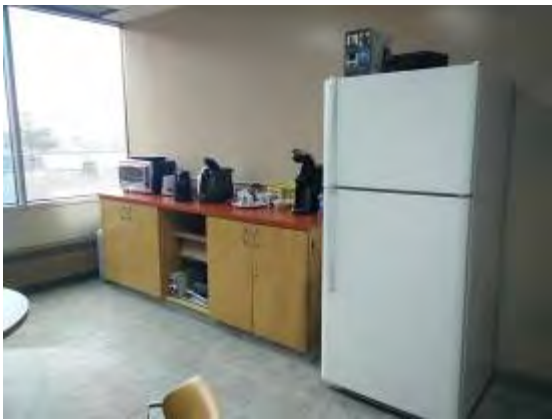
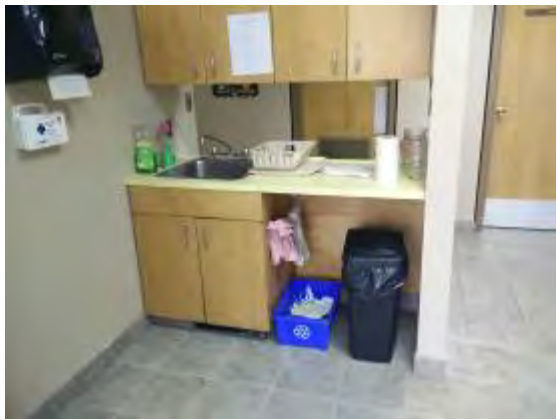
<p>Kitchenette on second floor</p>	<p>Kitchenette on second floor</p>

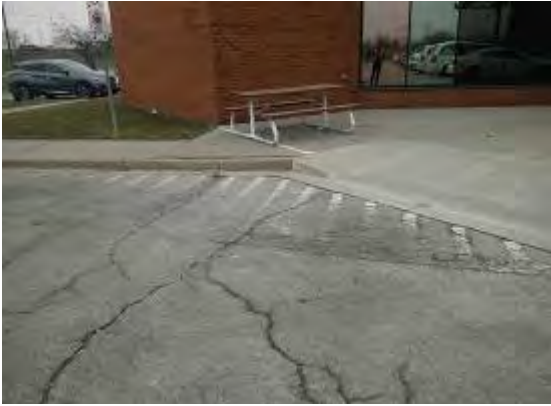
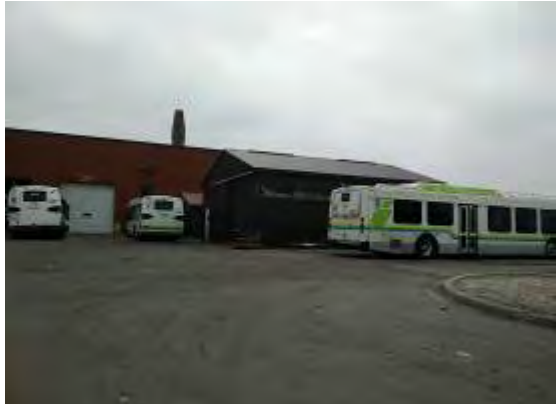
<p><b>Description</b>          The facility is situated on the north side of North Service Road. The site is generally flat and concrete paved throughout. No major deficiencies with the topography or ponding were found.</p>		
<p><b>Component Rating:</b> Good (2)</p>		<p><b>Installation Date:</b> 1979</p>
<p><b>Typical Life Span:</b> N/A</p>	<p><b>Remaining Life:</b> N/A</p>	<p><b>Current Effective Age:</b> 38</p>
<p><b>Recommendations</b>          The site is maintained under normal operations and maintenance. No allowances are carried.</p>		
<p><b>Project Breakdown</b></p>	<p><b>QTY:</b> N/A</p>	<p><b>Capital Cost:</b> N/A</p>

<p>Typical flat topography</p>	<p>Asphalt paved area</p>

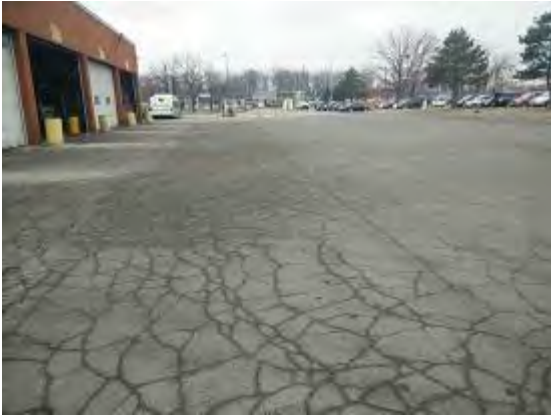
<p>Flat asphalt area</p>

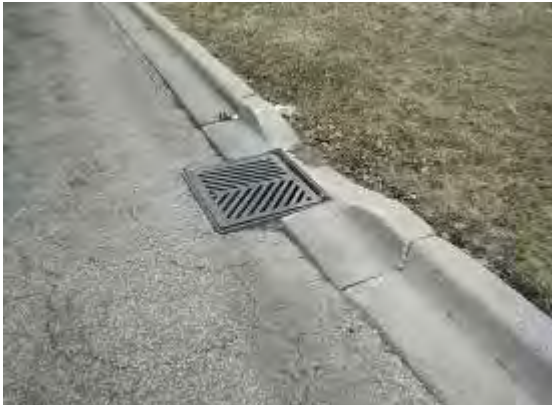
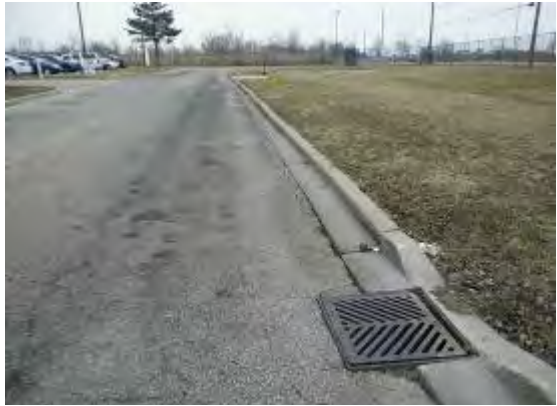
<p><b>Description</b>          The storm sewer system is located below grade from the municipal hookup to the building. The condition of the buried and concealed piping cannot be evaluated visually. Rain water collected on paved areas sloped towards catch basins installed within the employee &amp; public parking lots. Catch basins were also observed within the bus storage area. The catch basins are appeared to be in good condition. The adequacy of the drainage system could not be confirmed as there was no precipitation during the site visit however, with no reported issues it is assumed to be in good working order. No significant signs of deterioration were present.</p>		
<p><b>Component Rating:</b> Fair (3)</p>		<p><b>Installation Date:</b> 1979</p>
<p><b>Typical Life Span:</b> 40</p>	<p><b>Remaining Life:</b> 2</p>	<p><b>Current Effective Age:</b> 38</p>
<p><b>Recommendations</b>          We recommend that drains be flushed and scoped routinely. This maximizes the service life of the piping and also helps identify repair needs. We assume this will be done as part of ongoing maintenance. Minor repairs (if any) are considered under on-going routine maintenance.</p>

<p>Catch basin in visitor's parking lot</p>	<p>Catch basin in visitor's parking lot</p>

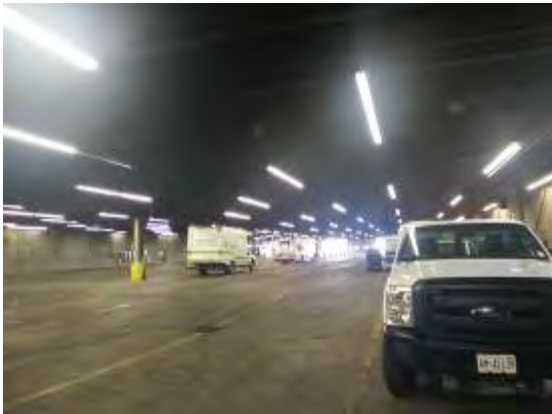
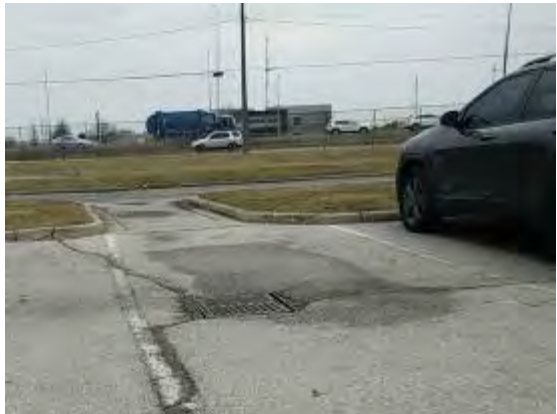
<p>Catch basin in bus storage area</p>	<p>Catch basin in visitor's parking lot</p>

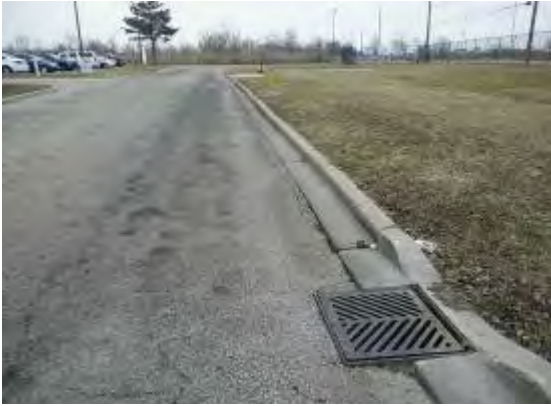
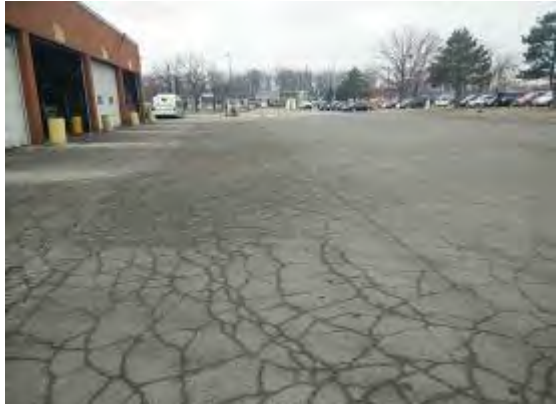
<p><b>Description</b>          There are two vehicular entrances provided for the facility. The south entrance is mainly used for public entry as the public parking lot is situated on the south side of the building. Designated egress signs/zones were found also displaying direction of street and bus directions. Egress exits were found throughout the perimeter of the building. No issues pertaining to access and egress to the site were reported by the site representative.</p>		
<p><b>Component Rating:</b> Good (2)</p>		<p><b>Installation Date:</b> 1979</p>
<p><b>Typical Life Span:</b> N/A</p>	<p><b>Remaining Life:</b> N/A</p>	<p><b>Current Effective Age:</b> 38</p>
<p><b>Recommendations</b>          No major capital expenditures are expected during the study period to address access and egress.</p>		
<p><b>Project Breakdown</b></p>	<p><b>QTY:</b> N/A</p>	<p><b>Capital Cost:</b> N/A</p>

<p>Vehicular entrance seen in distance</p>	<p>Bus access to facility</p>

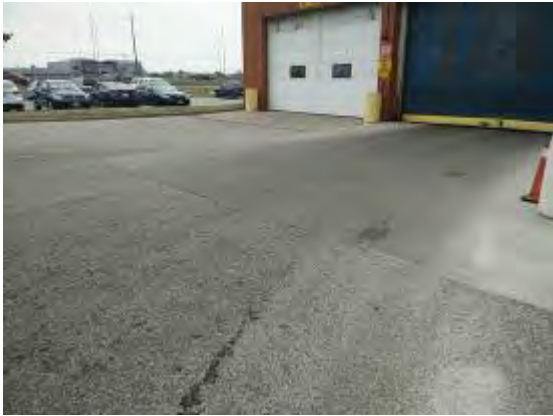
<p><b>Description</b></p> <p>There majority of the property is paved in asphalt. Concrete pads were typically found at the base of the garage door to provide additional toughness between the exterior and interior. A dedicated driveway ran parallel to North Service Road and provided internal north to south traffic. Heavy traffic areas including bus routes were observed to be in poor condition. The asphalt in these areas exhibit major cracking however, no significant potholes were found. The asphalt paving has passed its typical life expectancy. Buses were observed to be parked on gravel areas which may suggest that there is insufficient parking space provided for the facility.</p> <p>Concrete curbs are provided around the north and south parking lots. The concrete curbs were in good condition for the majority of its length, some minor deterioration and cracking were found.</p> <p>The top surface of asphalt paving materials was reviewed and assessed for condition. The adequacy and condition of underlying soils could not be assessed. No issues were reported by the site representative.</p>

Concrete slab on grade before garage entrance

<p><b>Component Rating:</b> Poor (4)</p>		<p><b>Installation Date:</b> 1979</p>
<p><b>Typical Life Span:</b> 20</p>	<p><b>Remaining Life:</b> 1</p>	<p><b>Current Effective Age:</b> 19</p>
<p><b>Recommendations</b></p> <p>Paving of the asphalt driveways and parking areas is recommended to be done within 1 year due to its condition. An allowance is carried. Replacement of the concrete curbing should coincide with the asphalt repaving. General maintenance such as cleaning engine fluids off the asphalt paved areas is considered under operations and maintenance.</p>		
<p><b>Project Breakdown</b></p>	<p><b>QTY:</b> 150,000sf</p>	<p><b>Capital Cost:</b> \$613,000</p>

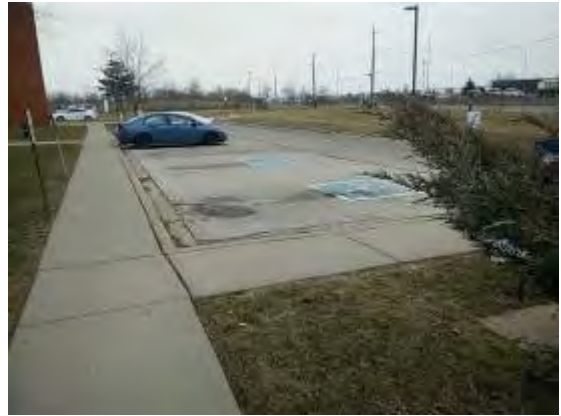
Visitor's parking lot

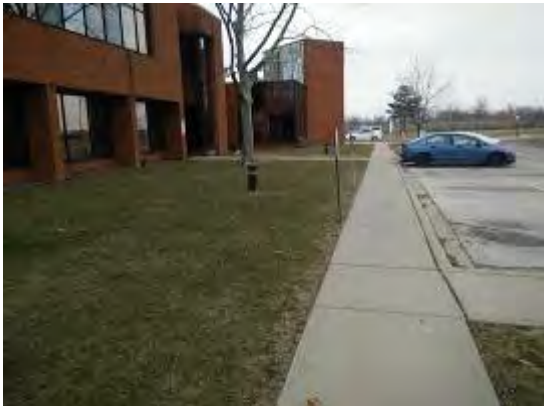
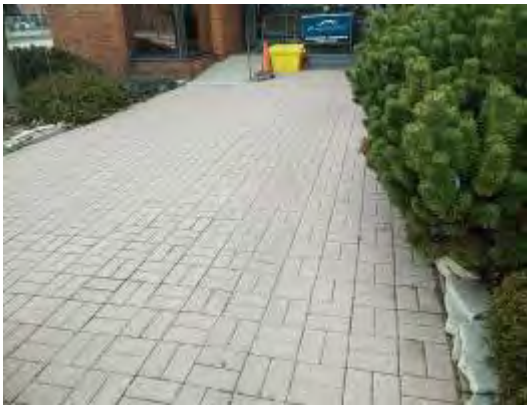
<p><b>Description</b>          Pedestrian walkways are constructed of poured concrete around the south parking lot. Brick interlocking was found from the parking lot to the main public entrance. A small ramp and exterior stairs located at the main public entrance matched the exterior average grade to the first floor level and was finished with ceramic tile. Overall, the component is in good condition with no major cracks observed. No significant signs of deterioration were present. No issues were reported.</p>		
<p><b>Component Rating:</b> Good (2)</p>		<p><b>Installation Date:</b> 1979</p>
<p><b>Typical Life Span:</b> 35</p>	<p><b>Remaining Life:</b> 5</p>	<p><b>Current Effective Age:</b> 30</p>
<p><b>Recommendations</b>          This item has been deferred, where possible, to extend its normal life span. Based on a normal life span for this component, repairs and/or replacements are anticipated during the study period. Appropriate costs are carried.</p>

<p>Concrete walkway from parking lot to visitor's entrance</p>	<p>Brick walkway to visitor's entrance</p>

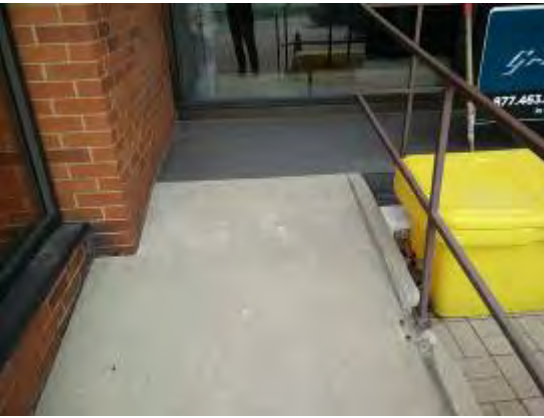
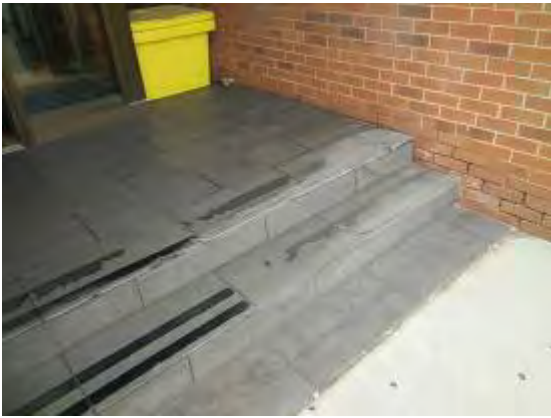
<p>Small ramp at visitor's entrance</p>	<p>Exterior stairs at visitor's entrance</p>

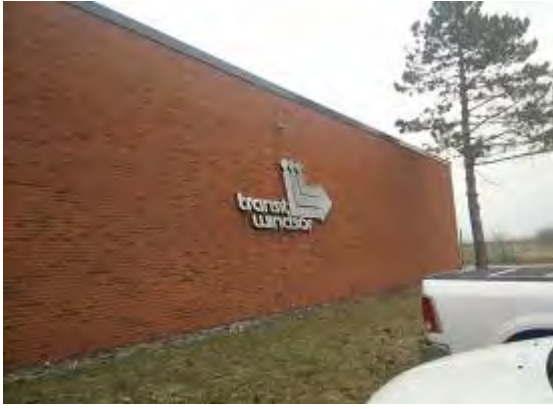
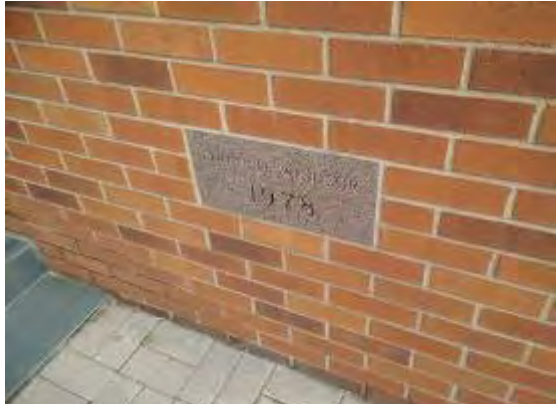
<p><b>Description</b>          Various signs and logos were installed around the perimeter of the building. A brushed metal logo was found on the south side of the building. A ground mounted sign displayed the main entrance and parking area for the public. The signs were reviewed from ground level and appeared to be in good condition with minor stains observed. Other signs installed throughout the site consist of vehicular &amp; pedestrian directional signs and bus designations. The signs appear to be replaced on an as-needed basis. No significant signs of deterioration were present. No issues were reported by the site representative.</p>		
<p><b>Component Rating:</b> Very Good (1)</p>	<p><b>Installation Date:</b> 2009</p>	
<p><b>Typical Life Span:</b> 40</p>	<p><b>Remaining Life:</b> 32</p>	<p><b>Current Effective Age:</b> 8</p>
<p><b>Recommendations</b>          The component is not anticipated for major repairs or replacement during the study period. No costs are carried.</p>

<p>Transit Windsor logo at front of building</p>	<p>Building date stamp</p>

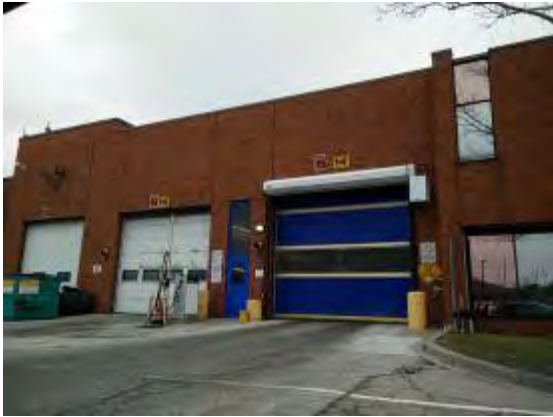
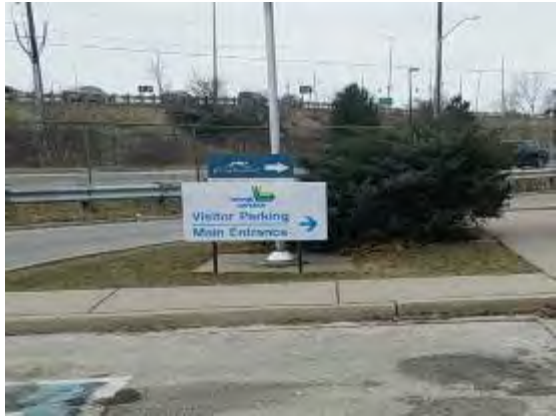
<p>Various signage around garage doors</p>	<p>Main entrance signage</p>

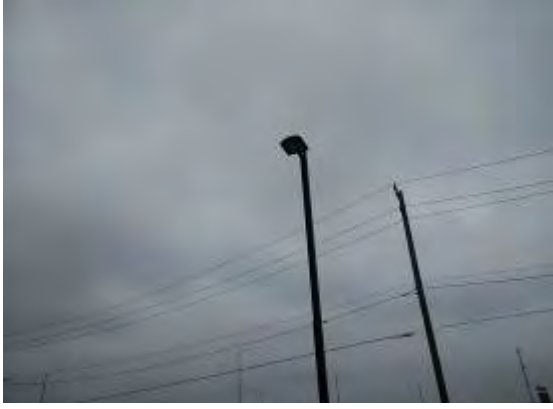
<p><b>Description</b>          Site lighting consists of pole-mounted high intensity discharge fixtures installed throughout the site. The light fixtures are mounted on a concrete bases that were in good condition. The fixtures were not on during the time of inspection however, with no issues reported it is assumed to be in working condition. No significant signs of deterioration were present. No issues were reported by the site representative.</p>		
<p><b>Component Rating:</b> Fair (3)</p>		<p><b>Installation Date:</b> 1979</p>
<p><b>Typical Life Span:</b> 25</p>	<p><b>Remaining Life:</b> 3</p>	<p><b>Current Effective Age:</b> 22</p>
<p><b>Recommendations</b>          This item has been deferred, where possible, to extend its normal life span. Based on a normal life span for this component, repairs and/or replacements are anticipated during the study period. Appropriate costs are carried.</p>

<p>Typical light standards on property</p>

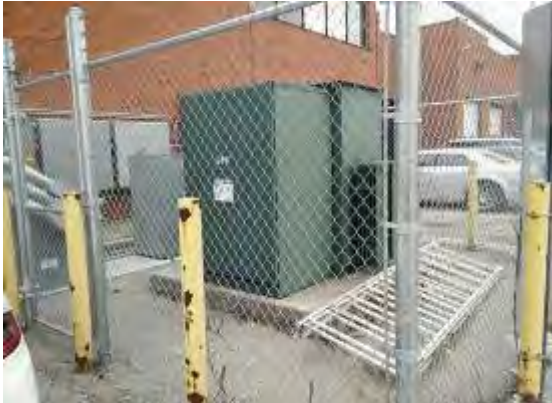
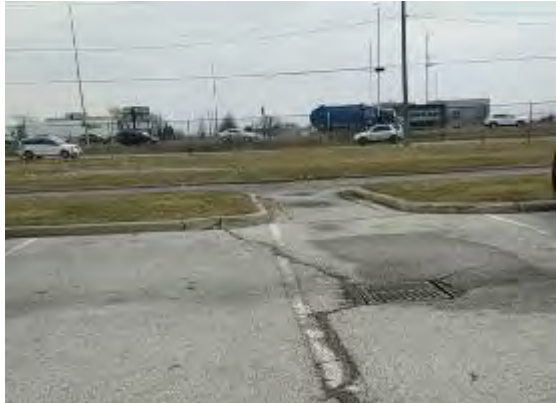
<p><b>Description</b>          The site is fitted with a chain link fence around the entire perimeter of the property. The chain link fence generally appeared to be in fair condition with surface wear from exterior elements. No major leaning was found for the length of the fence. Additional chain link fencing was found enclosing a city-owned transformer. No significant signs of deterioration were present. No issues were reported by the site representative.</p>		
<p><b>Component Rating:</b> Fair (3)</p>		<p><b>Installation Date:</b> 1979</p>
<p><b>Typical Life Span:</b> 25</p>	<p><b>Remaining Life:</b> 3</p>	<p><b>Current Effective Age:</b> 22</p>
<p><b>Recommendations</b>          This item has been deferred, where possible, to extend its normal life span. Based on a normal life span for this component, repairs and/or replacements are anticipated during the study period. Appropriate costs are carried.</p>

<p>Fencing around transformer</p>		<p>Chain link fence in background</p>
