Appendix C: Arborist Report

University Avenue EA Arborist Report

Municipal Class Environmental Assessment Study
 University Avenue and Victoria Avenue
Tree Assessment

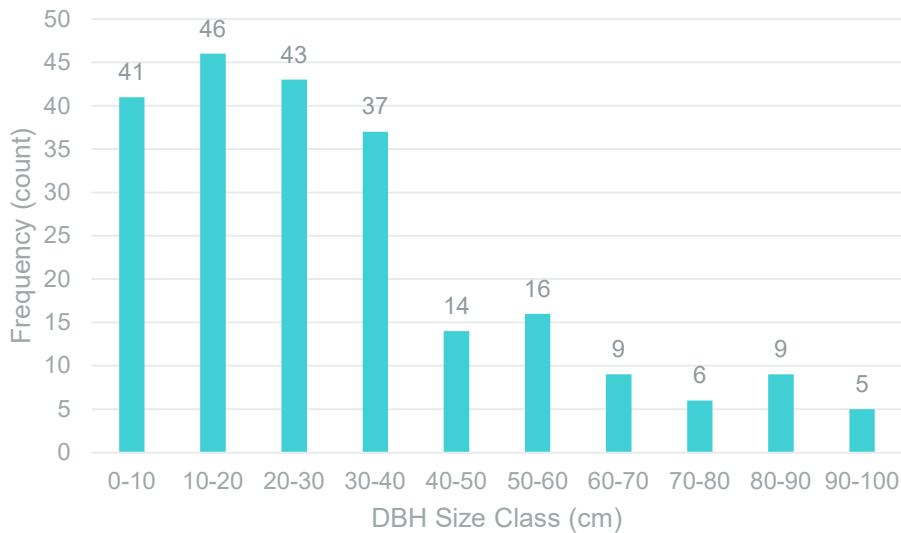
Figure 1. Tree size distribution in the study area.

The graph below illustrates that the tree size distribution for University Avenue is generally skewed to the left, with a significant drop in tree counts beyond the 40 cm DBH threshold. Trees less than 40 cm DBH make up almost 75% of all trees surveyed. Generally, the graph below shows a healthy tree size distribution. The relative disparity in numbers between trees less than 40 cm DBH and those above 40 cm DBH indicates that the future forest is promising. It is possible that the difference in size class at the 40 cm DBH threshold may indicate that municipal urban forestry management practices may favour removing larger trees as their hazard potential and their maintenance cost increases over time.

The size class of trees is an important metric for managing urban tree populations, as they indicate the relative age of trees as well as tree maintenance requirements. The ideal distribution is skewed left, with the greatest number of trees in the smallest DBH class decreasing to the least number of trees in the largest DBH class. This adds longevity and resiliency to the flow of functional benefits provided by the urban tree population, including aesthetic and ecological benefits.

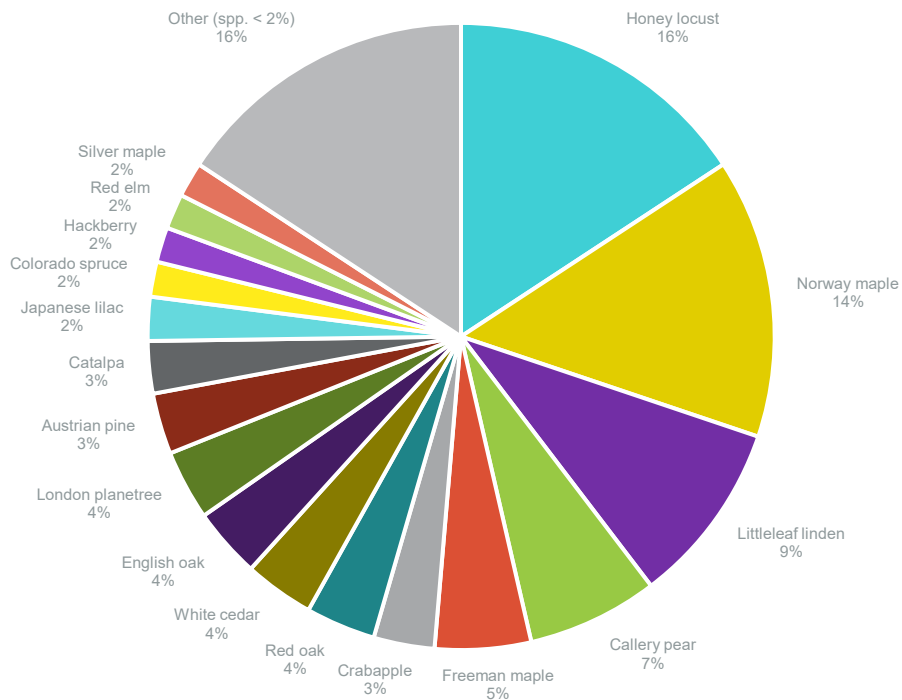
Figure 2. Tree species distribution in the study area (n=35 species).

Following this rule, the graphs below indicate that honey locust and Norway maple both exceed the 10% species rule (at 16% and 14% respectively); that maples generally are slightly overrepresented as a genus (at 23%); and that family diversity among trees along University Avenue is well under the 30% mark, with the pine, legume, and rose families tied for the highest share at 11% each.

Compared to many urban streets, the species diversity of the trees inventoried along University Avenue is very good.
