The Corporation of the City of Windsor

Value for money audit: Purchased services - Winter road clearing

FINAL Internal audit report

May 1, 2020

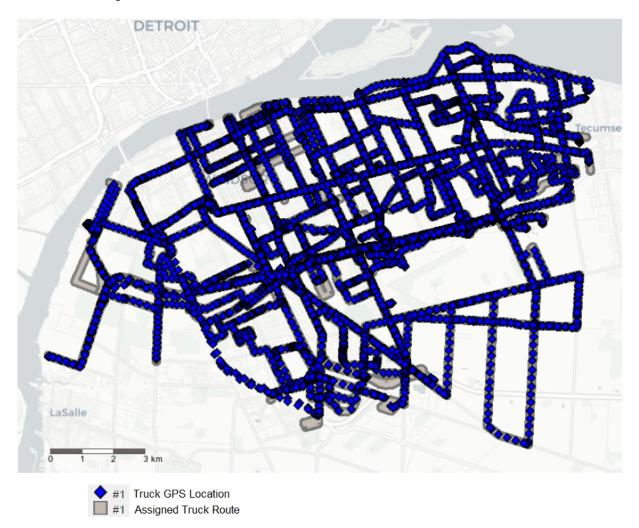
Map 1 - On March 16th, 2019, 97% of all routes were covered by all contractor trucks. The grey areas with no overlapping blue dots indicate the portions of the roads were not covered by any of the trucks during the event.

- 1. In seven out of 52 winter events the contractor had less than 99% of the overall coverage of all routes assigned to them by all the trucks; Refer to Truck Overall Coverage Maps in appendix D.

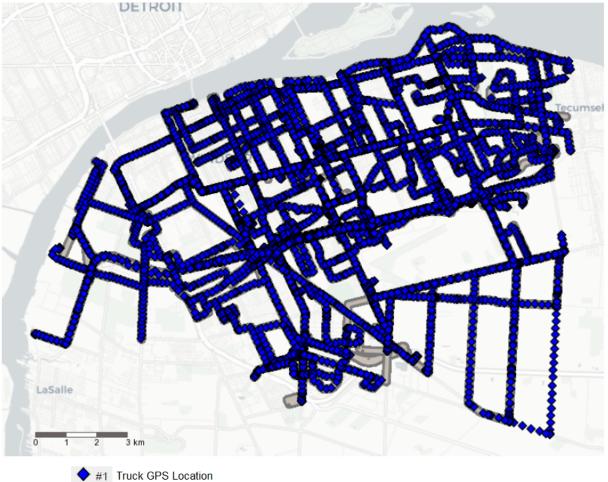
Map 2 - On February 20th, 2019, 98% of all routes were covered by all contractor trucks. The grey areas with no overlapping blue dots indicate the portions of the roads were not covered by any of the trucks during the event.

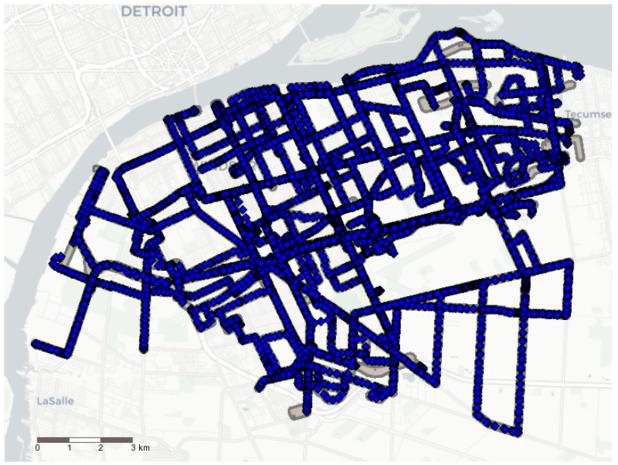
Map 3 - on November 11th, 2018, 98% of all routes were covered by all contractor trucks. The grey areas with no overlapping blue dots indicate the portions of the roads were not covered by any of the trucks during the event.

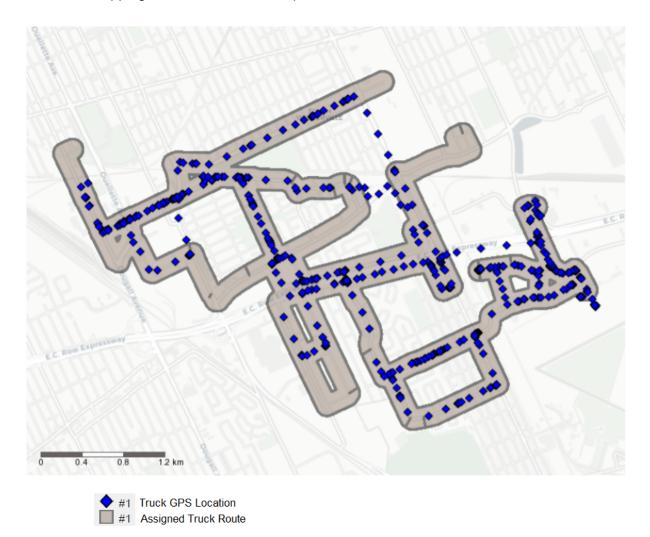
Map 1 - On March 16th, 2019. truck 420 only completed 84% of its assigned route. The grey areas with no overlapping blue dots indicate the portions of the roads were not covered.

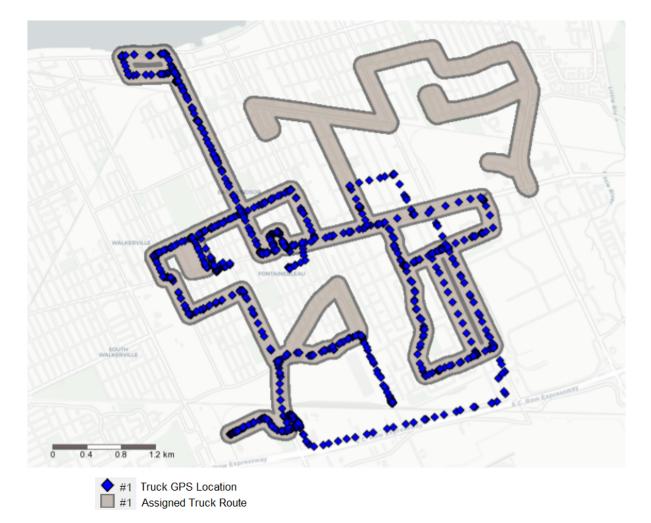
Map 2 - On December 30th, 2018, truck 422 only completed 63% of its assigned route. The grey areas with no overlapping blue dots indicate the portions of the roads were not covered.

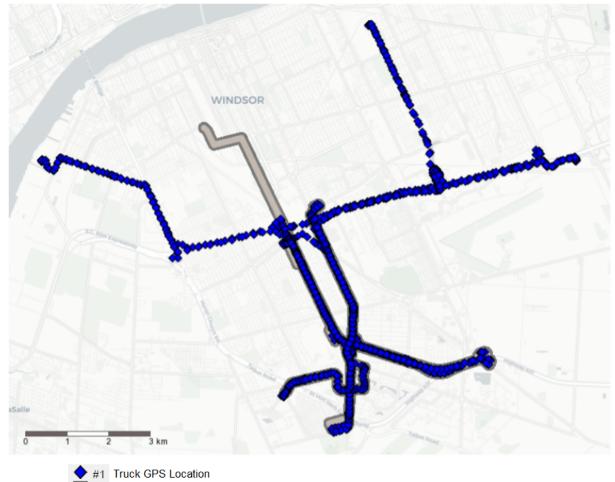
Map 3 - on December 13th, 2017, truck 417 only completed 83% of its assigned route. The grey areas with no overlapping blue dots indicate the portions of the roads were not covered.

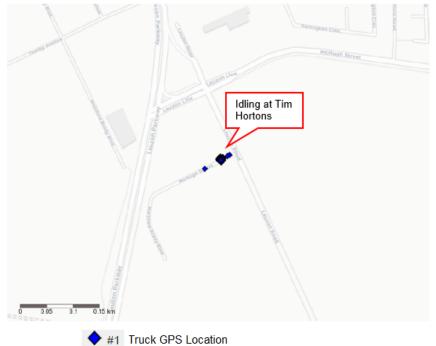
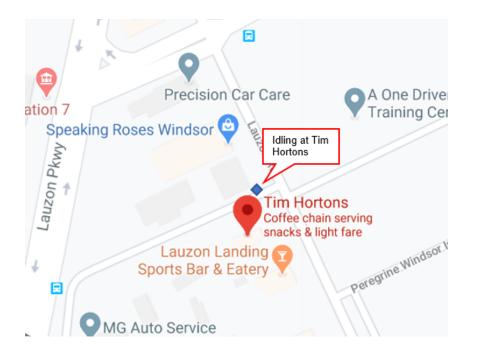
Map 1 - On February 27th, 2019, truck 423 took a 1 hour break starting around 12:39 pm, potential risk as this is near a Tim Hortons

- 3. We noted 12 instances where contractor trucks had more than one hour idle time during operations. (Trucks are entitled to half an hour break for every 4 hours of operation). The related Supervisor Logs did not have any specific reasons for the idles such as equipment breakdown or traffic accident, etc. The positions where the trucks were idle may imply that the operators were possibly taking prolonged breaks; however we cannot state that with certainty. (See Example of Truck Idle Map in appendix D).

GPS will be used to establish an idle alarm which will indicate to the Technical Support person that a truck	Responsible party:	Maintenance Co-ordinator
has not moved for 30 min. Any issues found are to be called into the Supervisor for immediate action. The Technical Support person's findings of their GPS analysis will be logged and documented several times throughout their shift. If there is an instance where the unacceptable performance issues arise, a letter will be sent to the Contractor with a date in which to expect a reply and remediation to the performance.	Due date:	Q4 2020

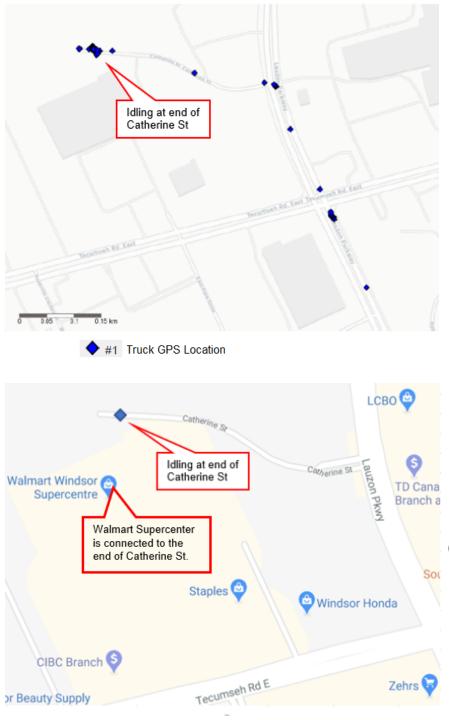
Map 2 - On December 15th, 2017, truck 423 took a 1 hour 24 minute break starting around 4:13 pm. The truck was stopped in a quiet area at the end of Catherine street. A Walmart Supercenter is connected to the end of Catherine St. .

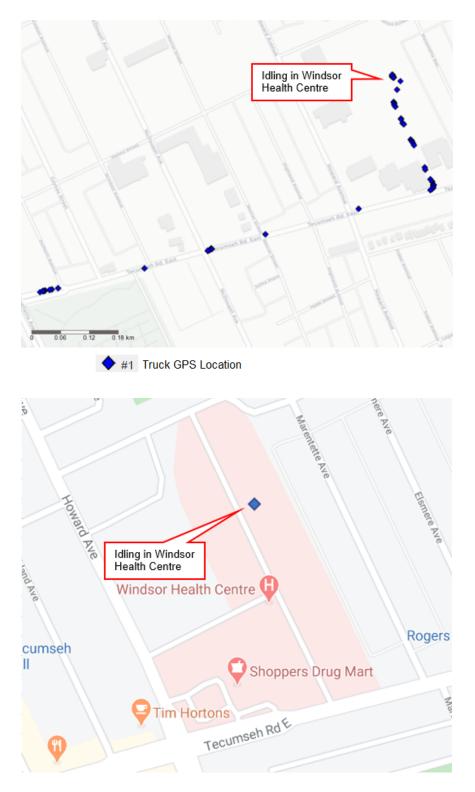
Map 3 - On January 22nd, 2019, truck 417 took two breaks greater than 1 hour each within the same shift. Map 11 shows the first break is for 1 hour 30 minutes starting around 11:35 pm. The driver was parked near the Windsor Health Centre.

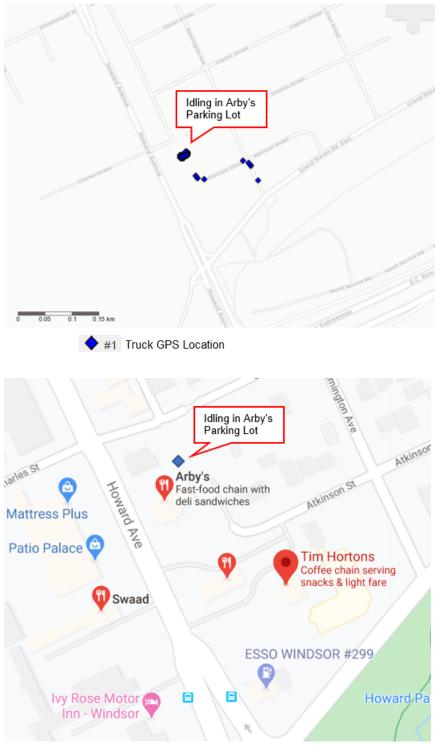
Map 4 - January 23rd, 2019 truck 417 took its second break at 1 hour 16 minutes starting around 12:52 pm. The truck GPS indicates it was idling in the parking lot of one of the restaurants in the area.
