### **UNDERWATER INSPECTION REPORT BY WATECH SERVICES INC.**

**UNDERWATER INSPECTION OF LAKE ST. CLAIR SEAWALL  
SEAWALL INSPECTION  
Windsor, Ontario**

**Prepared for:  
LANDMARK ENGINEERS Inc.**

**November 2019**

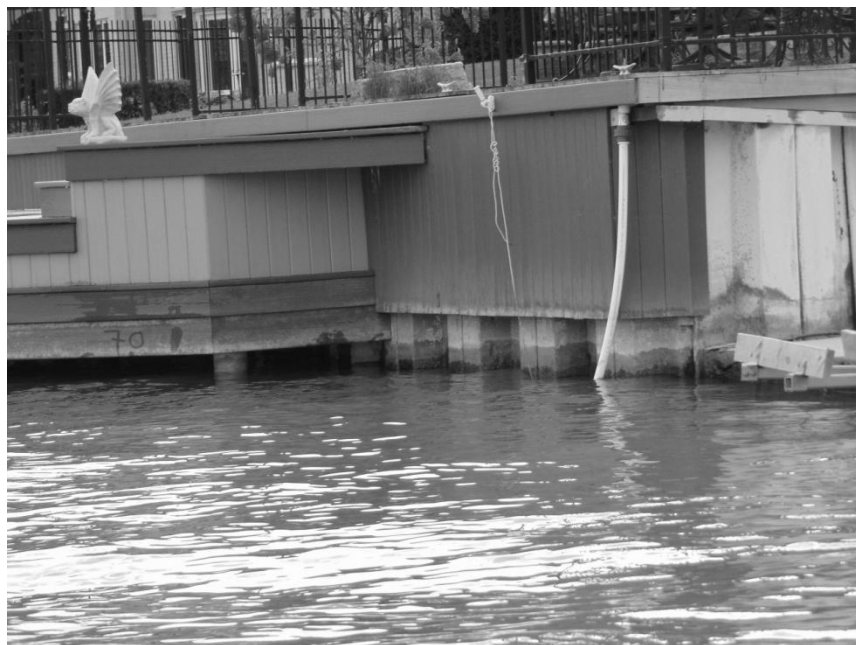
PHOTO # 12

2 pile SSP at chainage  
0+072. This marks the end  
of the SSP

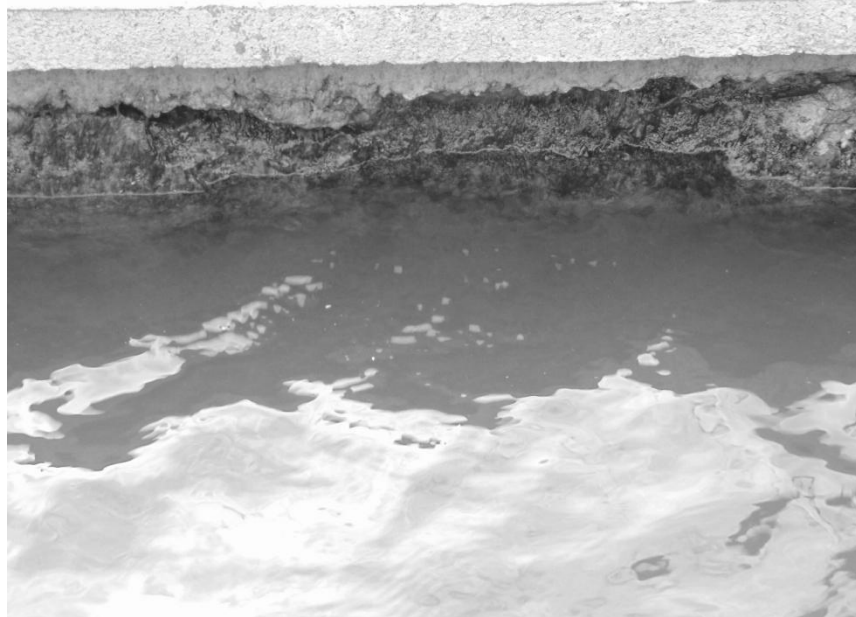
PHOTO # 34

Concrete panel area at chainage 0+229. Spalling on the vertical face, dimensioned at 0.5m long by 0.20m high by 0.05m deep

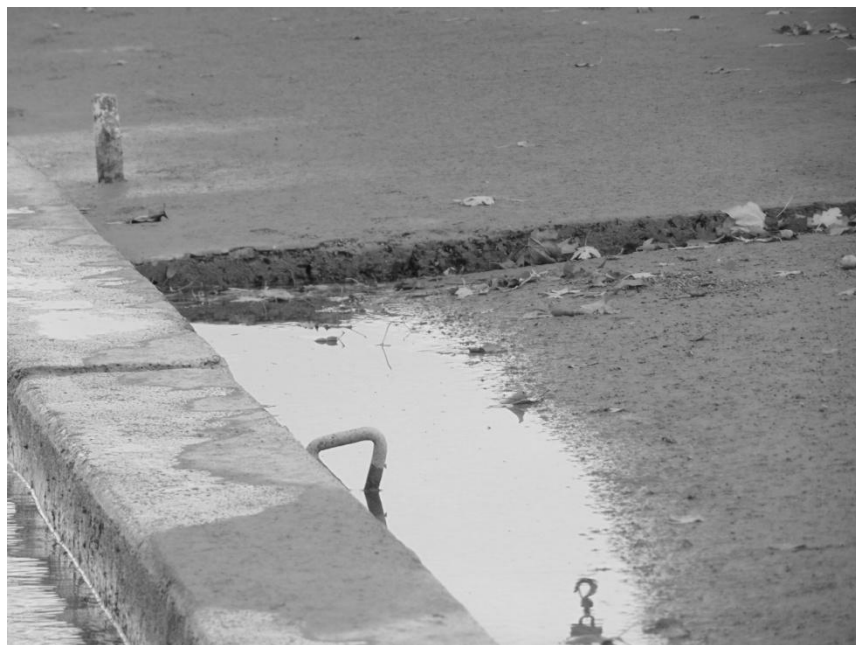
PHOTO # 44

Concrete panel area at chainage 0+285. Concrete panel deck has sunk 0.813m

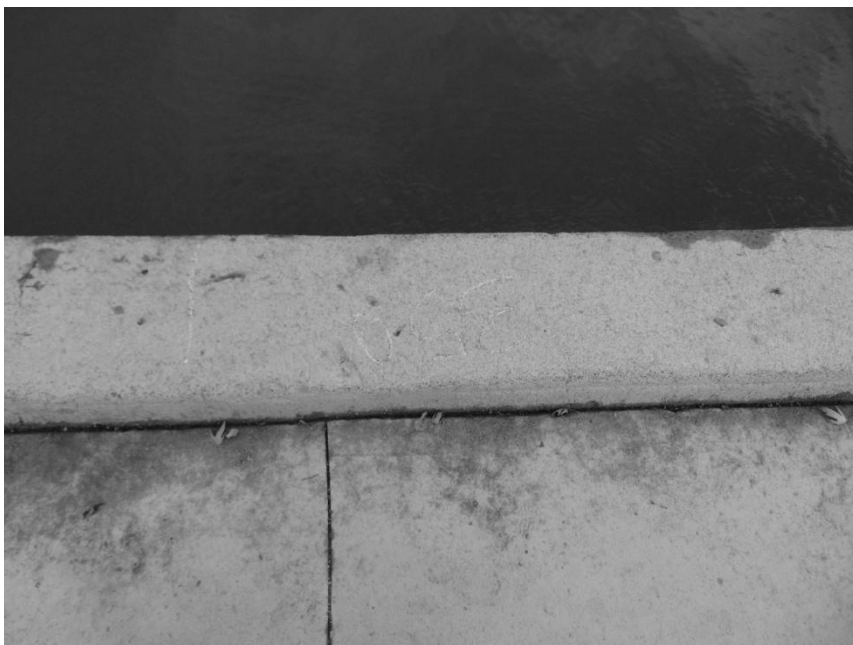
PHOTO # 54

0+338	Drainage hole measuring 100mm in diameter. No drain tile visible void behind wall noted
0+346	Drainage hole measuring 100mm in diameter. No drain tile visible void behind wall noted.
0+354	Drainage hole measuring 100mm in diameter. No drain

Concrete panel area at chainage 0+350

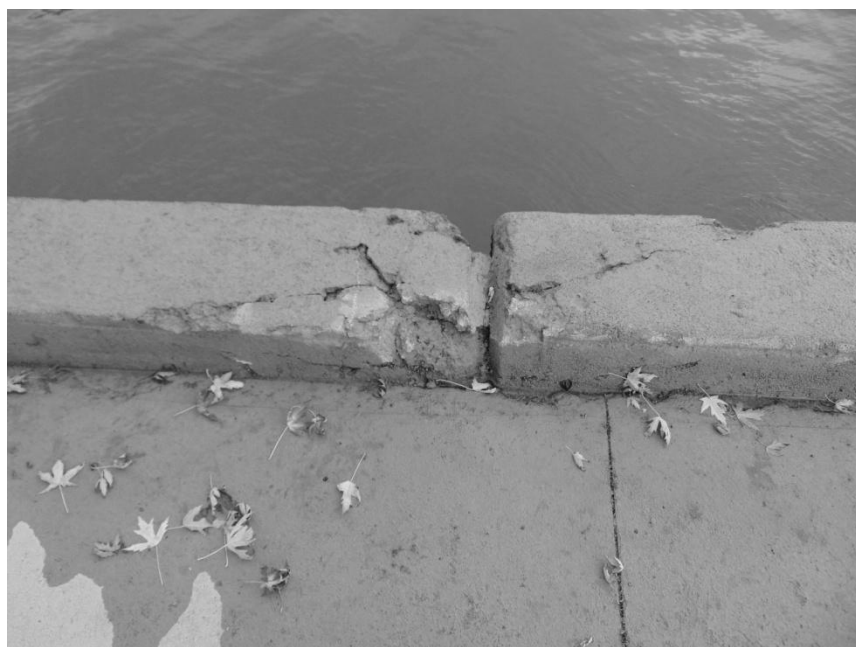
PHOTO # 56

tile visible void behind wall noted
0+360	Broken concrete located at the joint of the curb.
0+362	Drainage hole measuring 100mm in diameter. No drain tile visible void behind wall noted
0+369.4	Broken surface concrete at the point of deflection, to a depth of 50mm below the surface of the water. The concrete panel is at a lower elevation on the offshore side of the walkway, for a distance of 8.6 metres.
0+370	Drainage hole measuring 100mm in diameter. No drain tile visible void behind wall noted
0+378	End of the 8.6 metre long slope of the concrete deck. End of void at bottom of concrete panel.
0+420	The concrete panel area is at a higher elevation on the west side, and a lower elevation on the east side
0+428	Spalled concrete along the panel area, dimensioned 1 metre long by 0.5 metres wide by 100mm deep.
0+435	Concrete deck is in poor condition, with cracking and missing concrete. Beginning of offshore steel sheeting.

Concrete panel area at chainage 0+360. Broken concrete shown at the joint

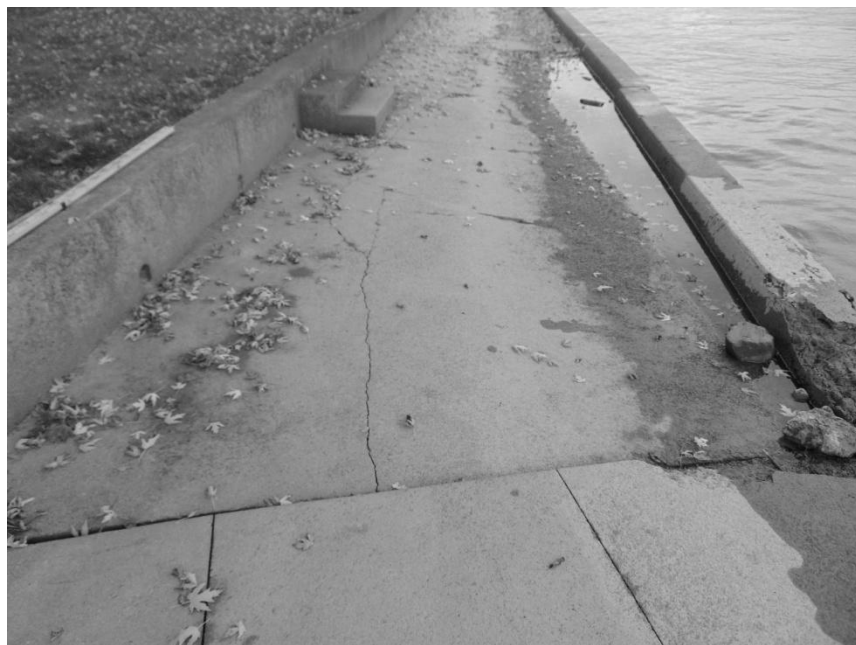
PHOTO # 60

Concrete panel area at chainage 0+369.4, looking west. Concrete is lowered on the offshore side of the walkway.

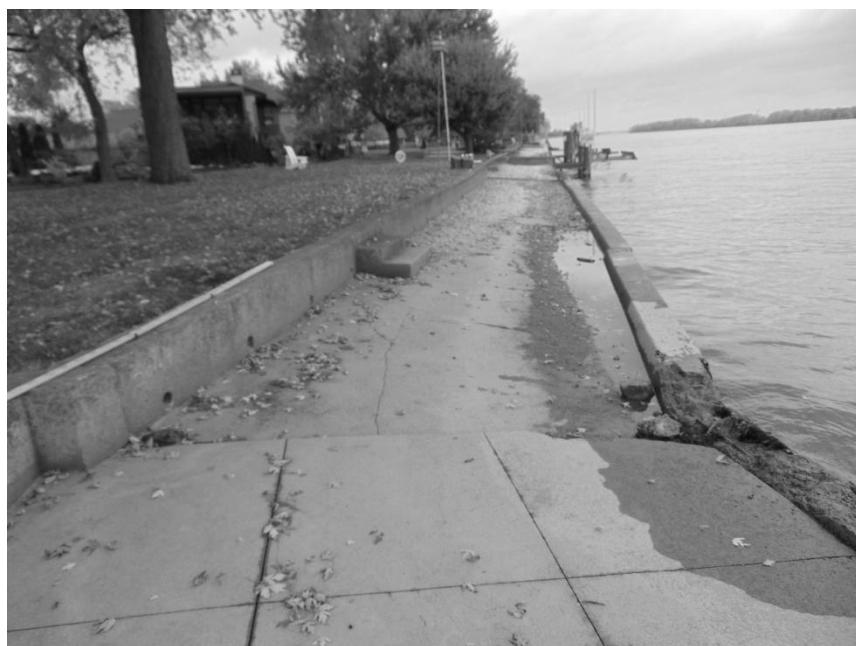
PHOTO # 61

Concrete panel area at chainage 0+369.4, looking west. Concrete is lowered on the offshore side of the walkway.

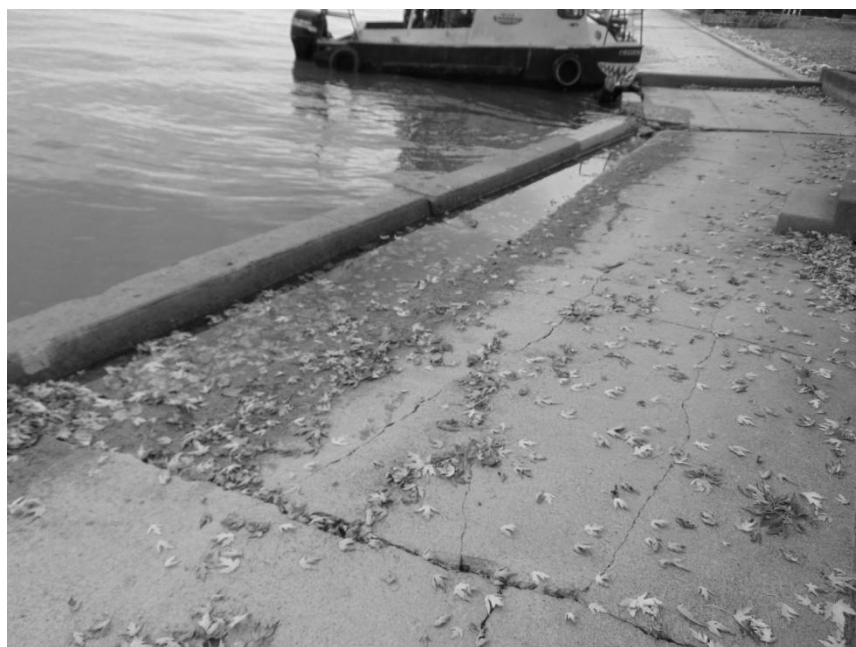
PHOTO # 62

Concrete panel area at chainage 0+390, for a length of 20m.

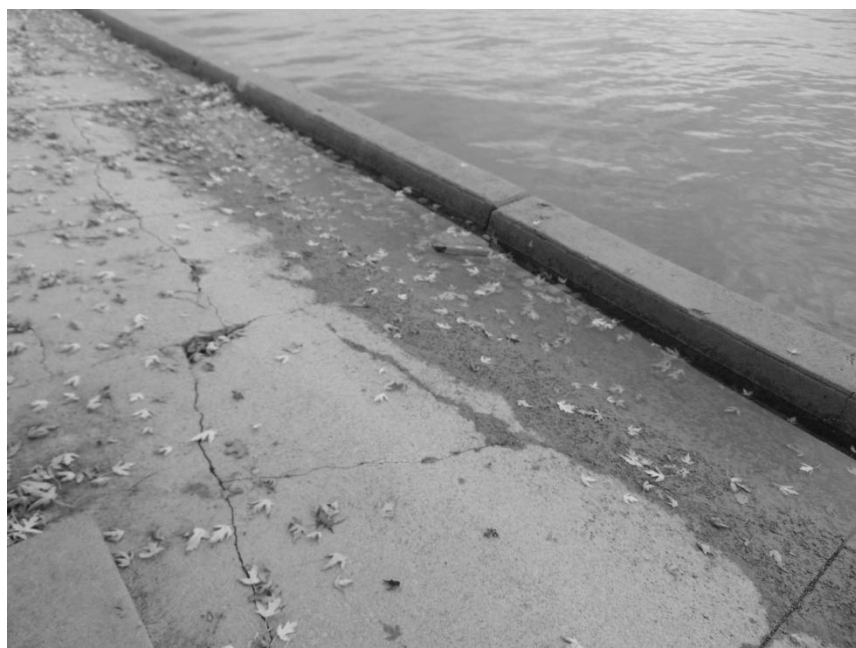
PHOTO # 63

Concrete panel area at chainage 0+369.4 to 0+378, showing the slope of the concrete deck

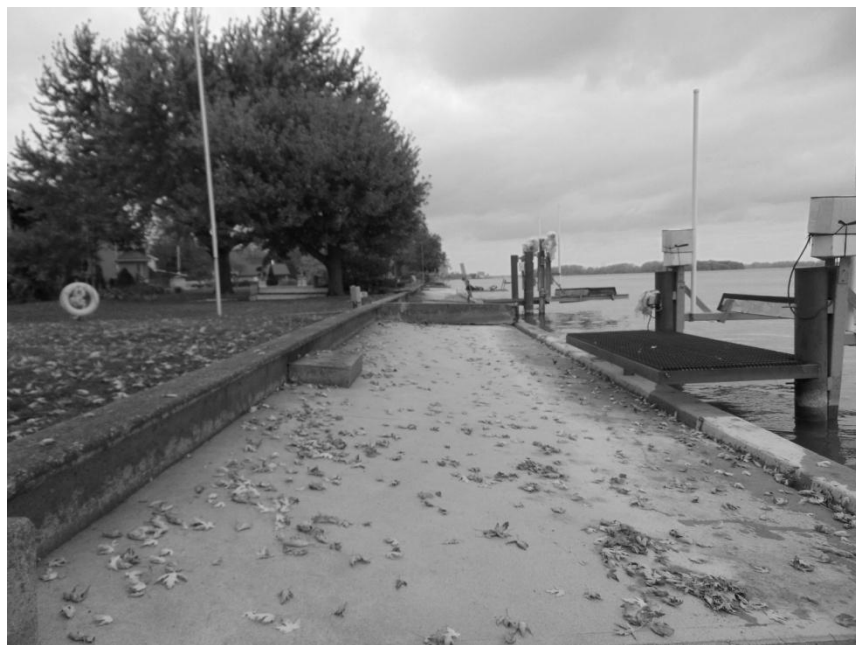
PHOTO # 64

Concrete panel area at chainage 0+369.4 to 0+378, showing the slope of the concrete deck

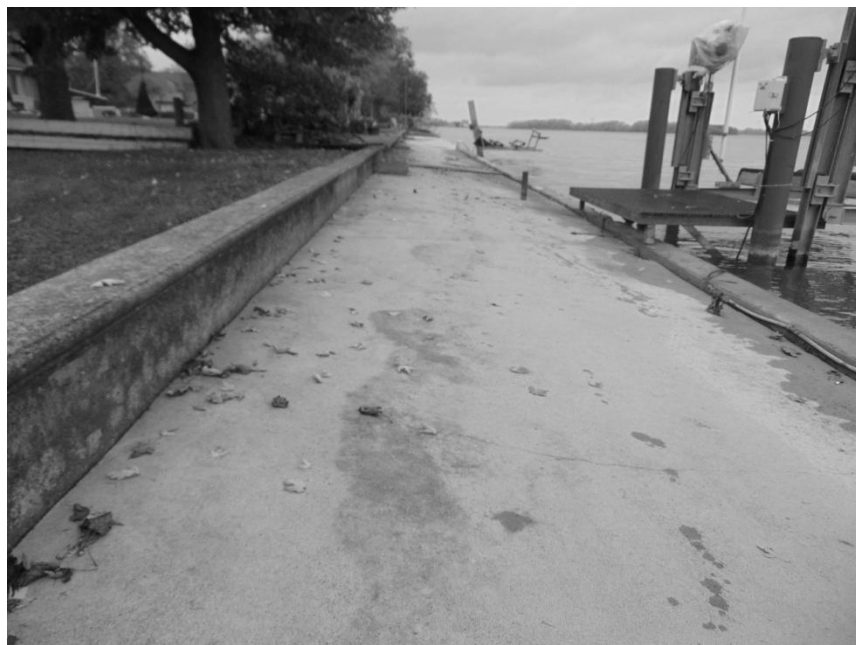
PHOTO # 65

Concrete panel area at chainage 0+390, looking west, showing the slope of the concrete deck

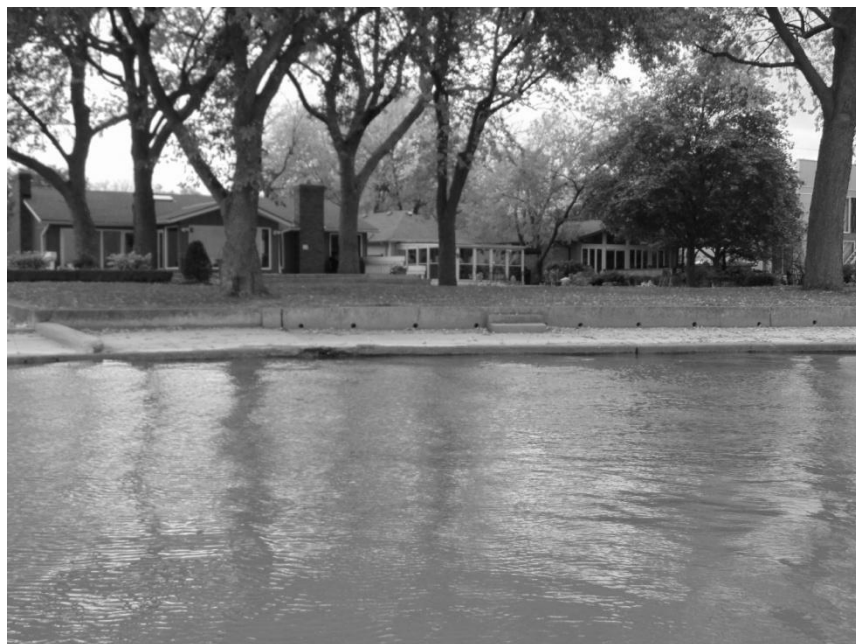
PHOTO # 66

Concrete panel area at chainage 0+400, looking west, showing the slope of the concrete deck

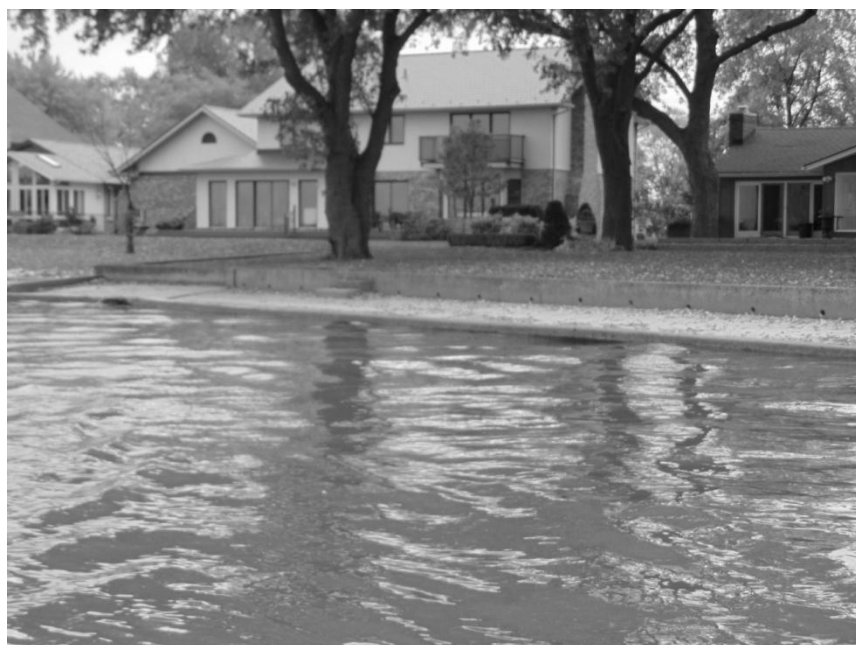
PHOTO # 67

Concrete panel area at  
chainage 0+369.4 to  
0+380

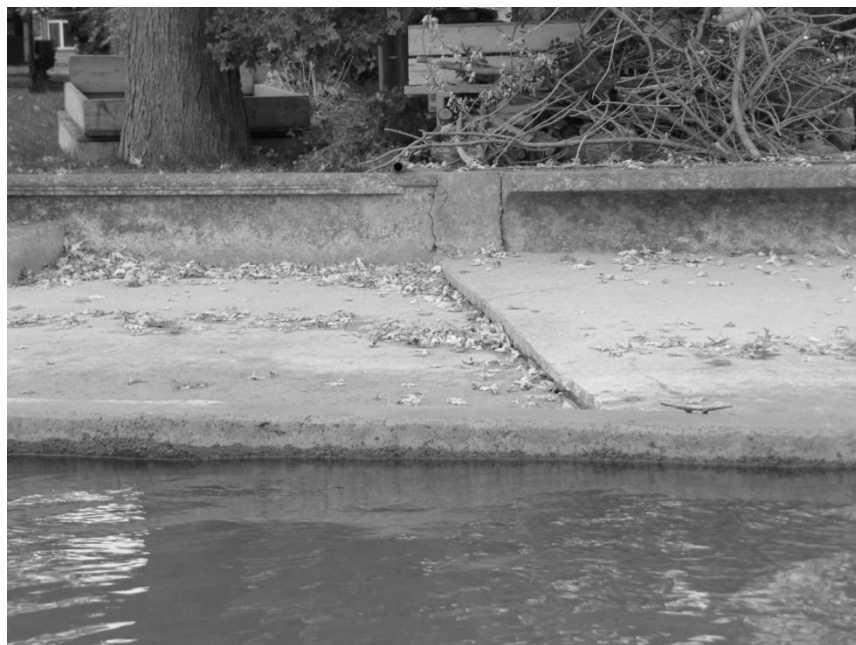
PHOTO # 70

Concrete panel area at chainage 0+428, showing spalled concrete dimensioned 1m long by 0.46m wide by 0.10m deep

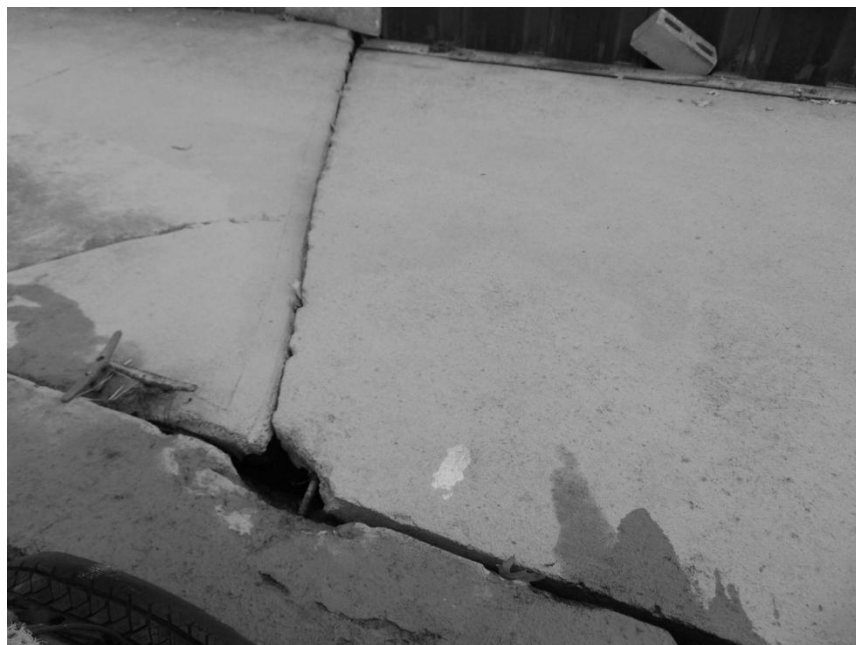
PHOTO # 71

Concrete panel area at chainage 0+420, showing a higher westerly elevation and a lower easterly elevation

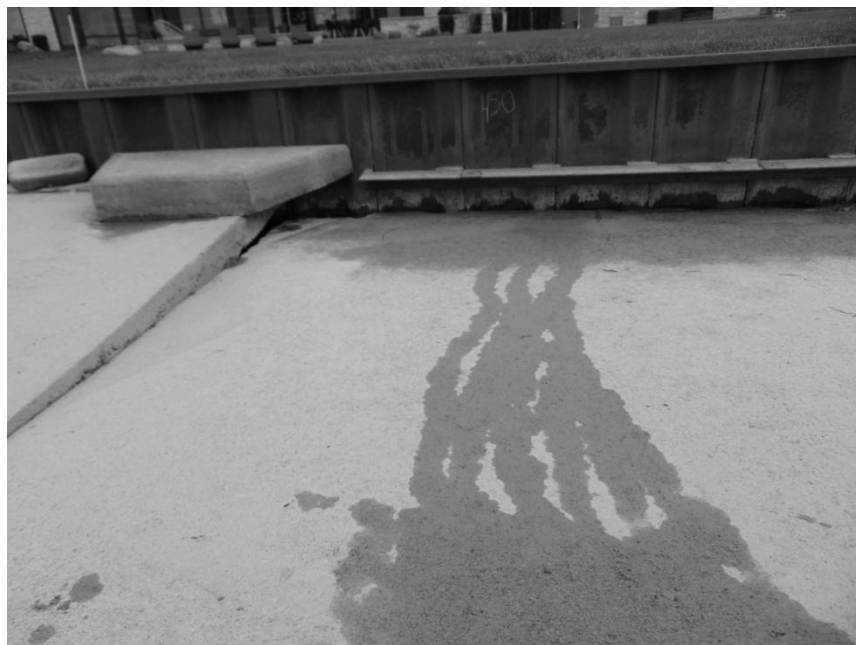
PHOTO # 73

Failed inshore panel at  
chainage 0+450

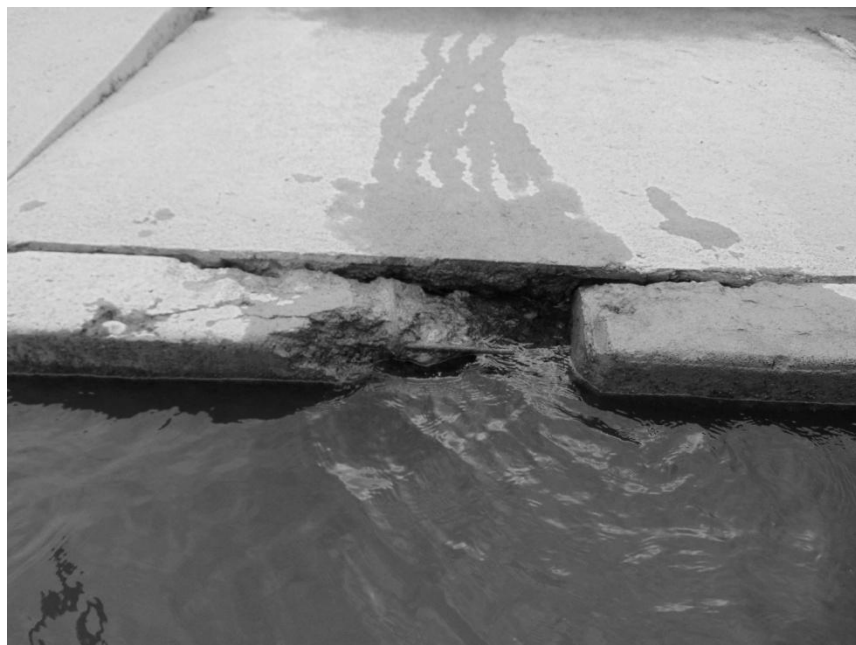
PHOTO # 74

Further view of the failed  
inshore panel at chainage  
0+450

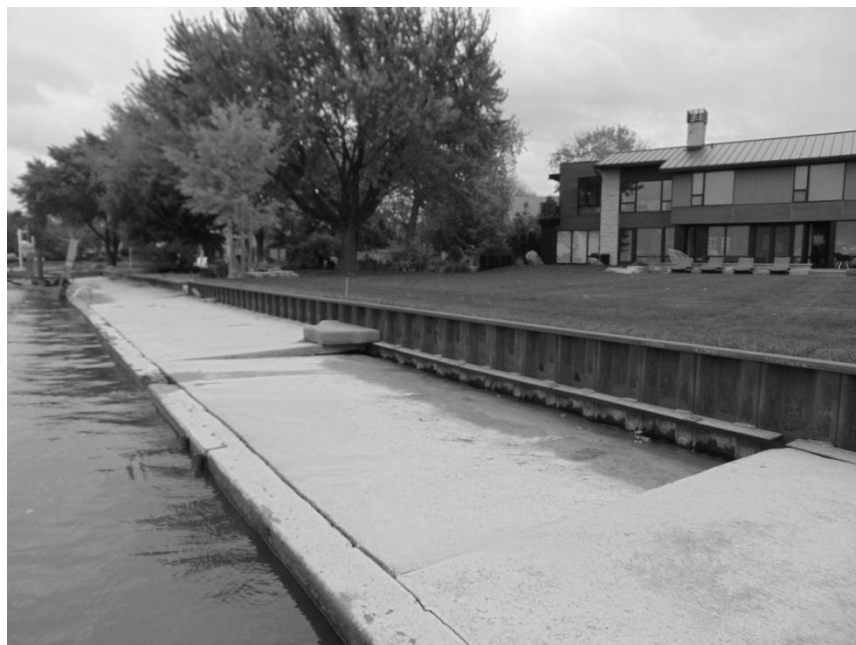
PHOTO # 76

Failed concrete deck at  
chainage 0+450 to 0+455

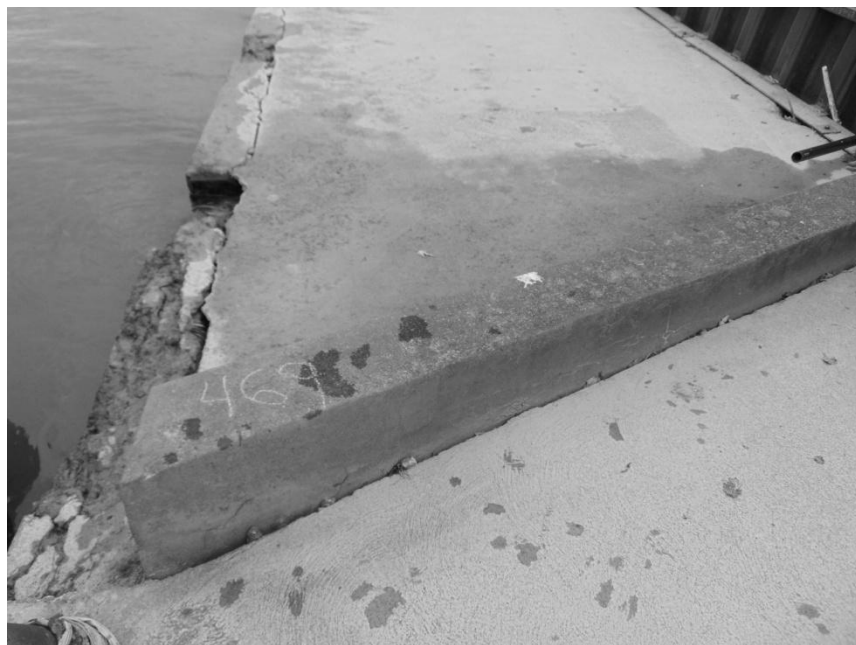
PHOTO # 77

Continuation of the failed  
deck at chainage 0+450 +  
0+455

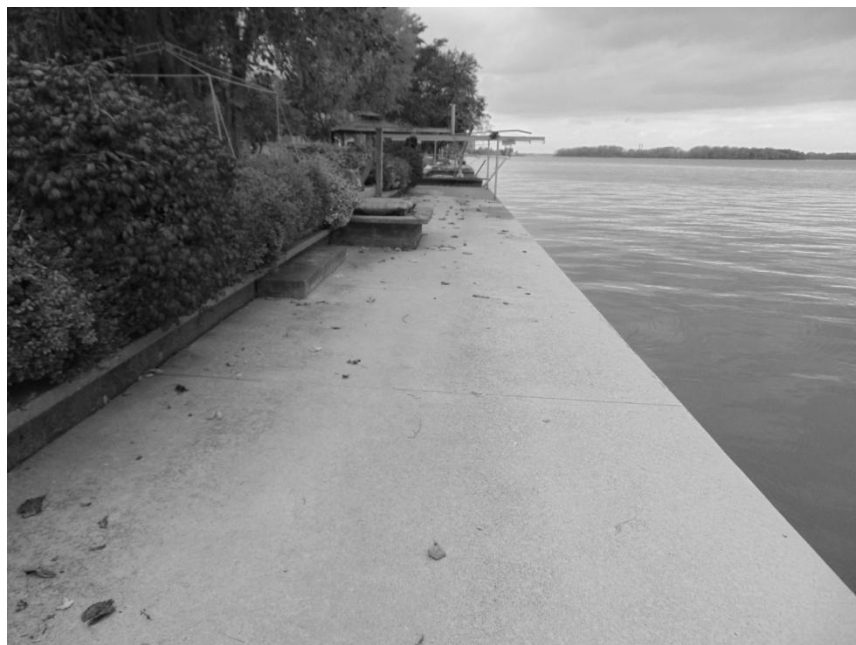
PHOTO # 80

Facing west from chainage 0+470

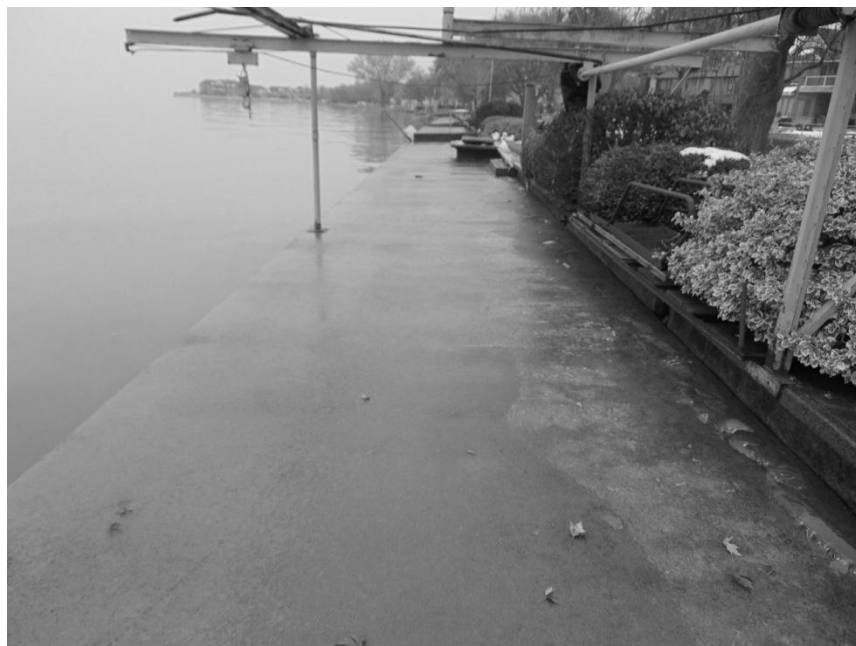
PHOTO # 81

Facing west at chainage 0+490

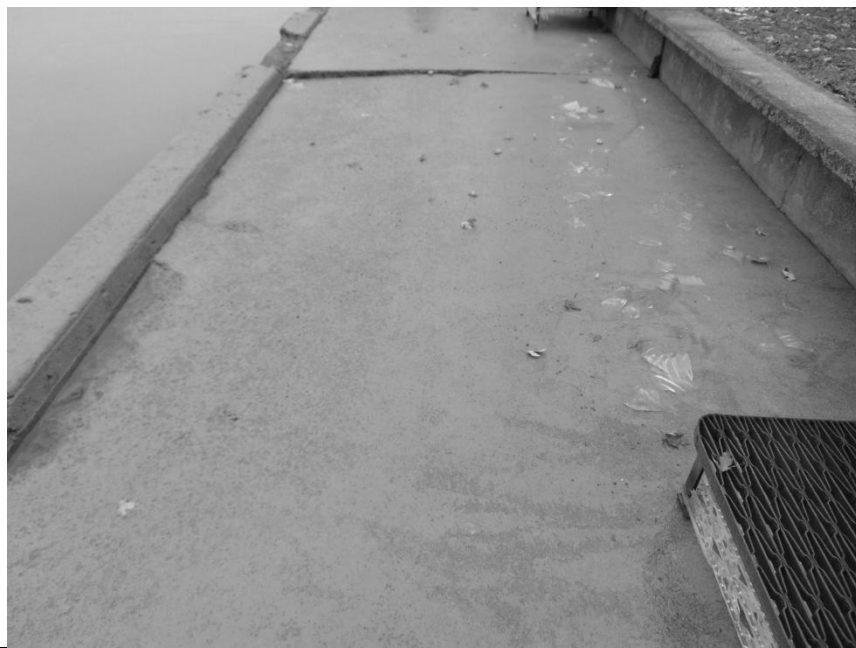
PHOTO # 82

0+520 looking east toward  
0+490

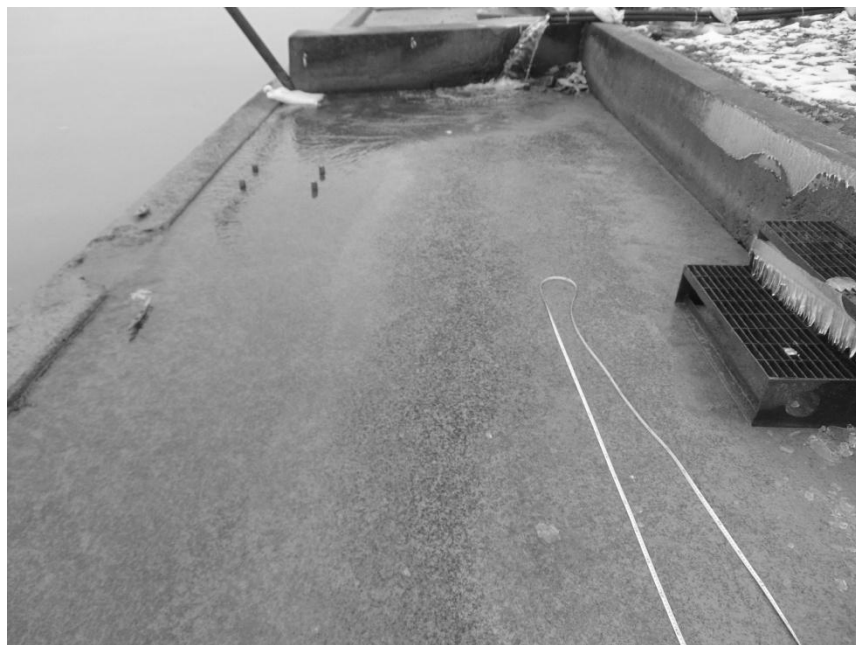
PHOTO # 83

0+530 looking east toward  
0+520 poor condition  
sloping toward water

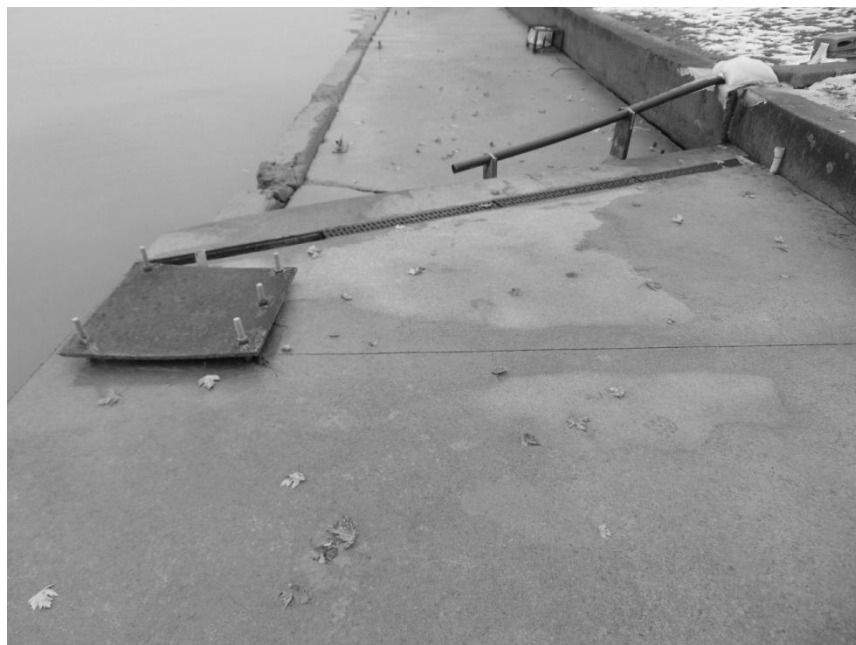
PHOTO # 85

0+550 looking east toward  
0+540 fair condition

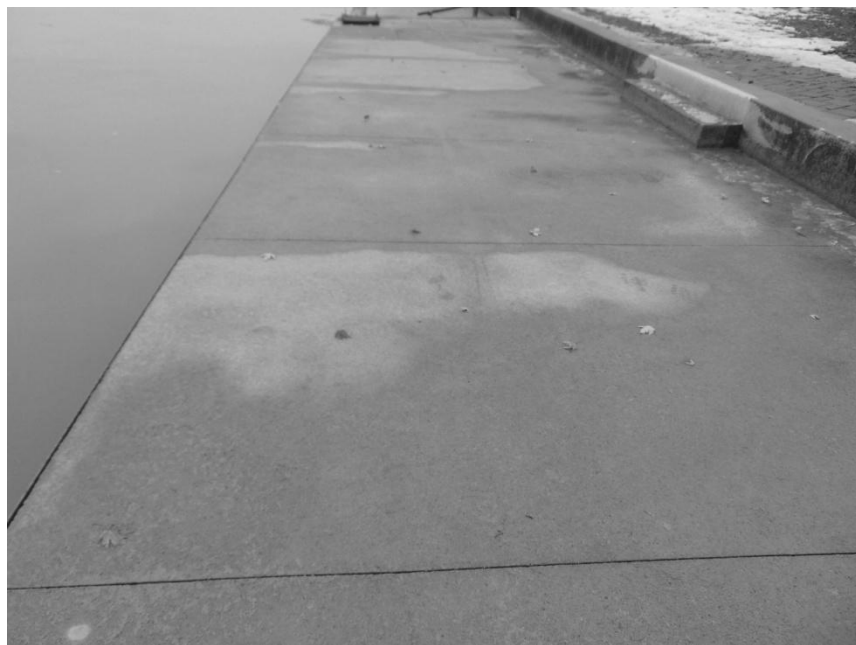
PHOTO # 86

0+560 looking east toward  
0+550 good condition

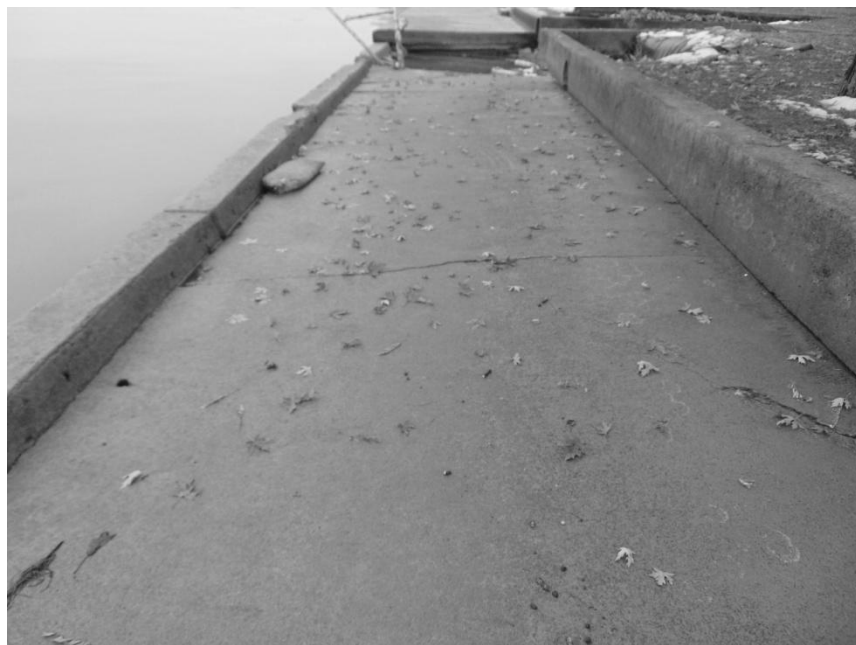
PHOTO # 88

0+580 looking east toward  
0+570 poor condition deck  
failing

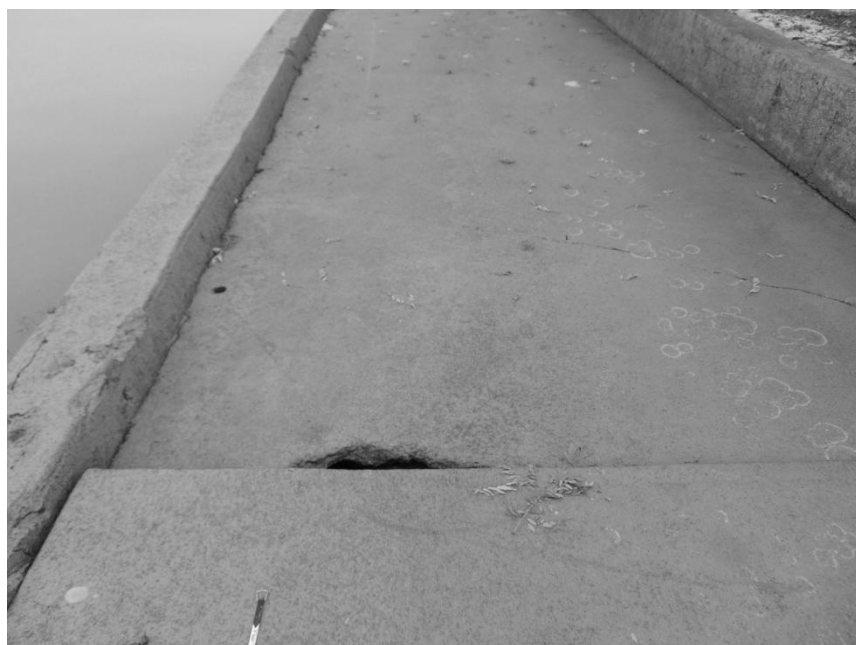
PHOTO # 89

0+590 looking east toward  
0+580 poor condition  
sloping toward water

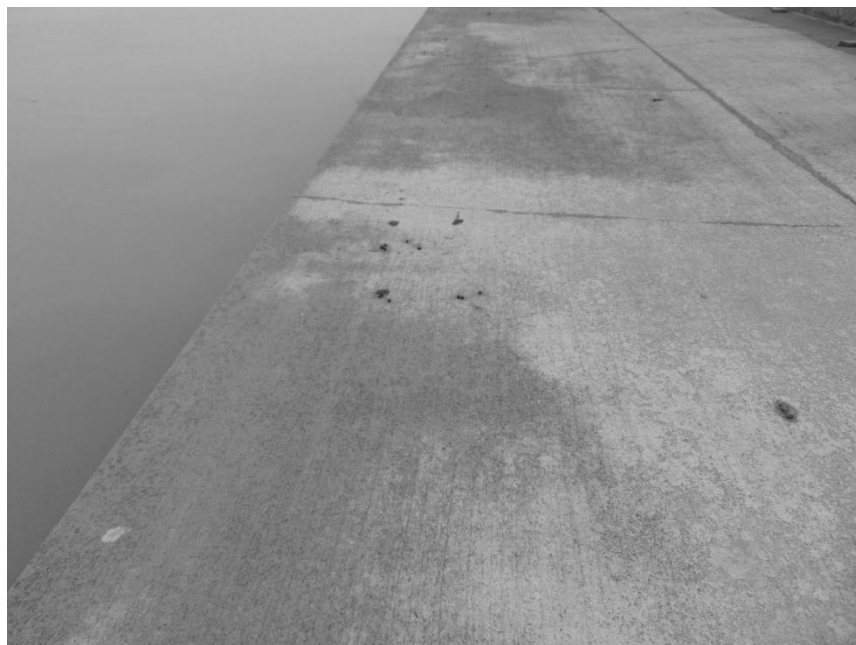
PHOTO # 91

0+610 looking east toward  
0+600 good condition

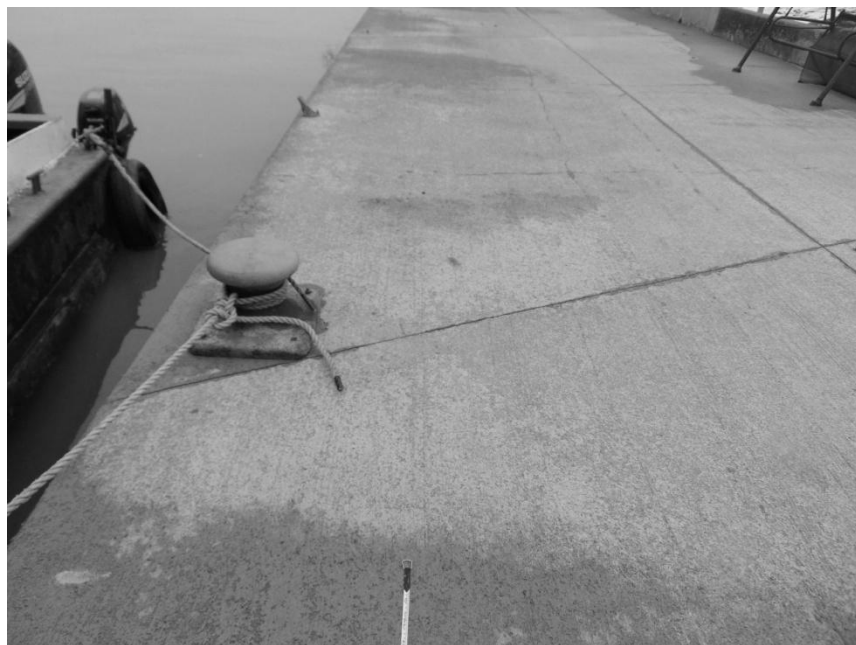
PHOTO # 92

0+620 looking east toward  
0+610 fair condition with  
surface cracking

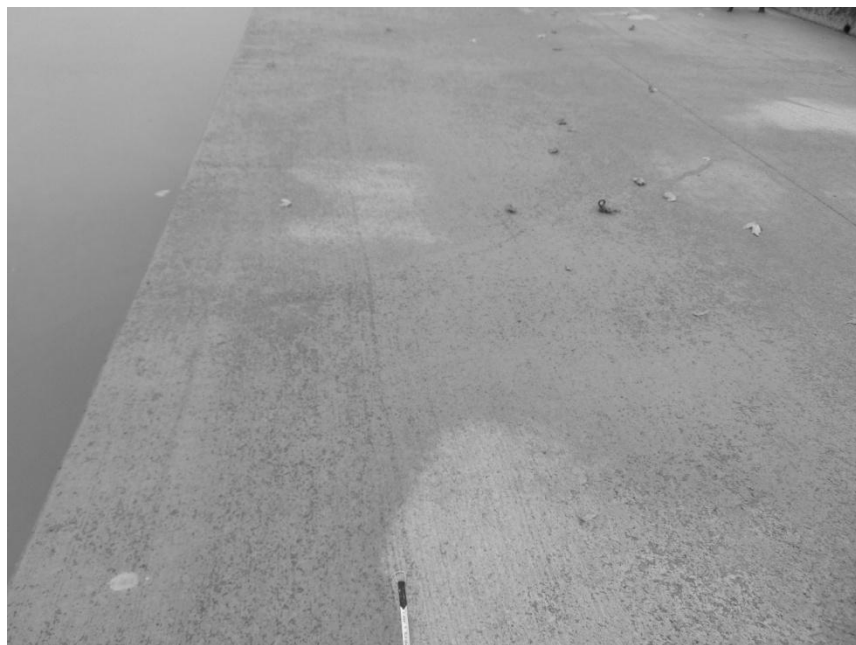
PHOTO # 94

0+640 looking east toward  
0+630 fair condition with  
surface cracking

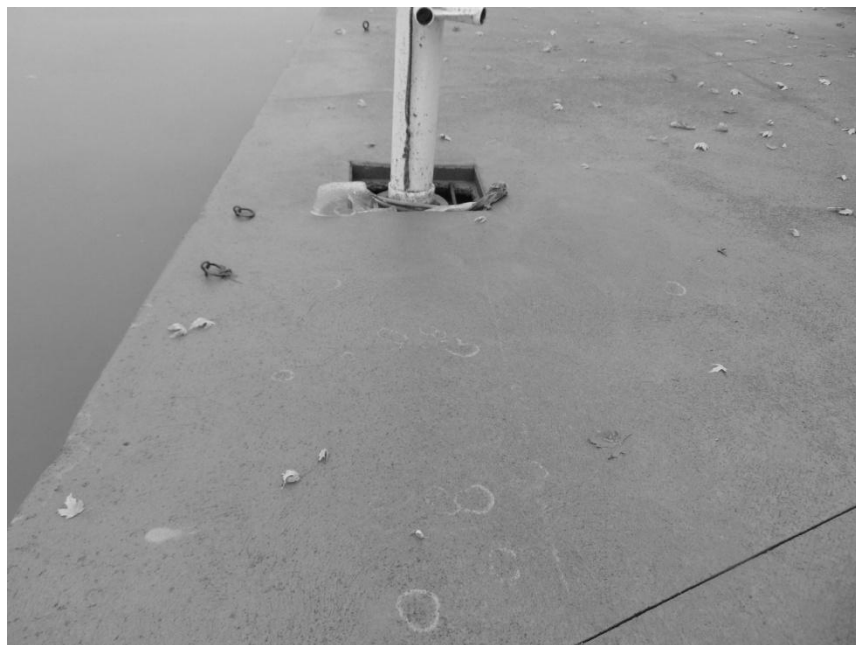
PHOTO # 95

0+650 looking east toward  
0+640 fair condition with  
surface cracking

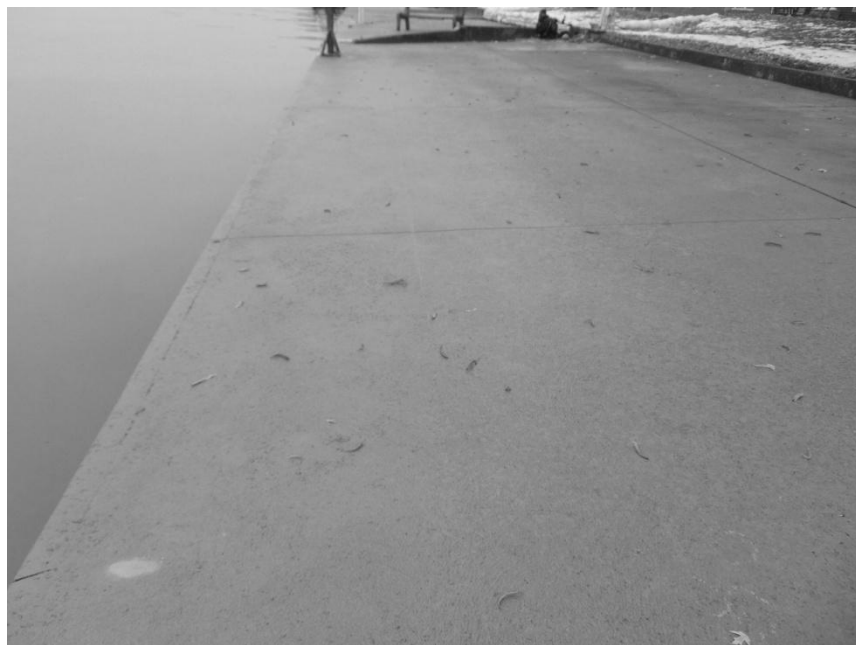
PHOTO # 97

0+670 looking east toward  
0+660 fair condition with  
surface cracking

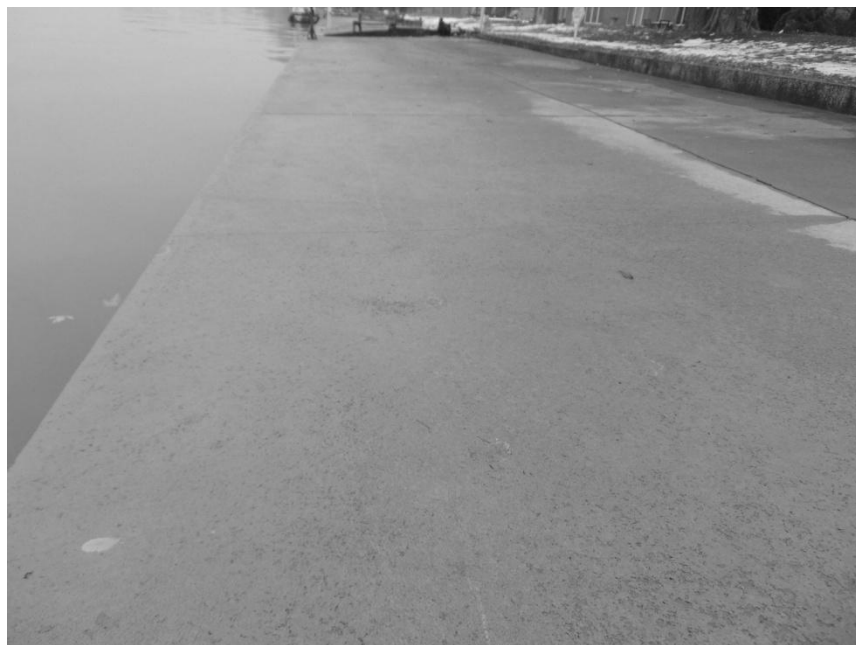
PHOTO # 98

0+680 looking east toward  
0+670 fair condition with  
surface cracking

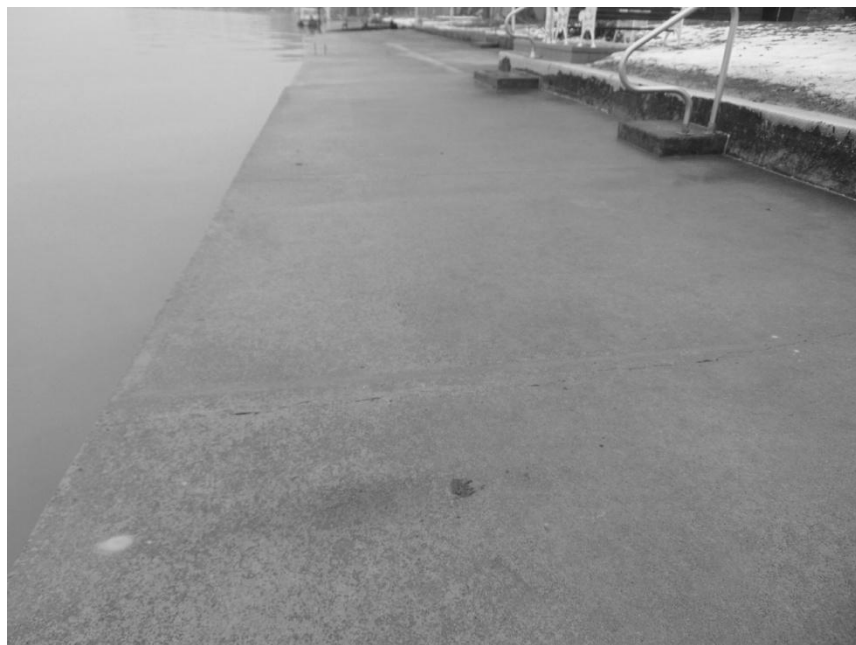
PHOTO # 100

0+700 looking east toward  
0+690 fair condition with  
surface cracking

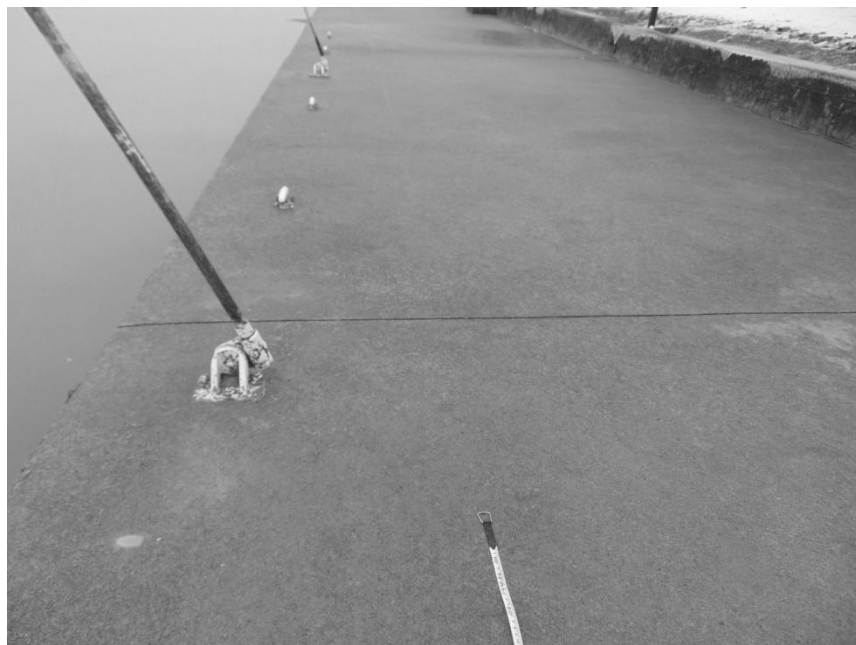
PHOTO # 101

0+710 looking east toward  
0+700 good condition

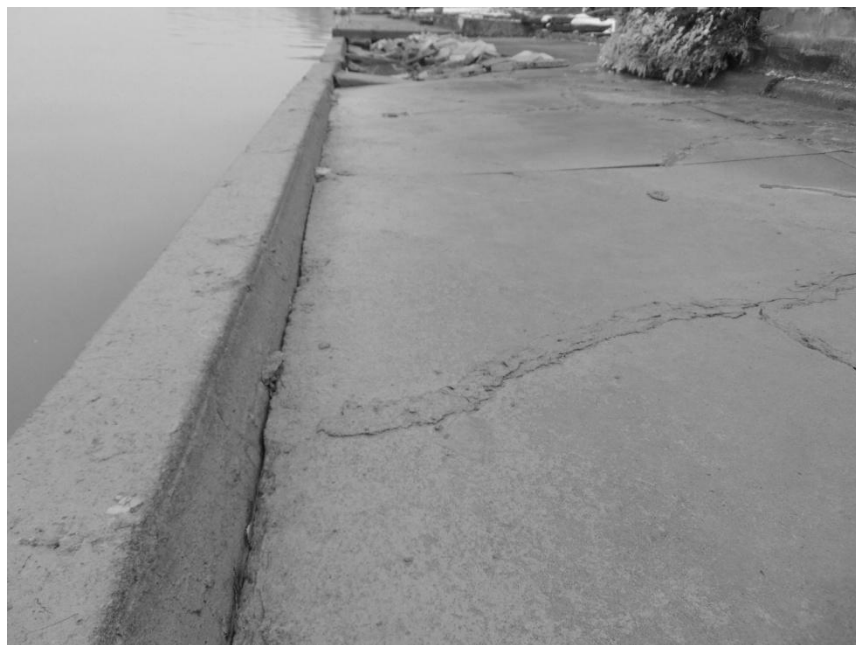
PHOTO # 104

0+740 looking east toward  
0+730 failed deck

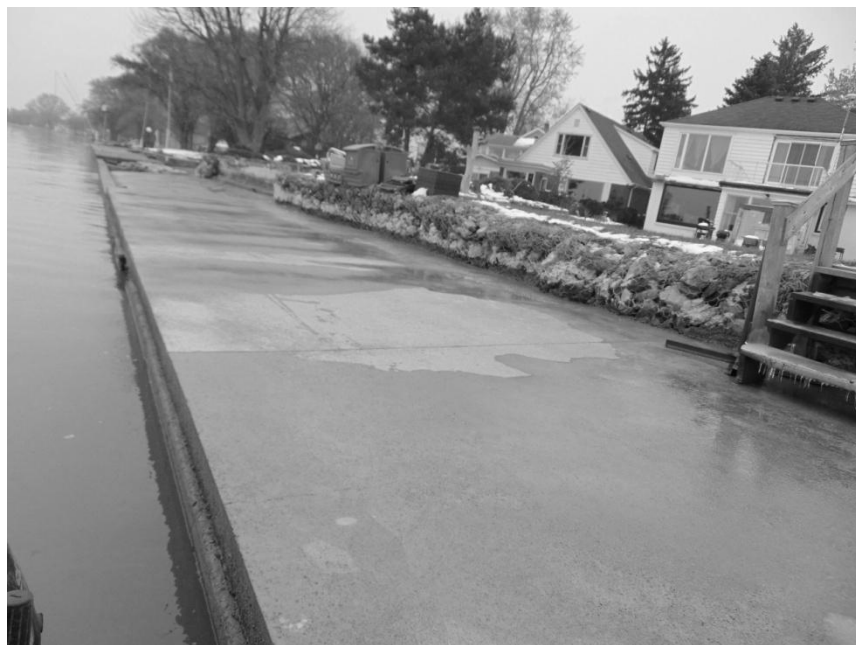
PHOTO # 106

0+760 looking east toward  
0+750 good condition

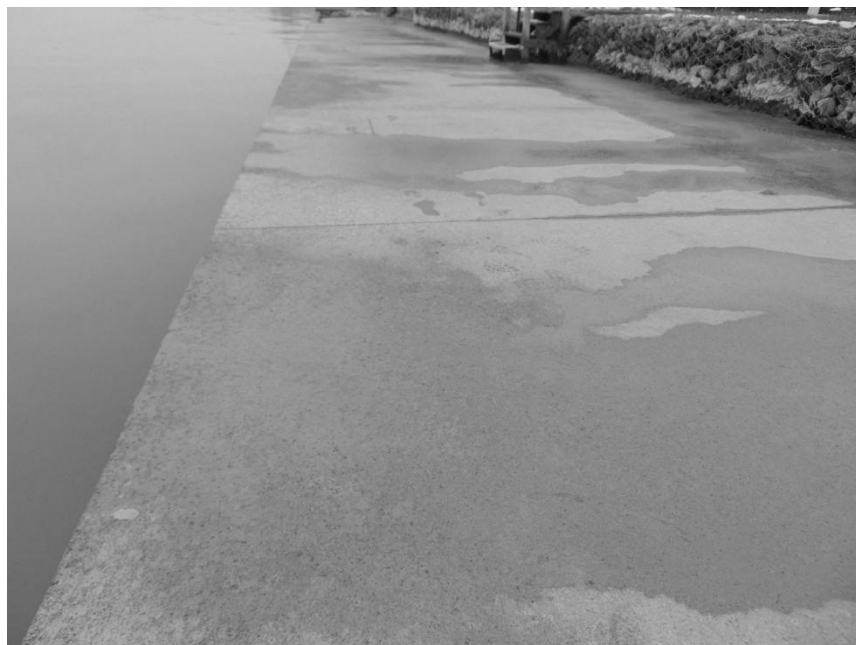
PHOTO # 107

0+770 looking east toward  
0+760 good condition

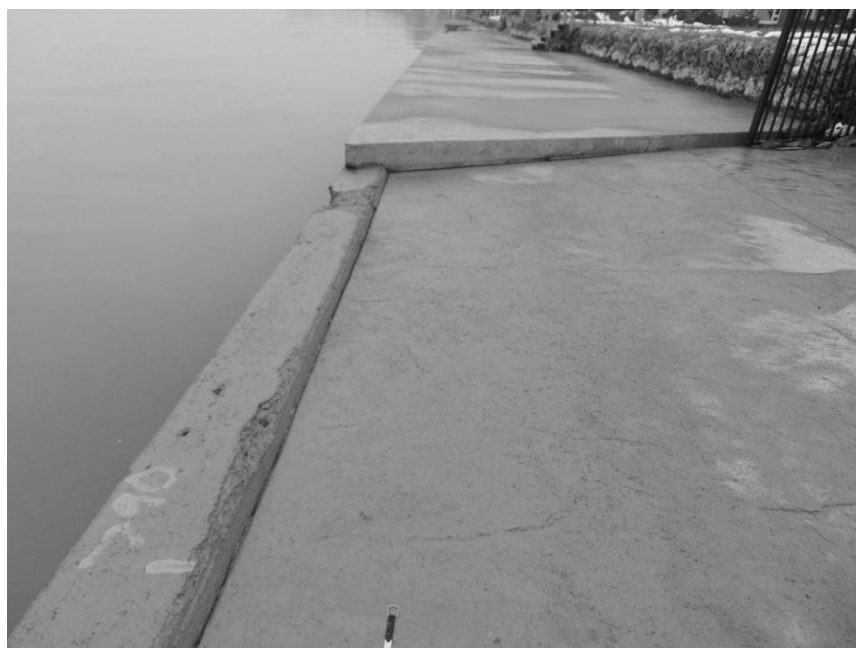
PHOTO # 108

0+780 looking east toward  
0+770 good condition

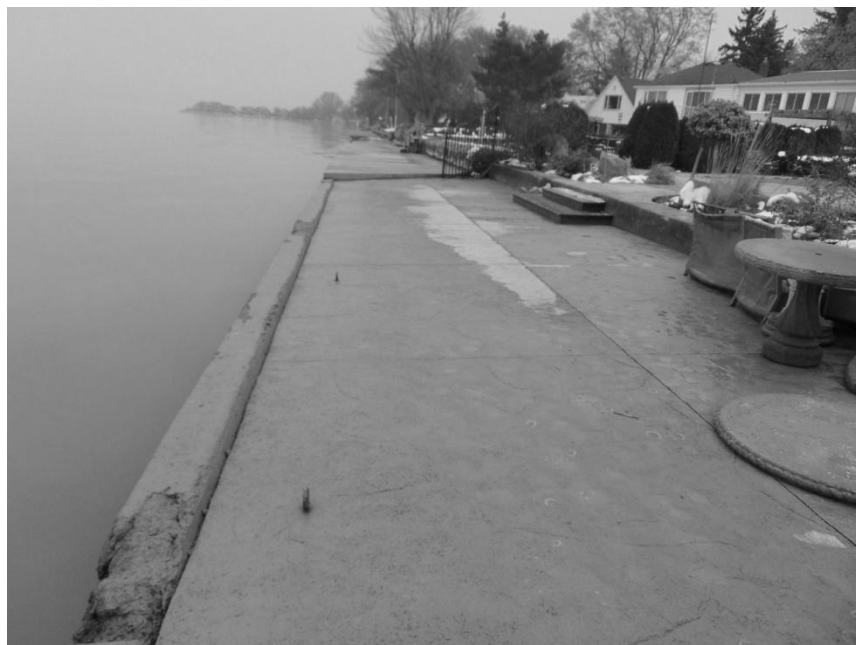
PHOTO # 109

0+790 looking east toward  
0+780 fair condition some  
surface cracks present
