### **UNDERWATER INSPECTION REPORT BY WATECH SERVICES INC.**

**UNDERWATER INSPECTION OF LAKE ST. CLAIR SEAWALL  
SEAWALL INSPECTION  
Windsor, Ontario**

**Prepared for:  
LANDMARK ENGINEERS Inc.**

**November 2019**

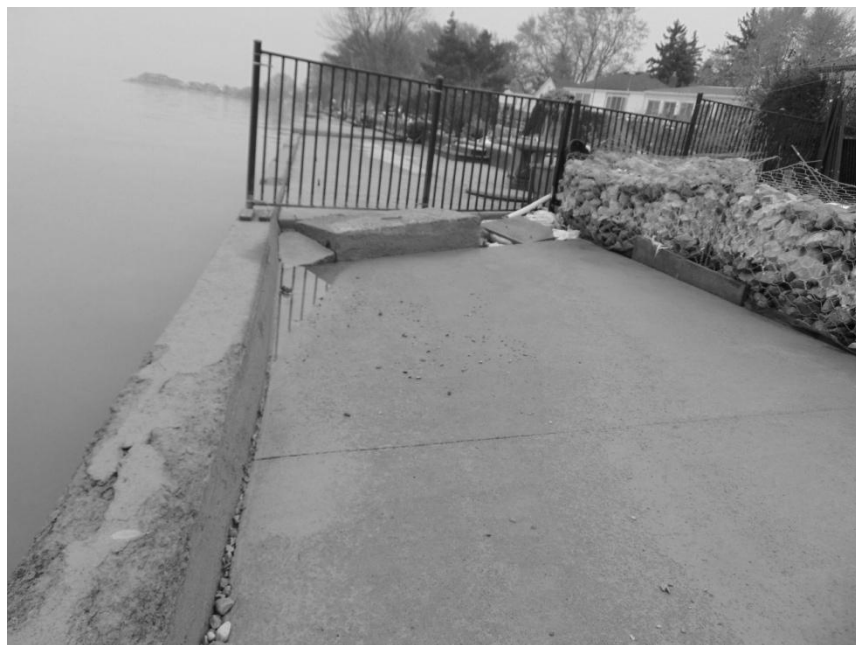
PHOTO # 110

0+800 looking east toward  
0+790 good condition

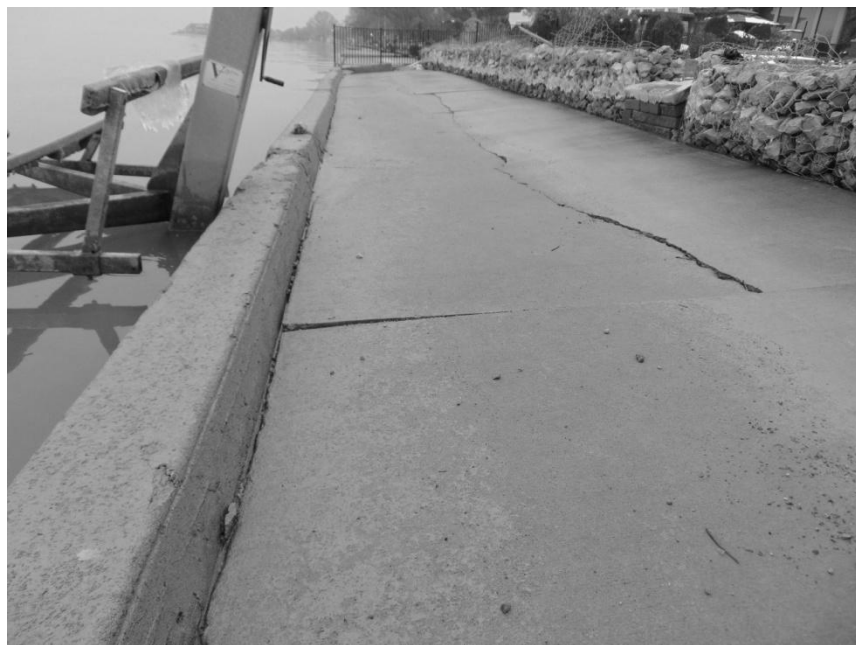
PHOTO # 112

0+820	Failed concrete deck in poor condition.

0+820 looking east toward  
0+810 poor condition deck  
failed

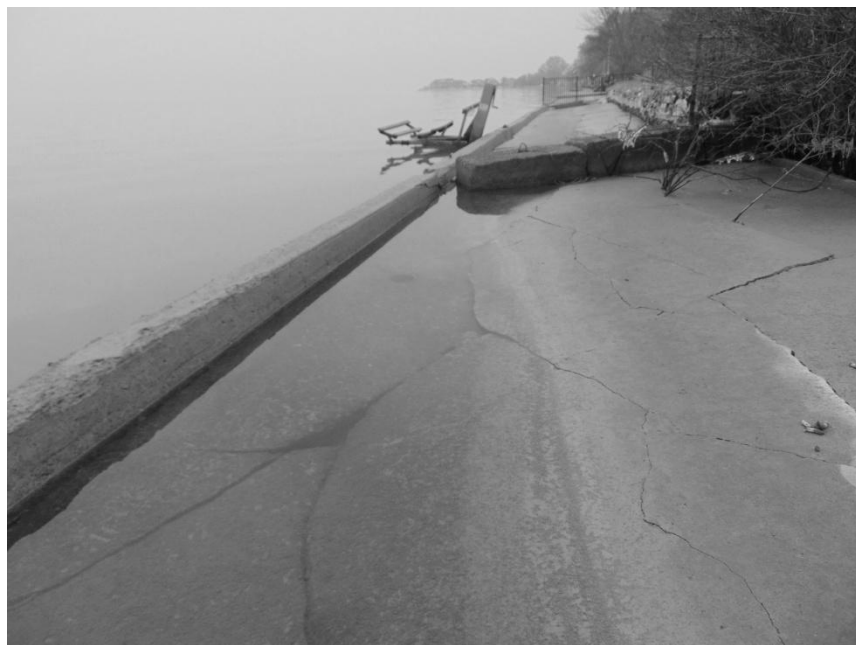
PHOTO # 113

0+830 looking east toward  
0+820 poor condition deck  
failed

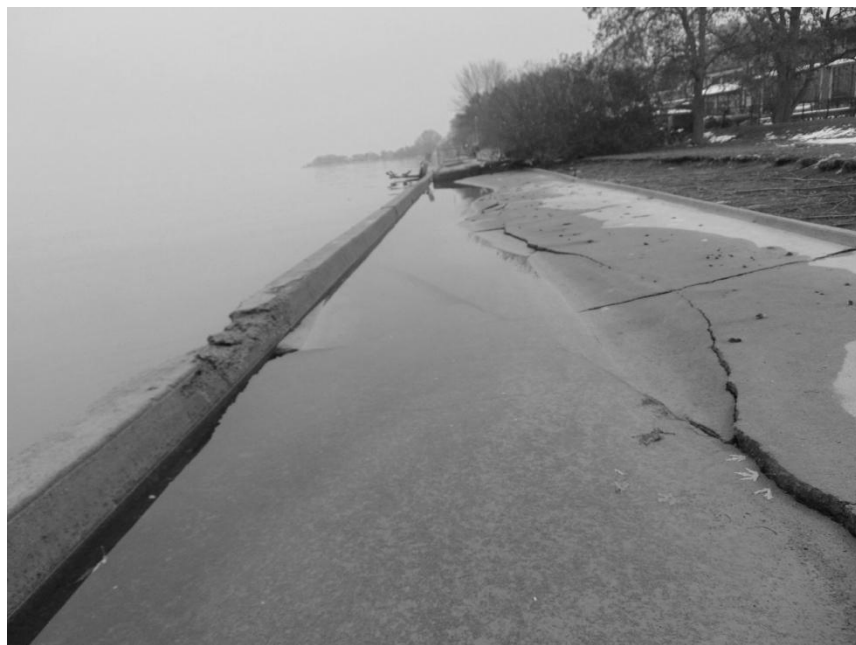
PHOTO # 115

0+850 looking east toward  
0+840 poor condition deck  
failed

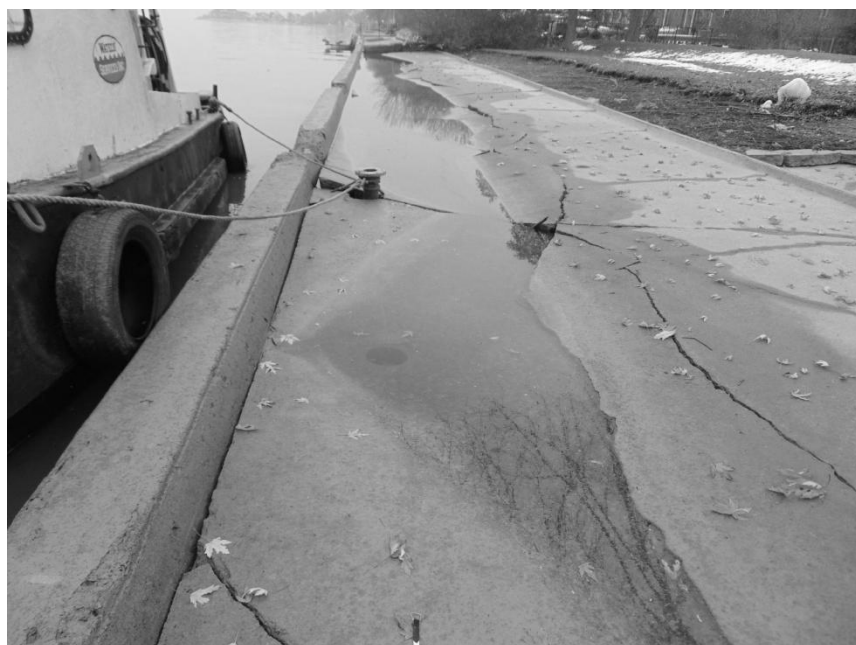
PHOTO # 116

0+860 looking east toward  
0+850 poor condition deck  
failed

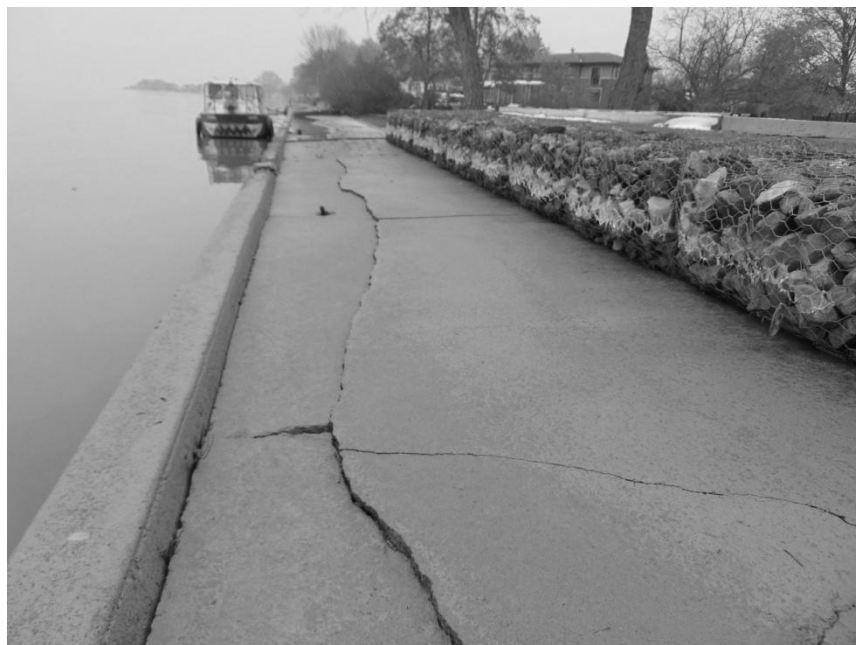
PHOTO # 118

0+880 looking east toward  
0+870 poor condition deck  
failed

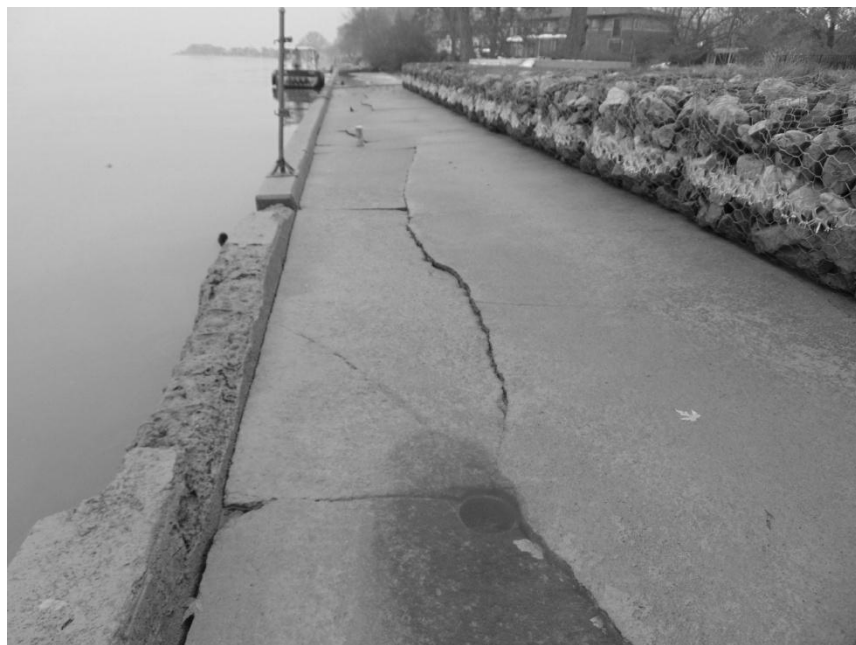
PHOTO # 119

0+890 looking east toward  
0+880 poor condition deck  
failed

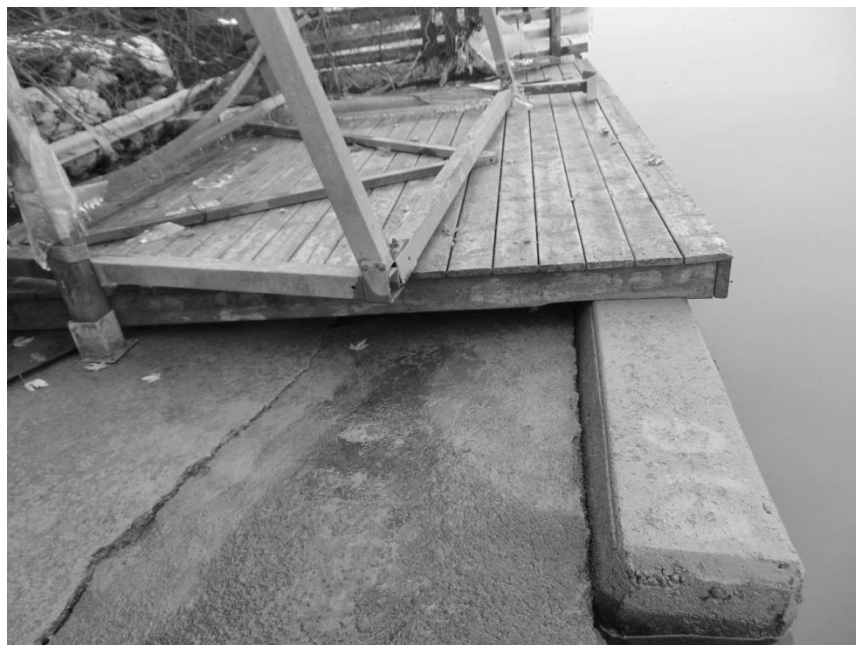
PHOTO # 122

0+910

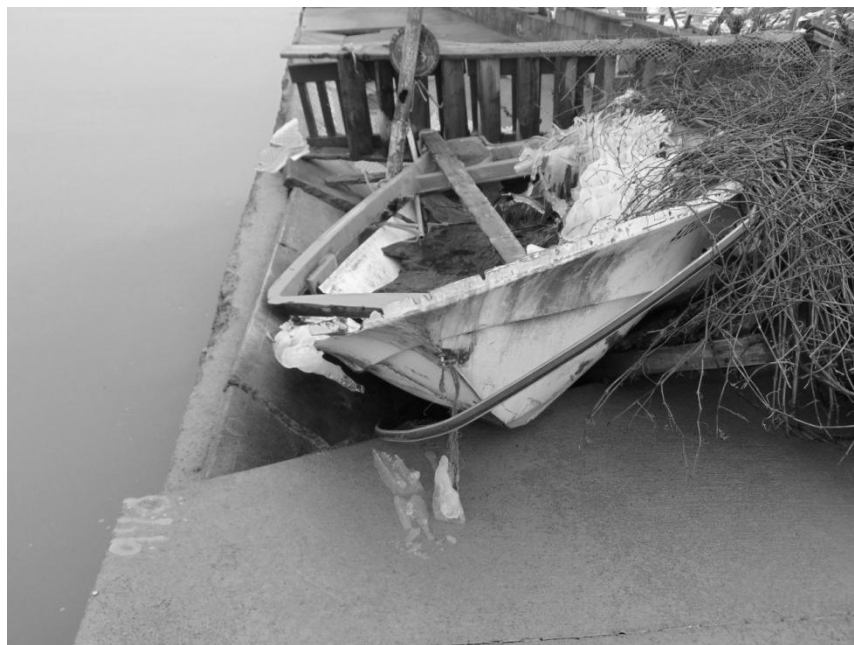
PHOTO # 125

0+935 looking east toward  
0+917 poor condition deck  
failed

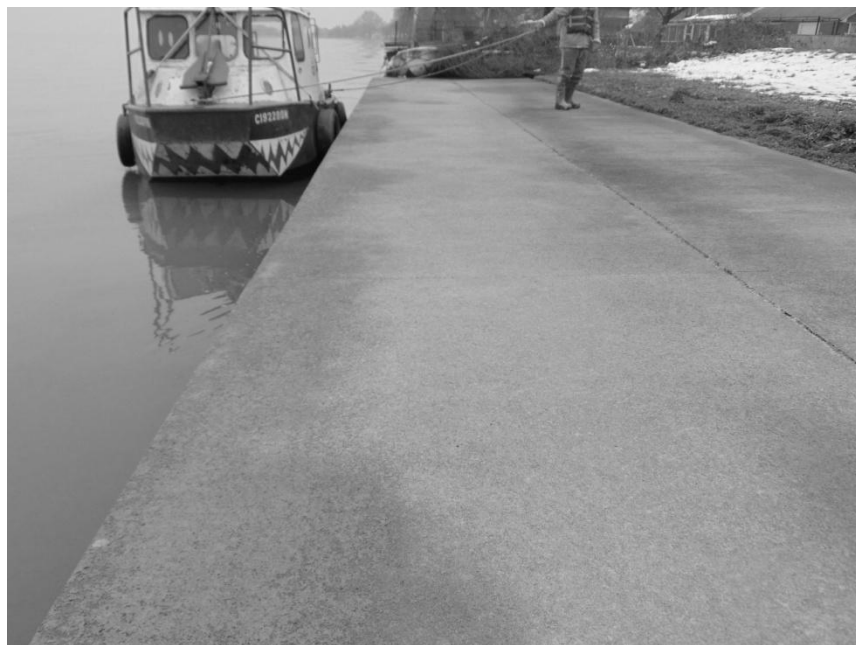
PHOTO # 127

0+950 looking east toward  
0+940 good condition

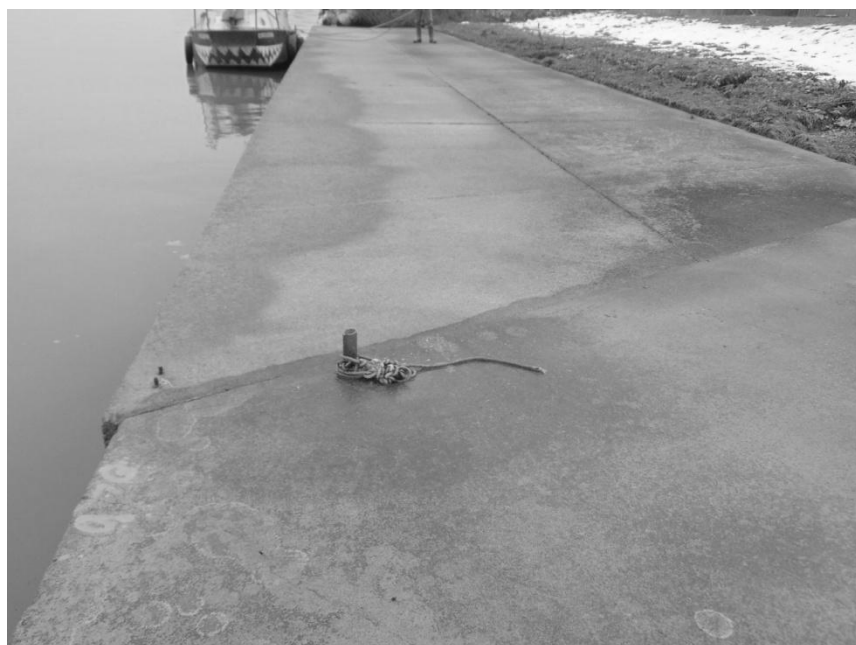
PHOTO # 128

0+960 looking east toward  
0+950 good condition

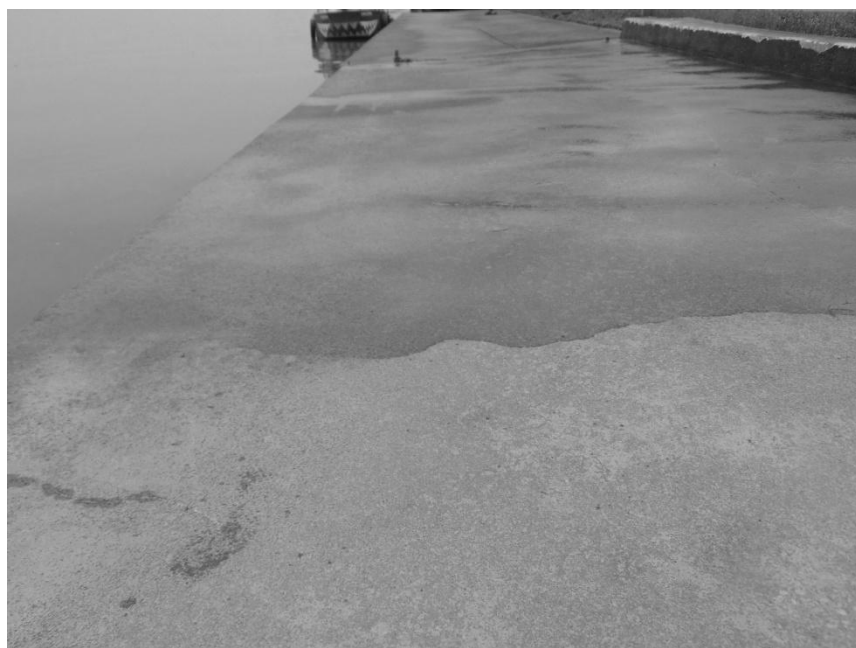
PHOTO # 129

0+970 looking east toward  
0+960 in good condition

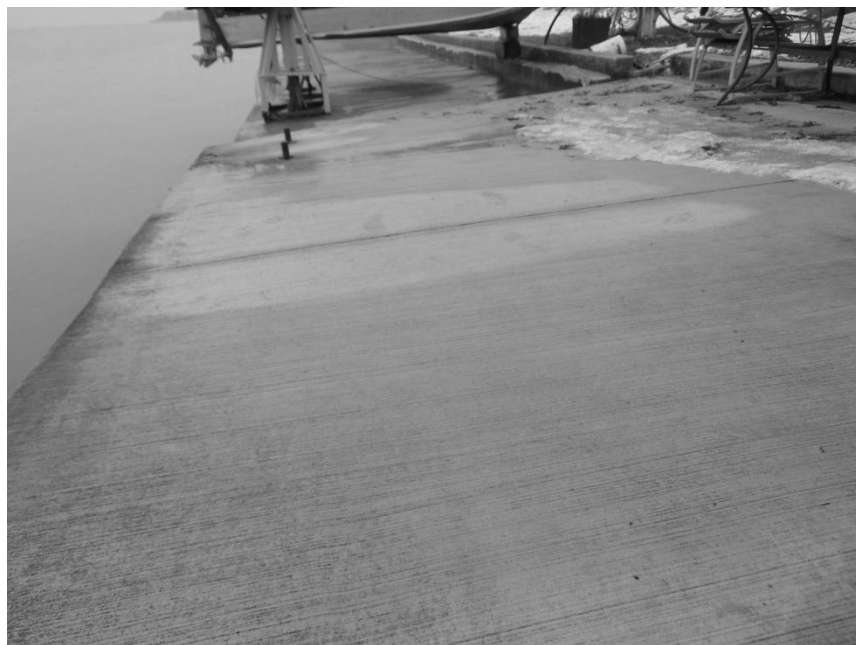
PHOTO # 130

0+980 looking east toward  
0+970 good condition

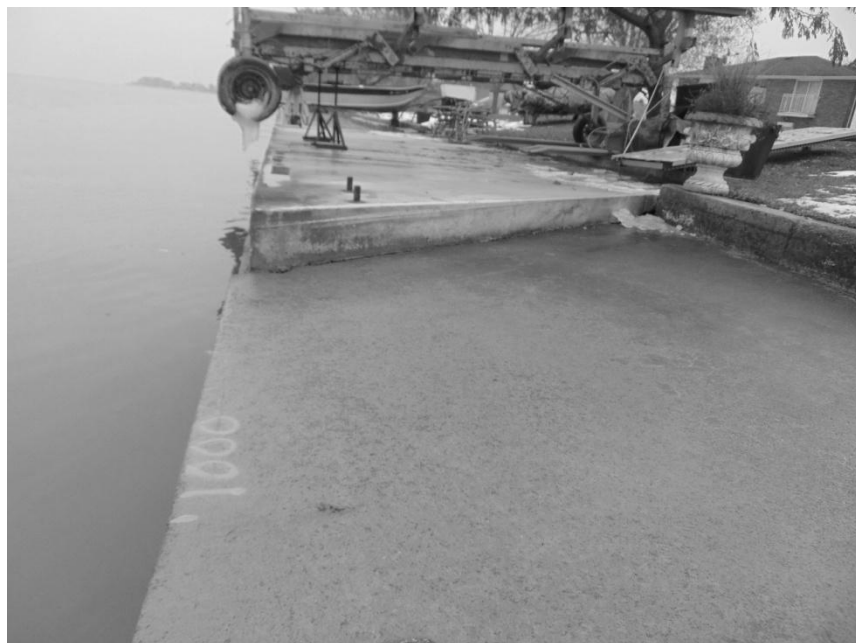
PHOTO # 131

0+990 looking east toward  
0+980 good condition

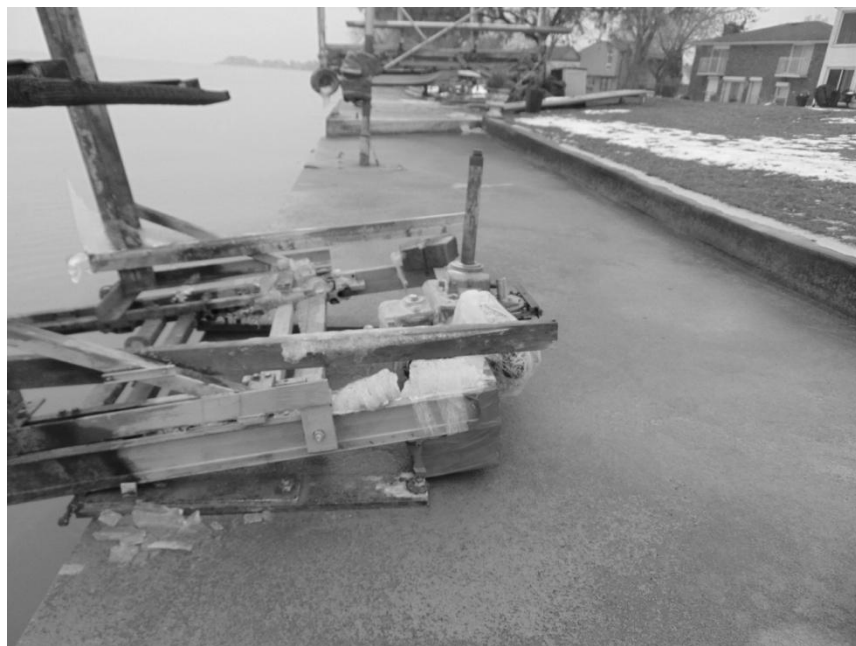
PHOTO # 132

1+010 looking east toward  
0+990 good condition

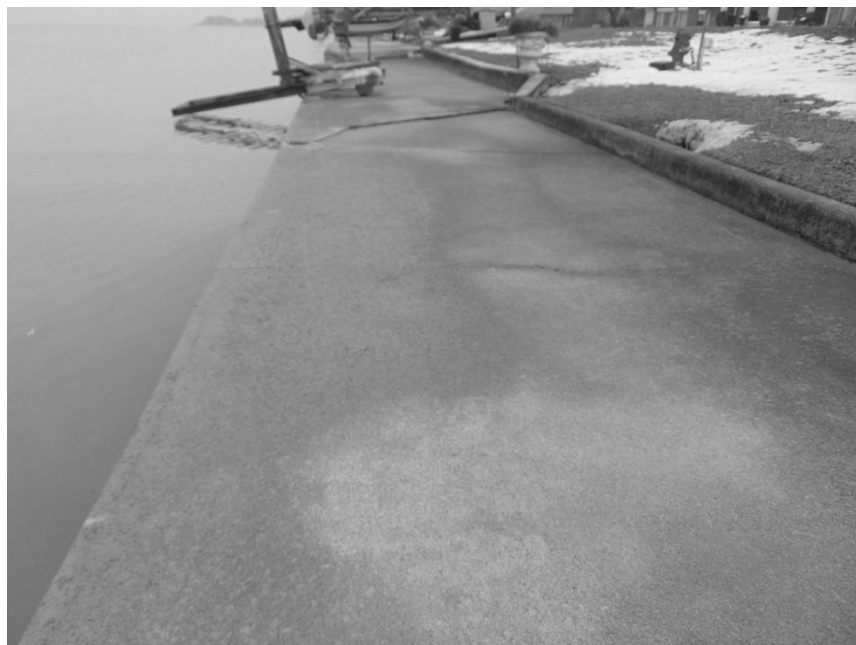
PHOTO # 133

1+020 looking east toward  
1+010 fair condition

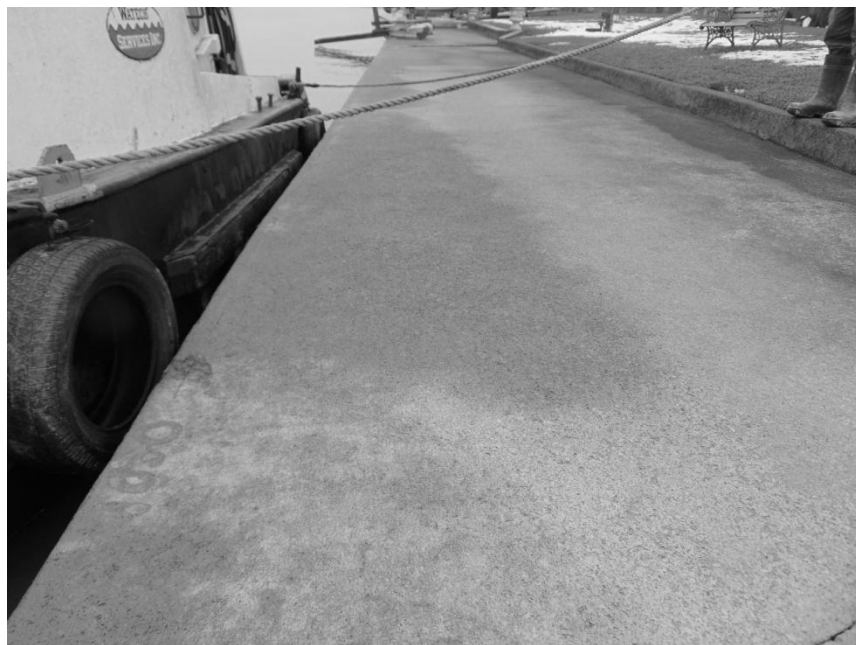
PHOTO # 134

1+030 looking east toward  
1+020 good condition

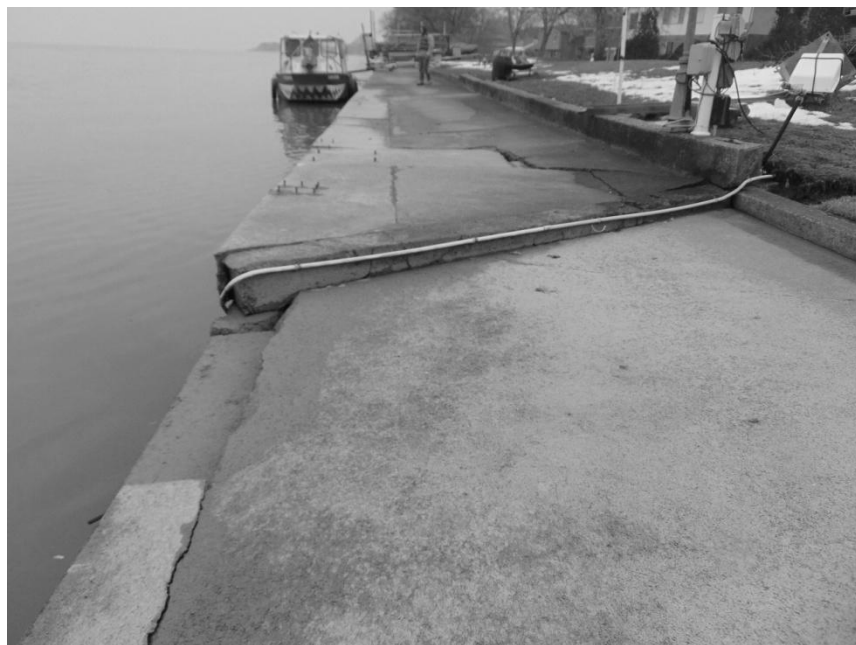
PHOTO # 136

1+050 looking east toward  
1+040 poor condition

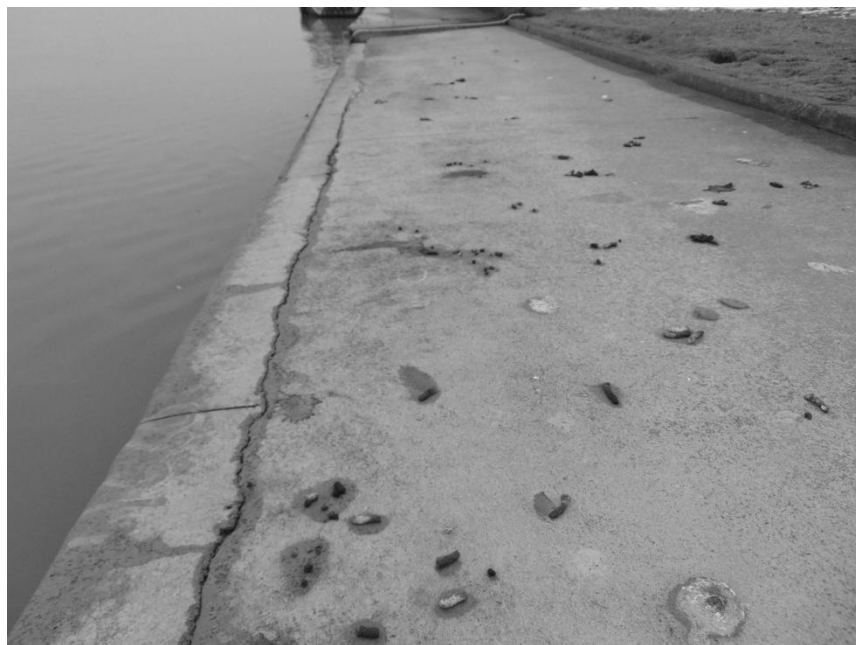
PHOTO # 137

1+060 looking east toward  
1+050 fair condition

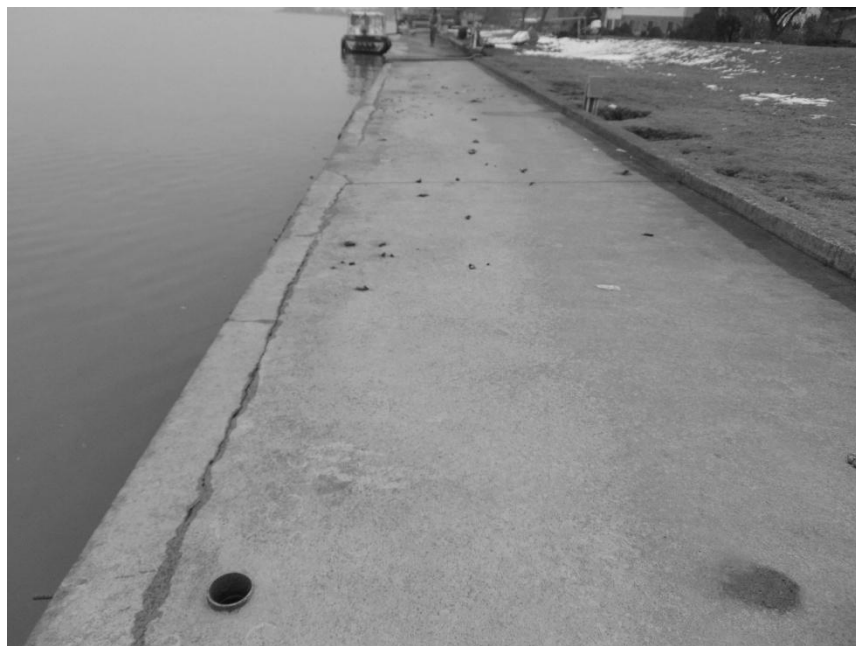
PHOTO # 138

1+070 looking east toward  
1+060 fair condition

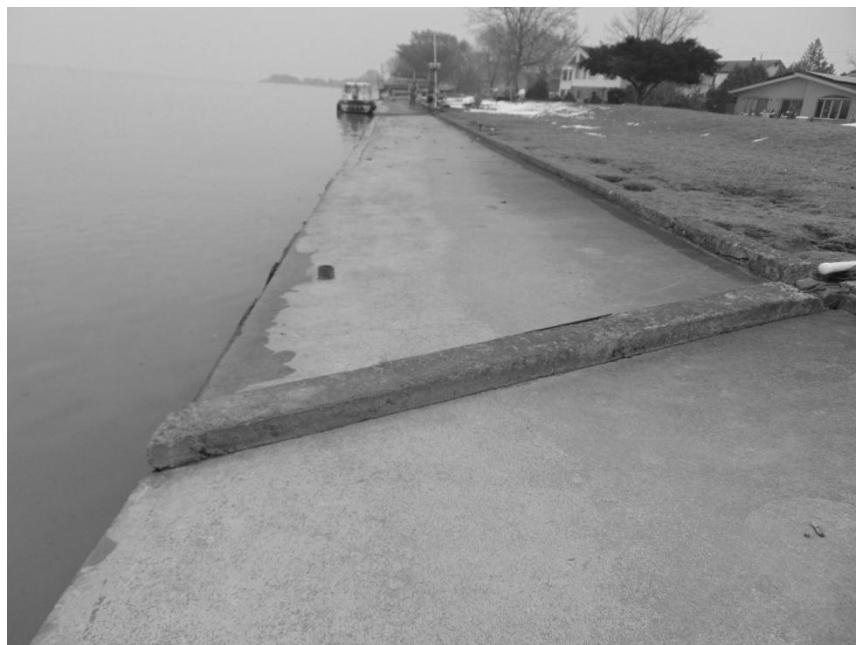
PHOTO # 139

1+080 looking east toward  
1+070 good condition

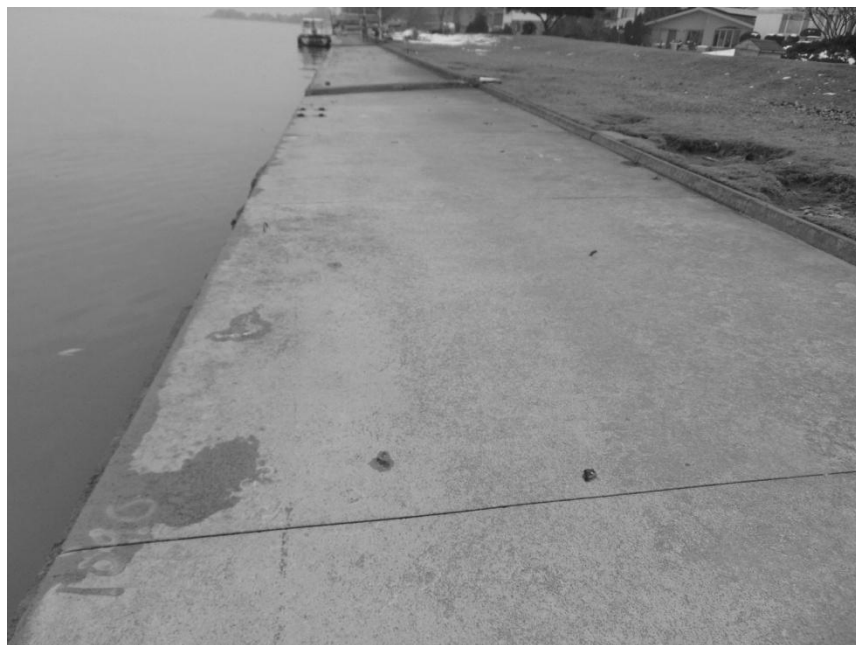
PHOTO # 140

1+090 looking east toward  
1+080 good condition

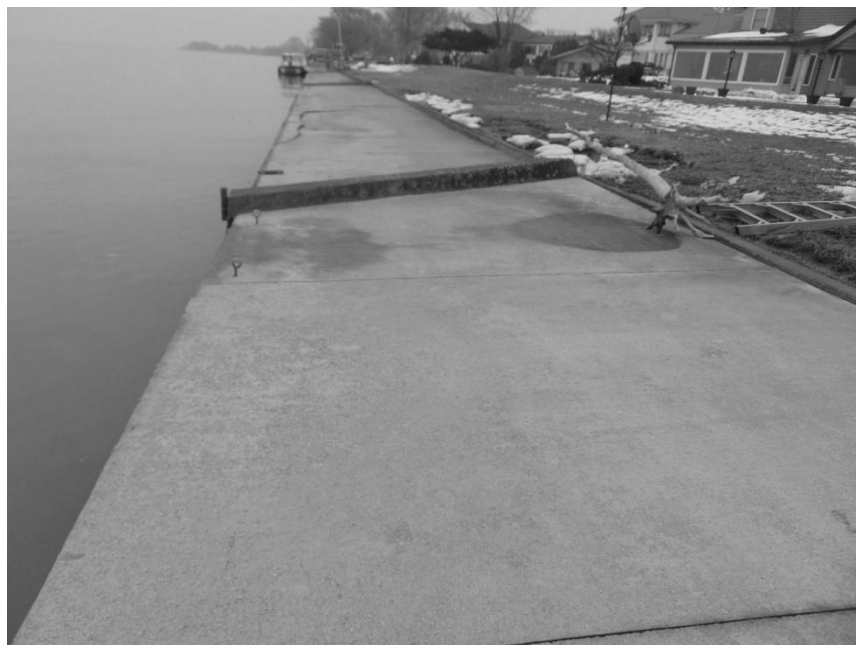
PHOTO # 142

1+110 looking east toward  
1+100 good condition

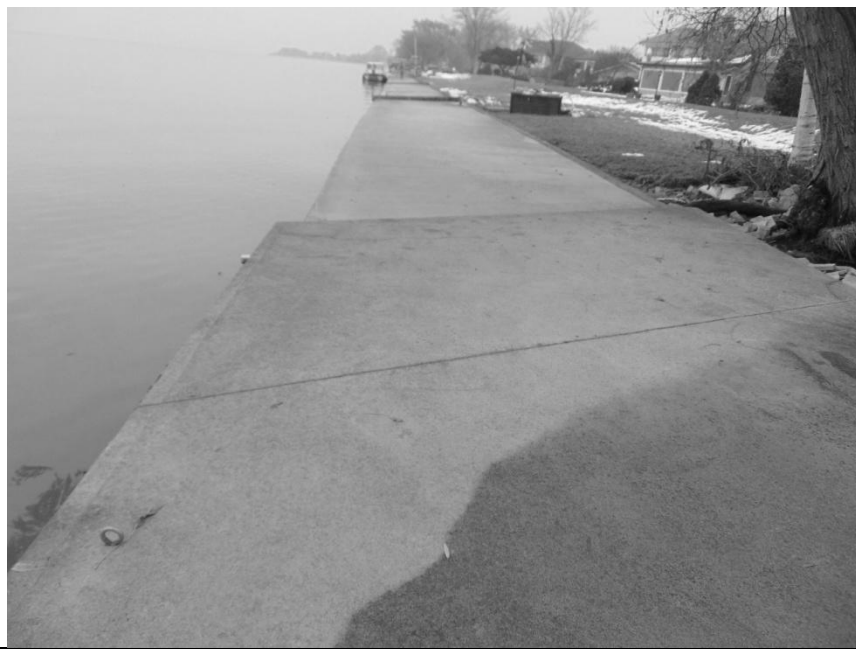
PHOTO # 144

1+130 looking east toward  
1+120 good condition

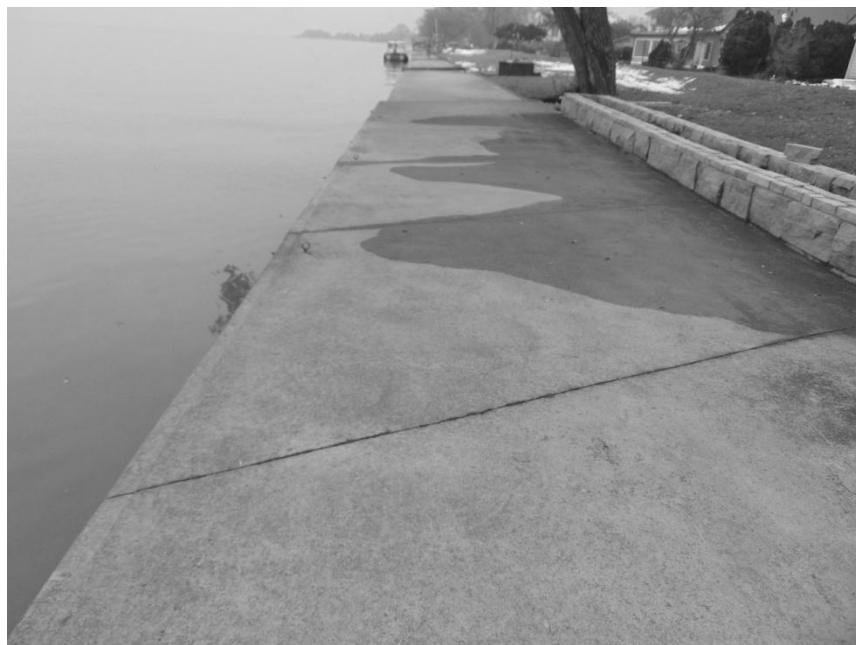
PHOTO # 145

1+140 looking east toward  
1+130 good condition

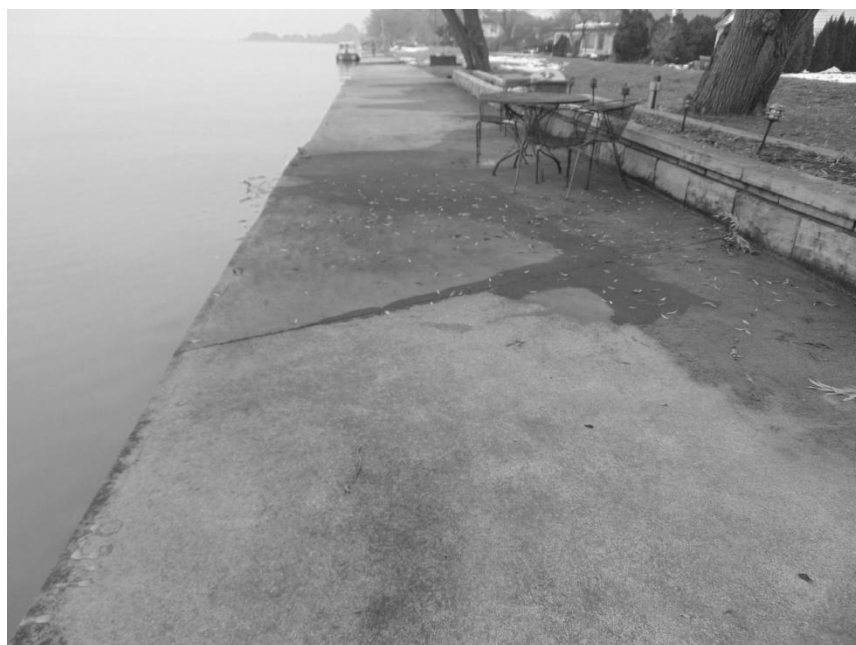
PHOTO # 146

1+150 looking east toward  
1+140 good condition

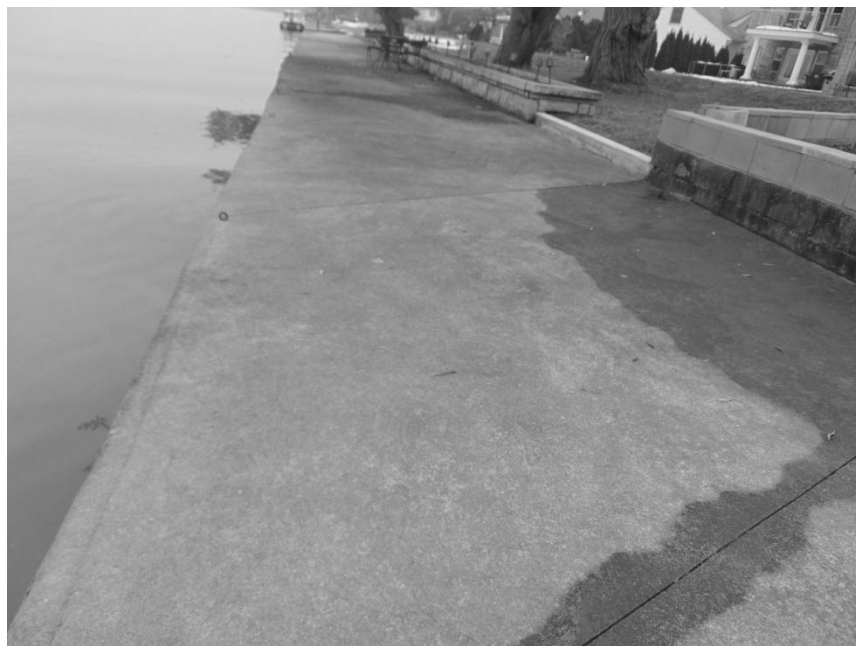
PHOTO # 147

1+160 looking east toward  
1+150 good condition

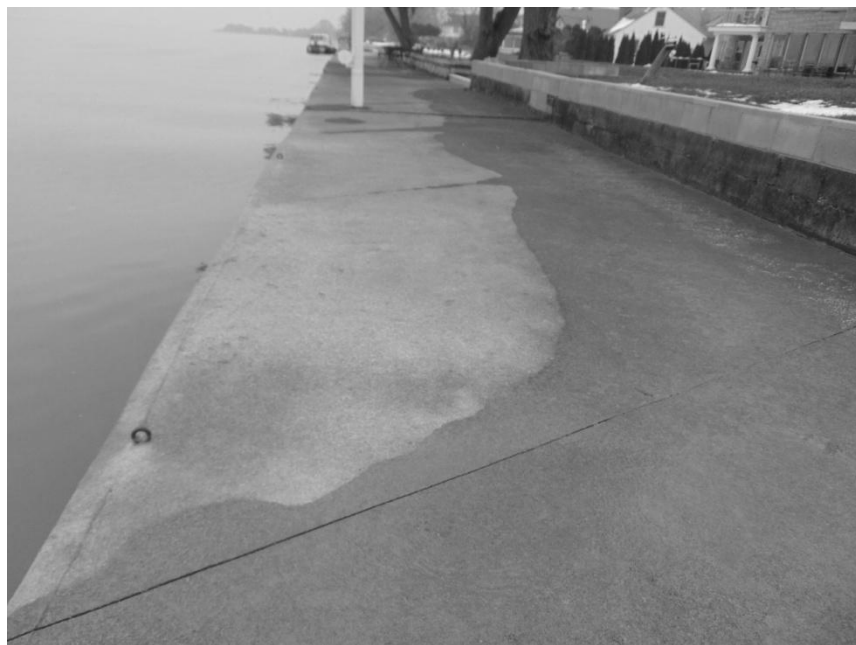
PHOTO # 148

1+170 looking east toward  
1+160 good condition

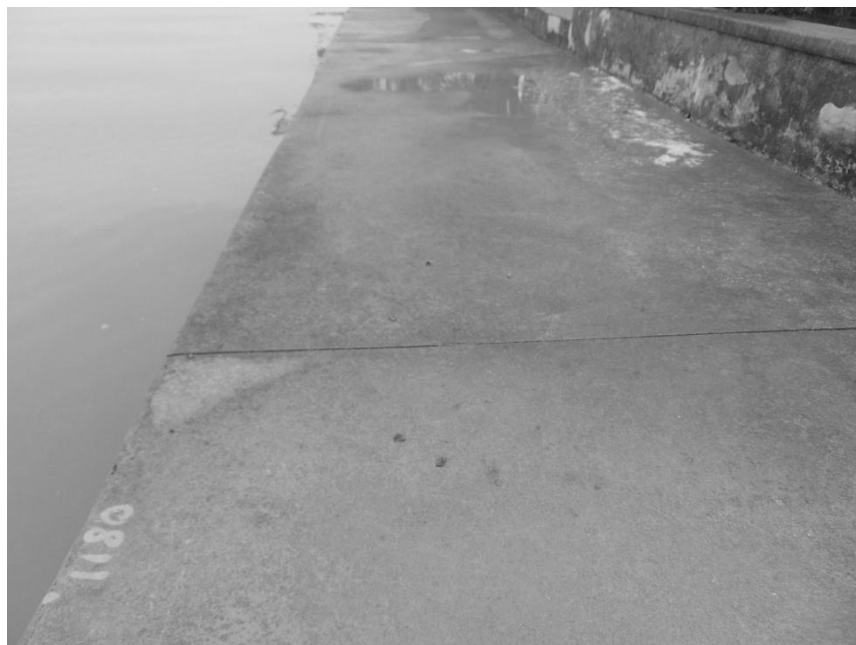
PHOTO # 149

1+180 looking east toward  
1+170 good condition

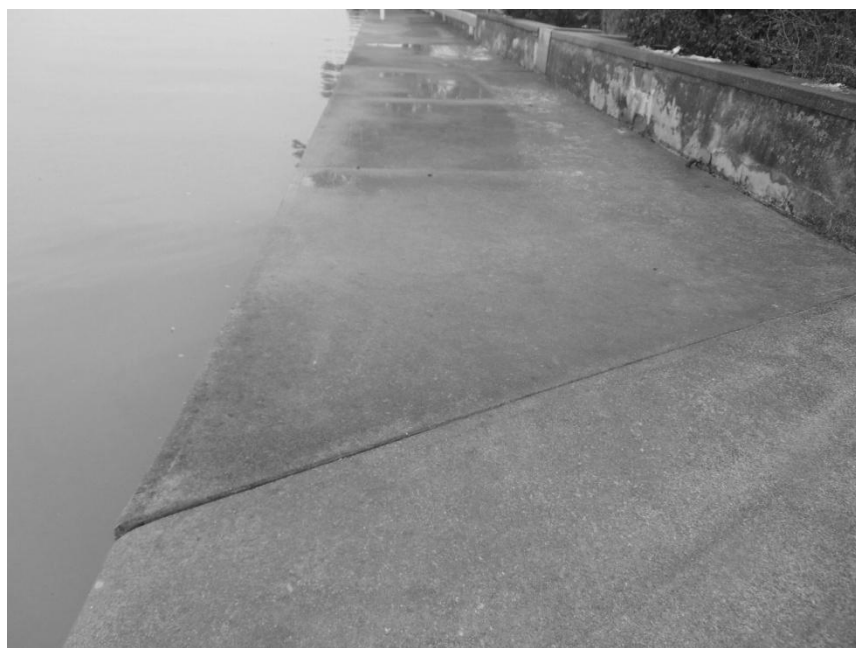
PHOTO # 150

1+190 looking east toward  
1+180 good condition

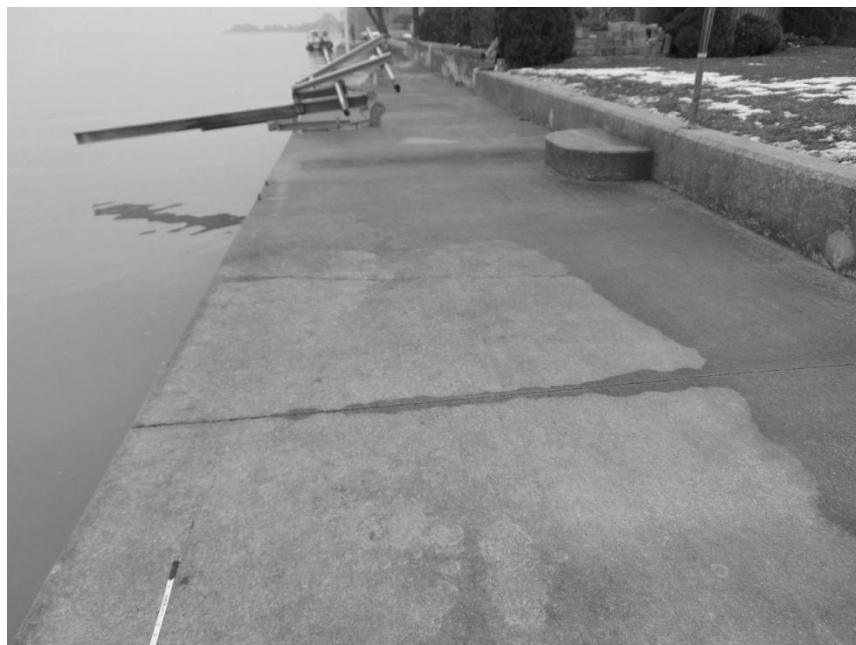
PHOTO # 151

1+200 looking east toward  
1+190 good condition

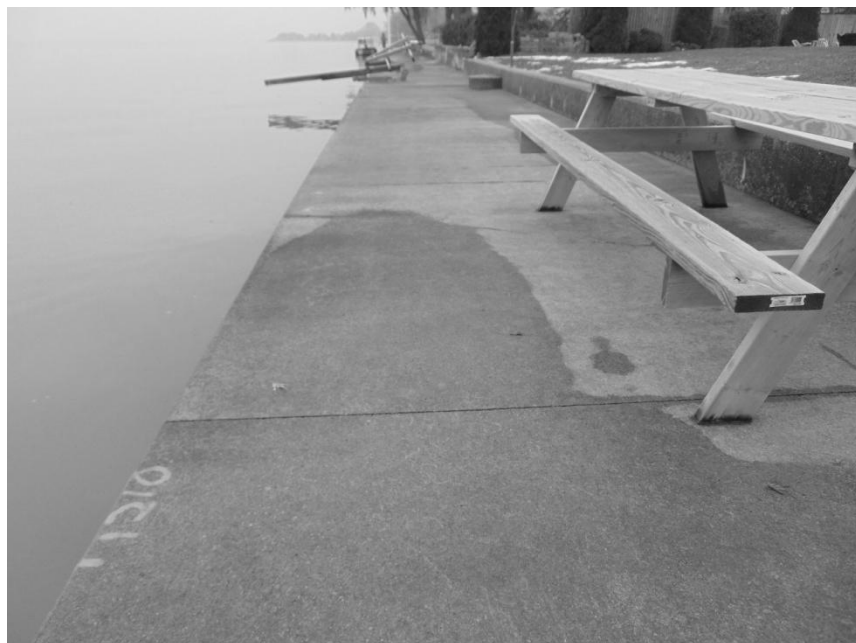
PHOTO # 152

1+210 looking east toward  
1+200 good condition

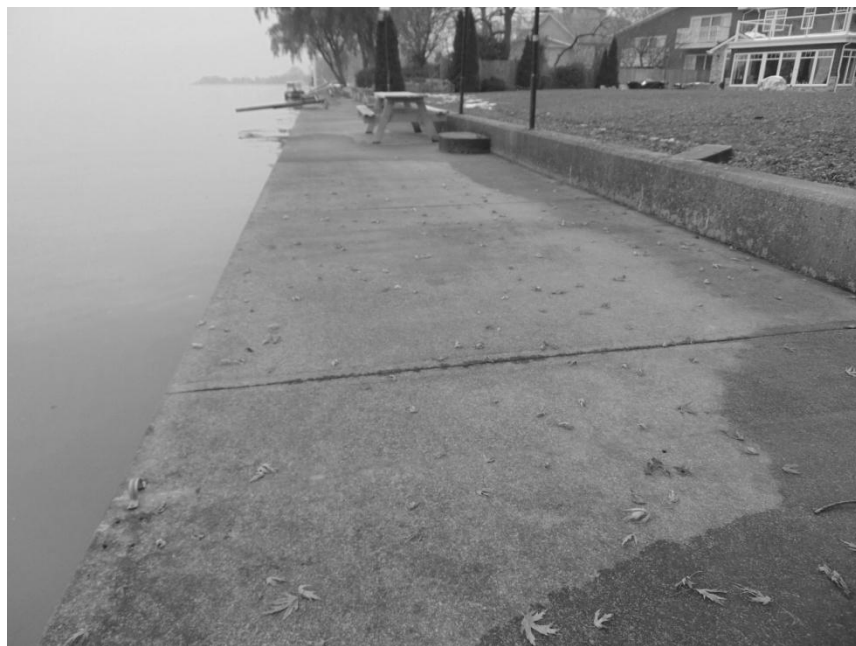
PHOTO # 153

1+220 looking east toward  
1+210 good condition

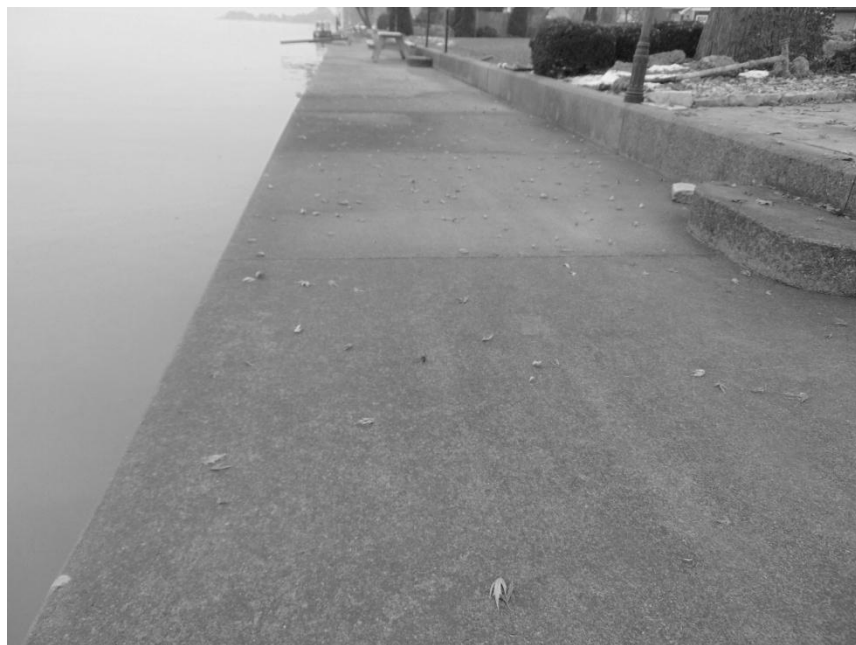
PHOTO # 154

1+230 looking east toward  
1+220 good condition

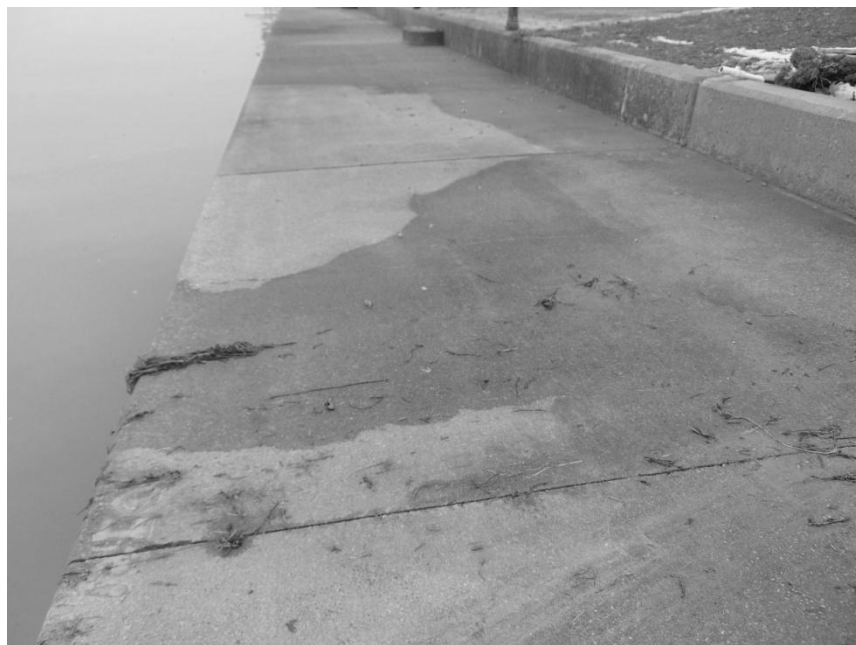
PHOTO # 155

1+240 looking east toward  
1+230 good condition

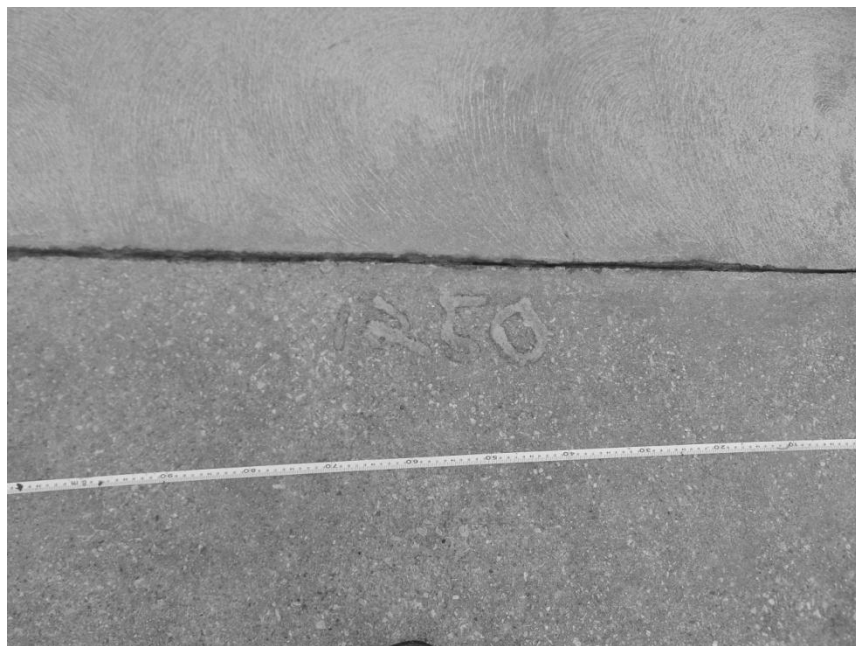
PHOTO # 156

1+250 looking east toward  
1+240 good condition

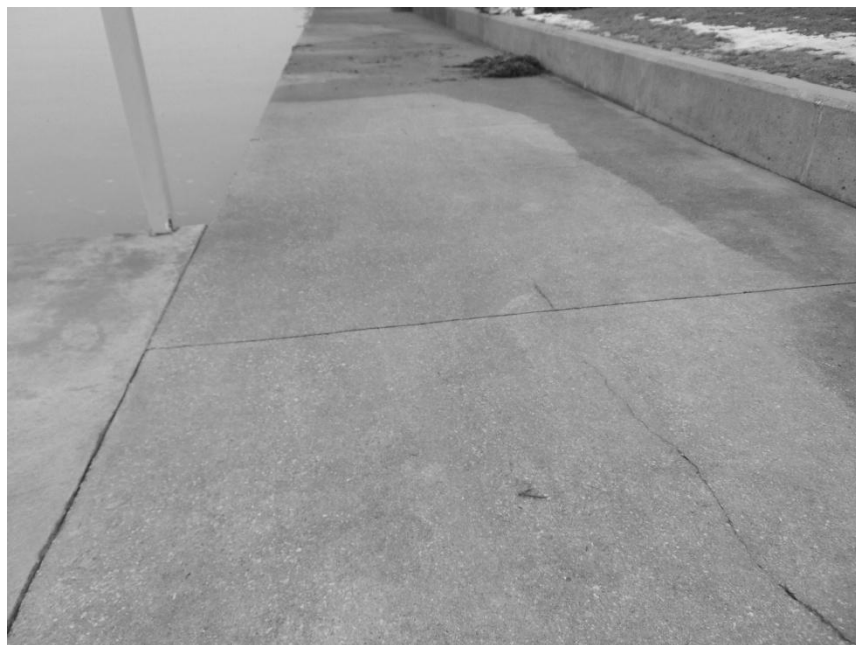
PHOTO # 157

1+250

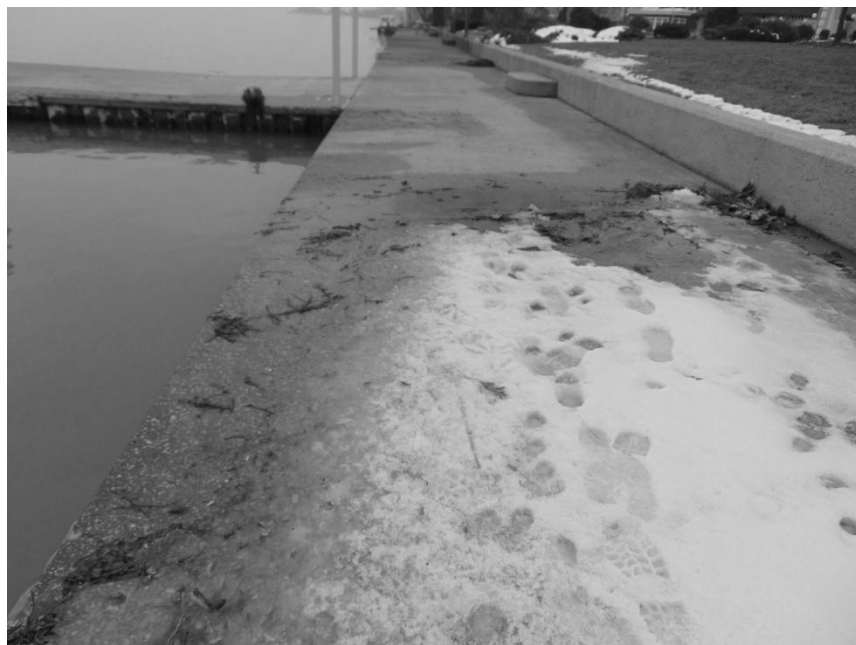
PHOTO # 158

1+250 looking east toward  
1+240 good condition

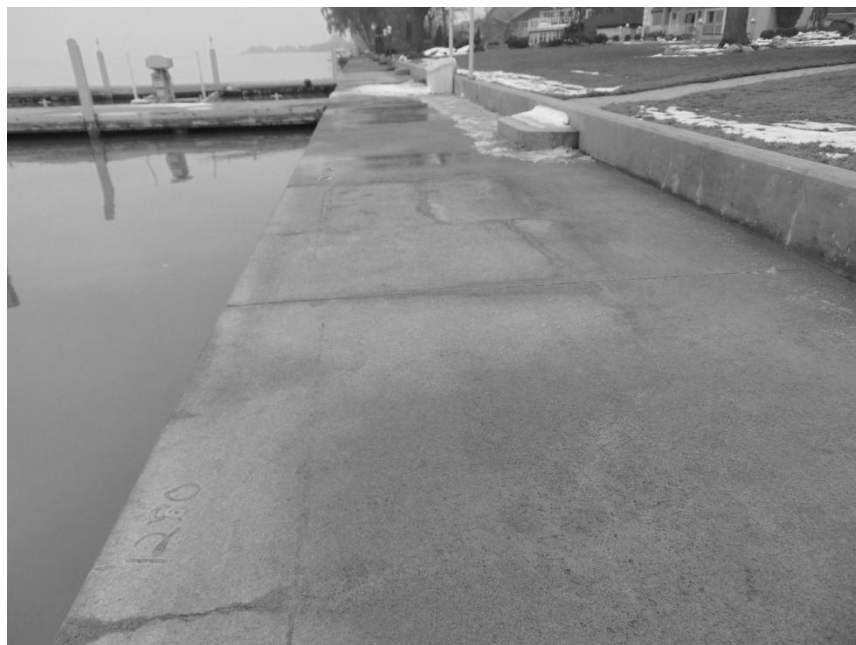
PHOTO # 160

1+270 looking east toward  
1+260 good condition

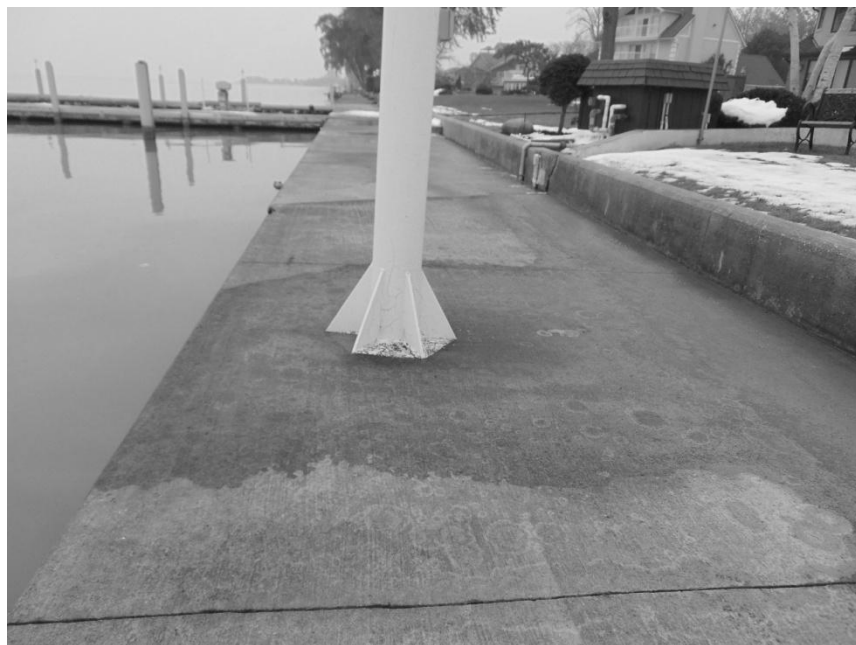
PHOTO # 161

1+280 looking east toward  
1+270 good condition
