### **UNDERWATER INSPECTION REPORT BY WATECH SERVICES INC.**

**UNDERWATER INSPECTION OF LAKE ST. CLAIR SEAWALL  
SEAWALL INSPECTION  
Windsor, Ontario**

**Prepared for:  
LANDMARK ENGINEERS Inc.**

**November 2019**

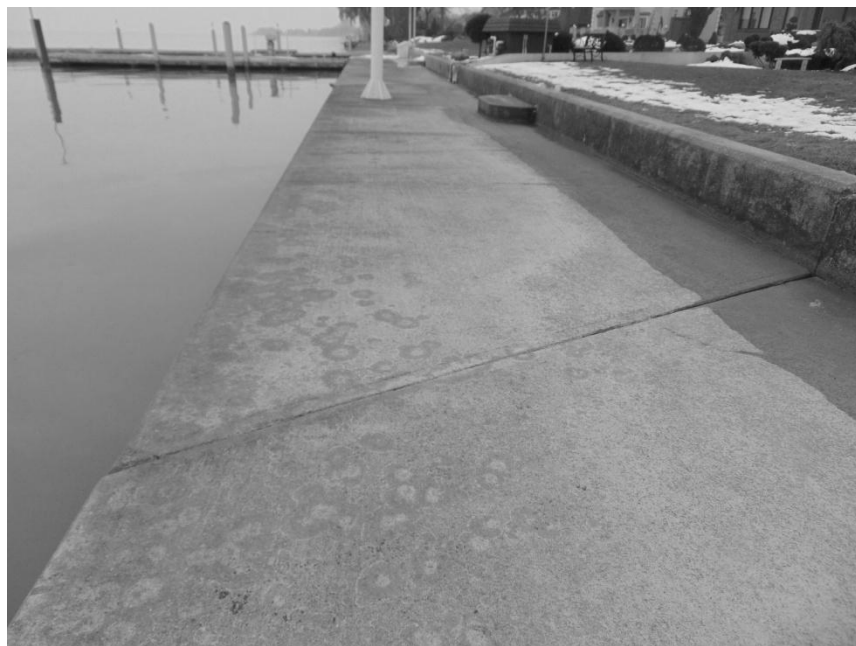
PHOTO # 162

1+290 looking east toward  
1+280 good condition

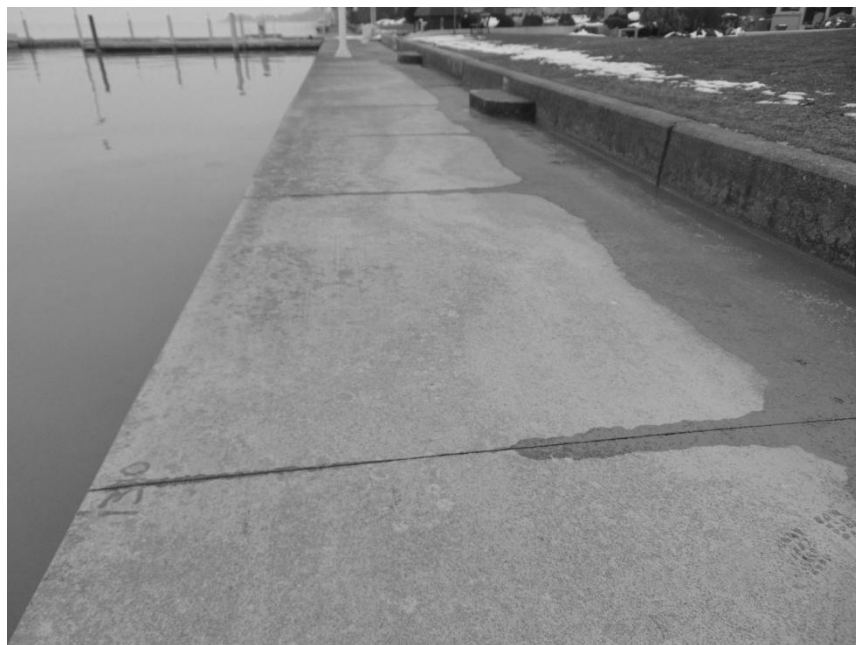
PHOTO # 163

1+300 looking east toward  
1+290 good condition

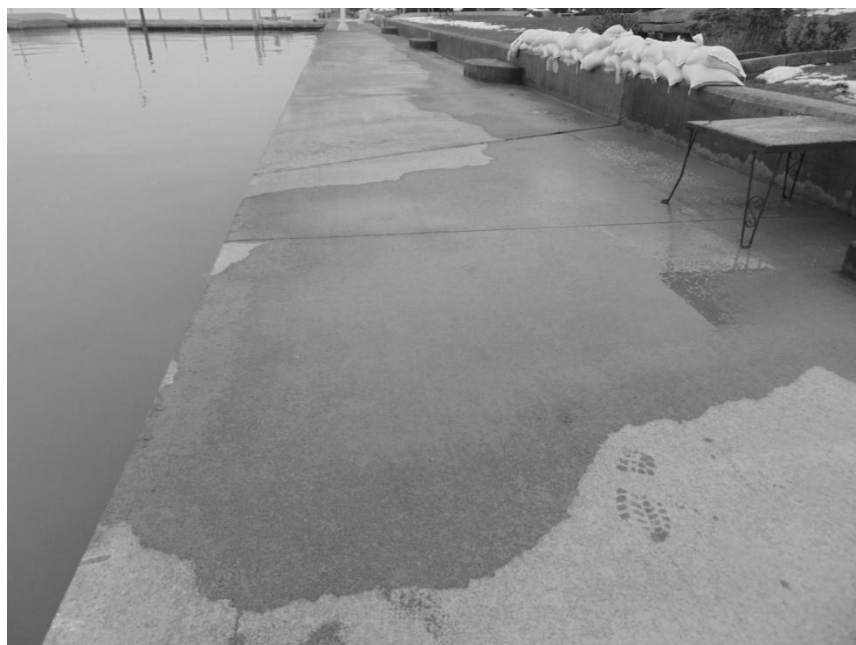
PHOTO # 164

1+310 looking east toward  
1+300 good condition

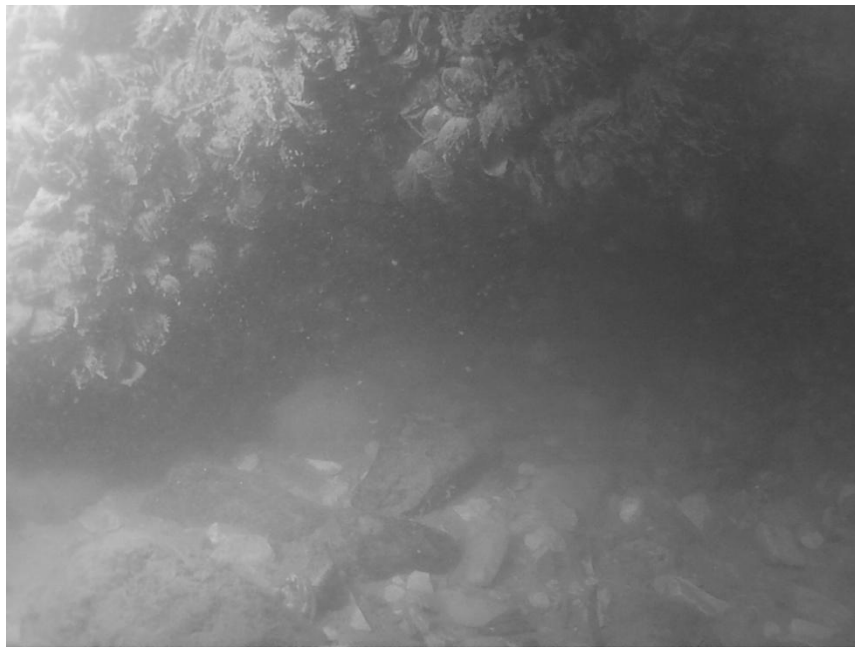
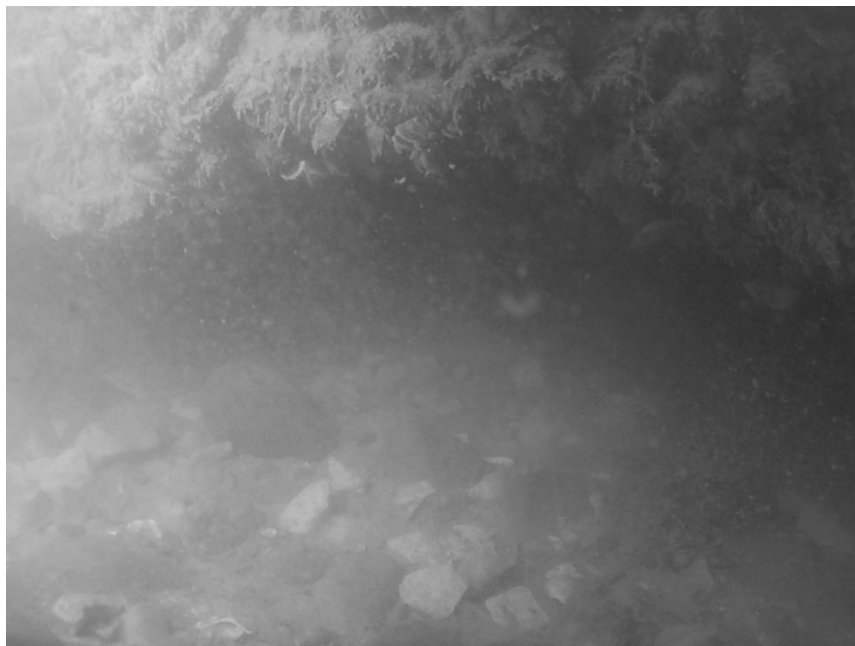
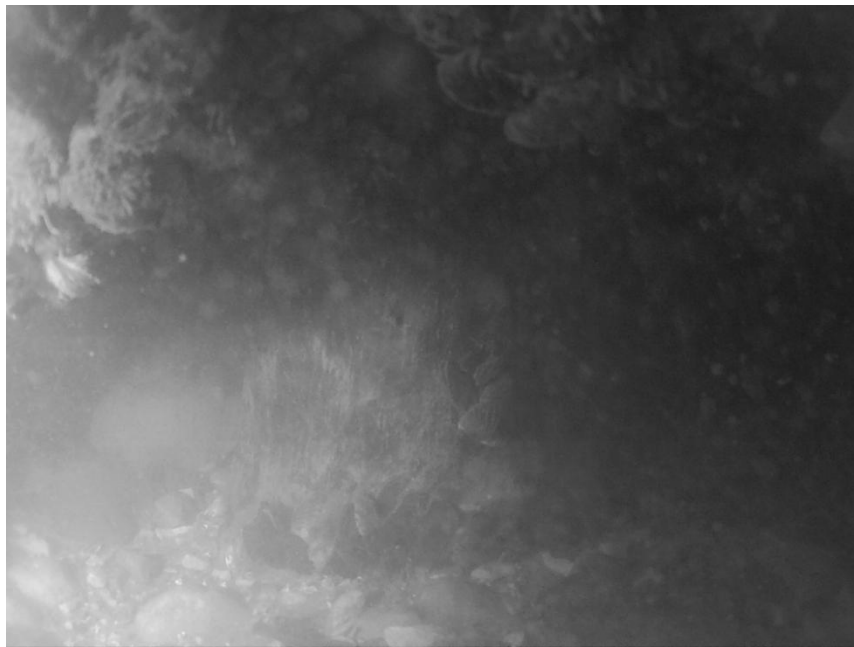
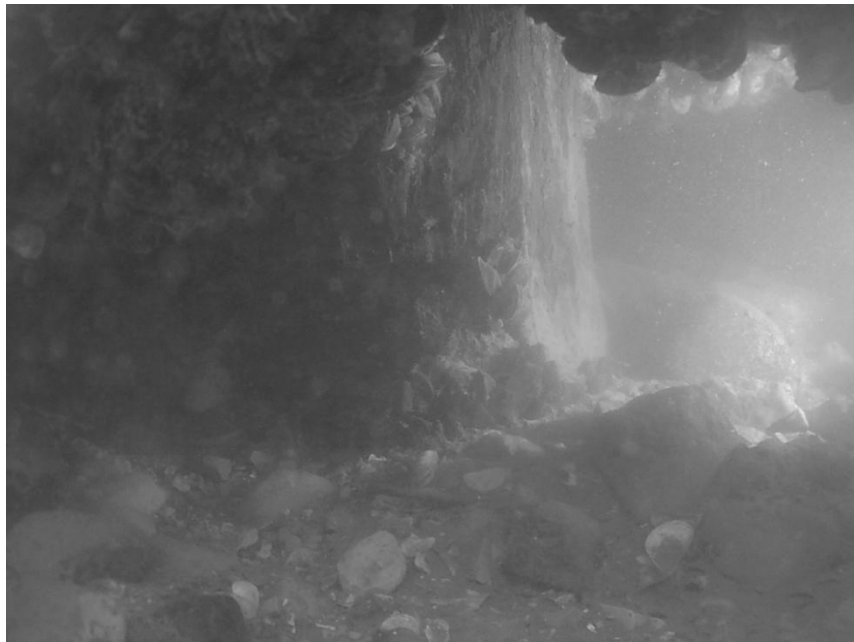
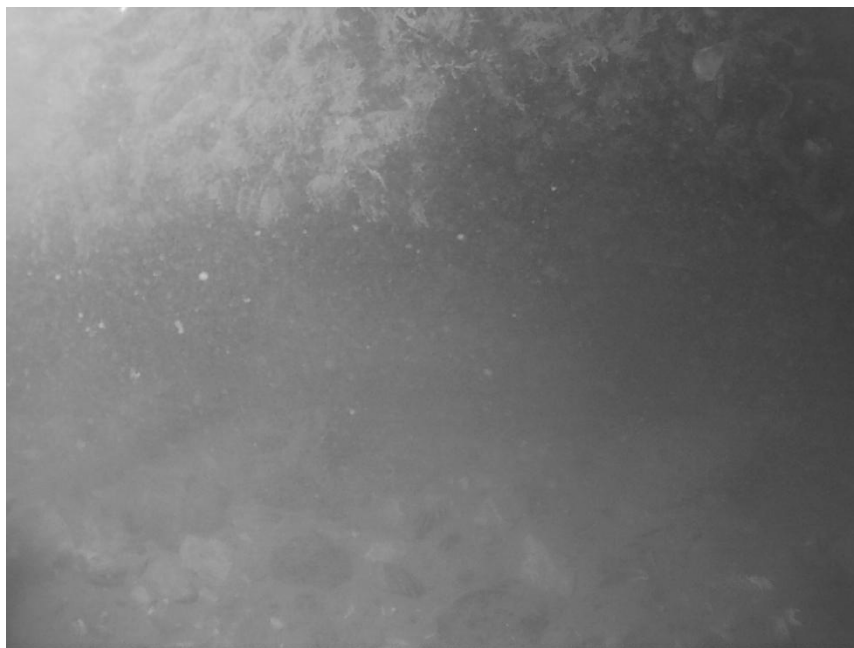
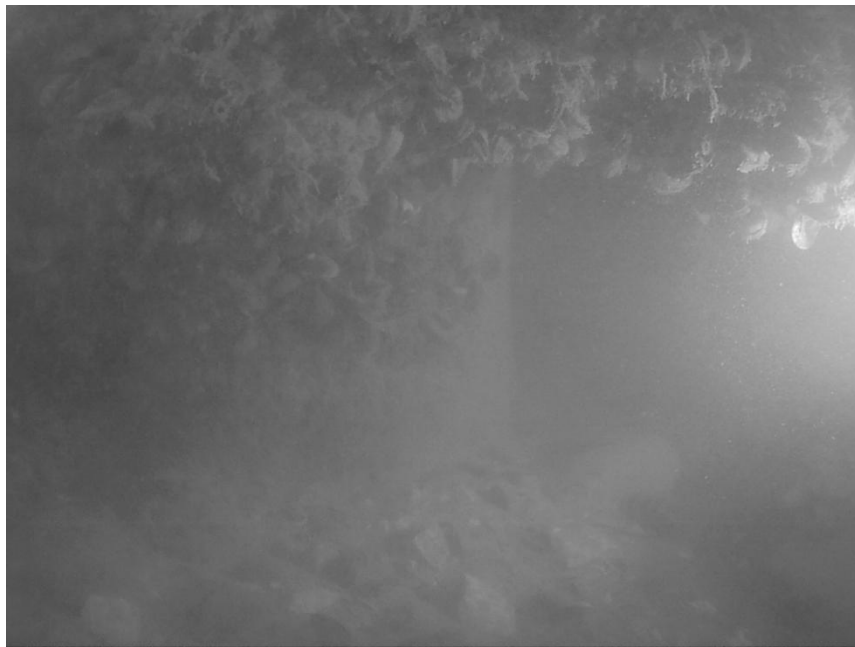
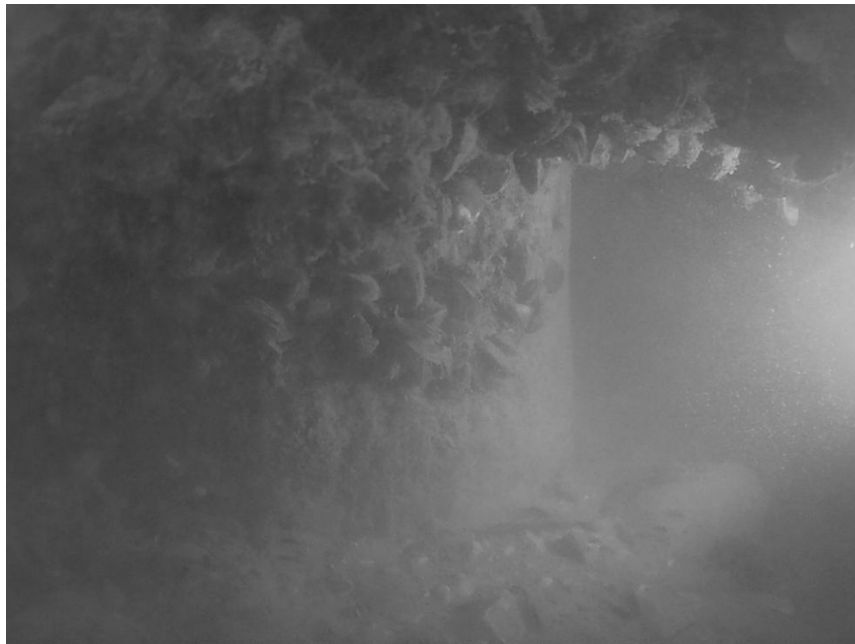
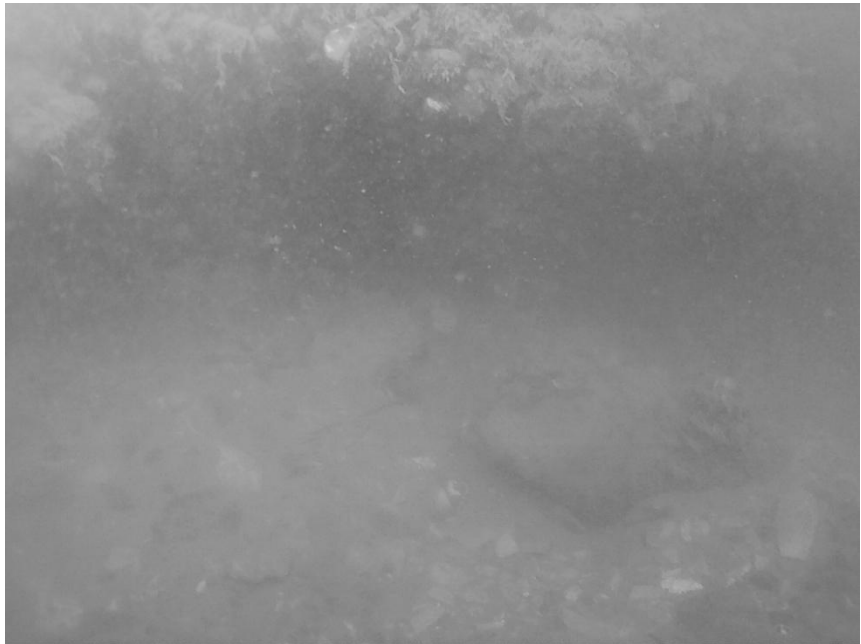
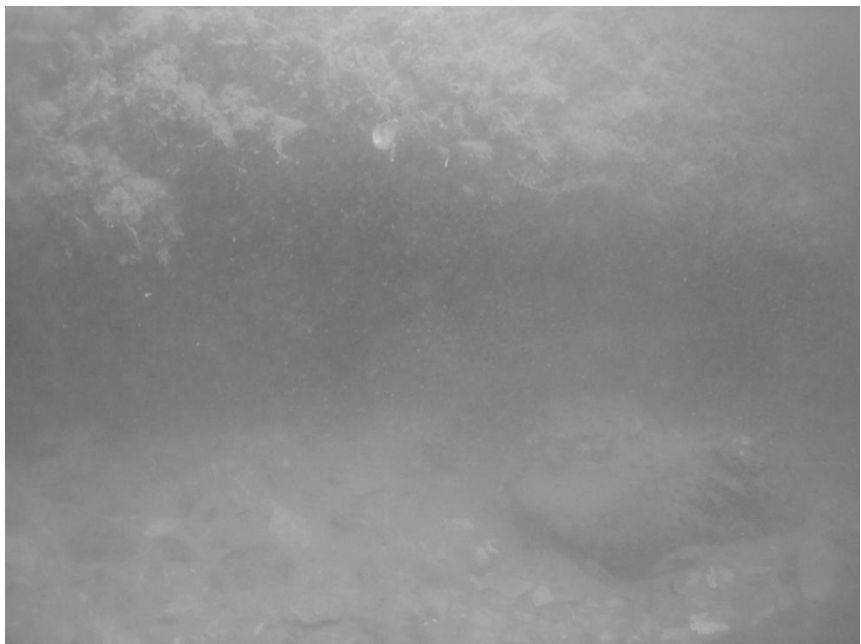
Typical panel bottom and supporting timber at chainage 0+330

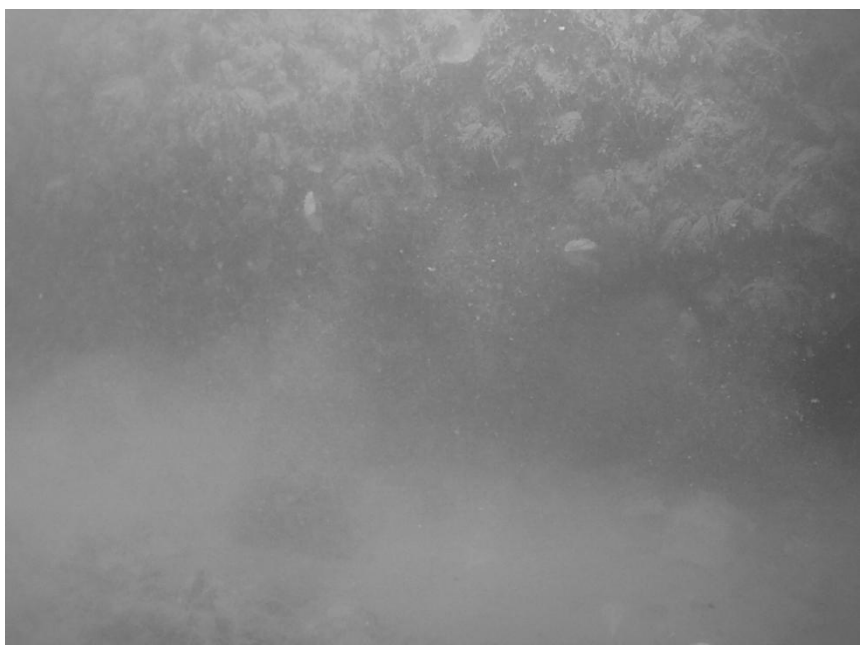
PHOTO # 39
	Typical panel bottom and supporting timber at chainage 0+330

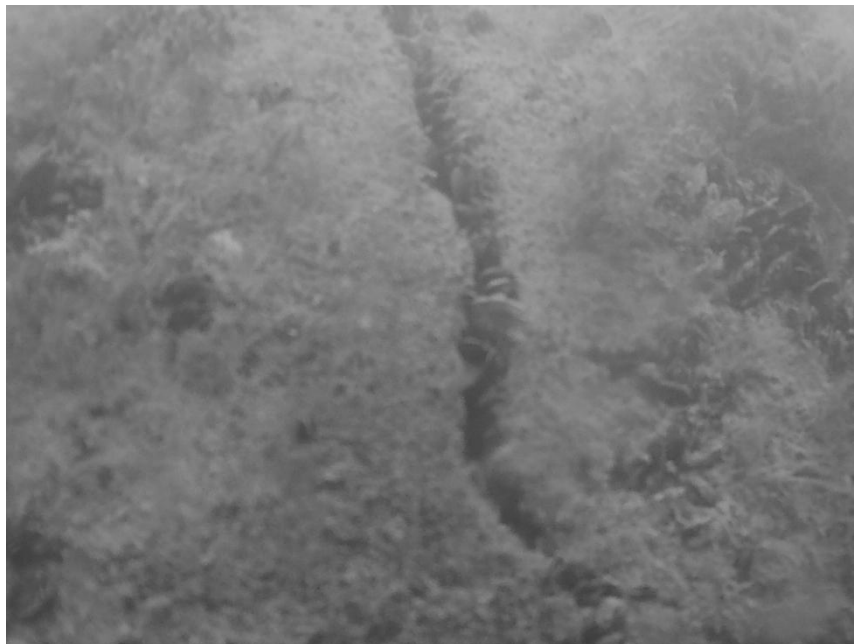
PHOTO # 47

Vertical cracking in concrete panel Station 0+796
